THE AIRPLANE FACTORY (Pty) Ltd, Registration no 2002/022837/07
Hangar 8 Tedderfield Airpark, Nettleton Road, Eikenhof, 1872, Johannesburg South
PO Box 308, Eikenhof, 1872, South Africa. Tel: +27 (0) 11 948 9898 Fax: +27 (0) 86 632 4493
E-mail: sales@airplanefactory.co.za Web: www.airplanefactory.co.za
Approved Maintenance Organisation AMO1264 Manufacturing Organisation M677

SERVICE BULLETIN

#008

TITLE:	Inspection of propeller hub – ground adjustable Warp Drive propellers
RELEASE DATE:	10 November 2016
EFFECTIVE DATE:	10 November 2016
REASON:	Risk of failure of propeller hub in ground adjustable Warp Drive propeller systems fitted to Rotax 912 iS engines.
DESCRIPTION:	This Service Bulletin provides instructions for the removal of the propeller and hub for purposes of, and the inspection of, the propeller hub on ground adjustable Warp Drive propeller systems fitted to aircraft with Rotax 912 iS engines.
MODELS AFFECTED:	All Sling LSA and Sling 2 aircraft fitted with a Rotax 912 iS engine and a ground adjustable Warp Drive propeller.
COMPLIANCE TIME:	At each 100 hour or 12 month (annual-type) inspection.
TYPE OF MAINTENANCE:	Class 1 product maintenance – removal and inspection of p

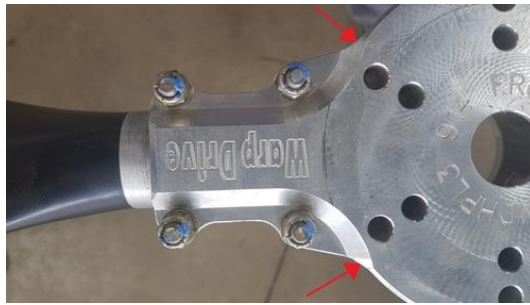
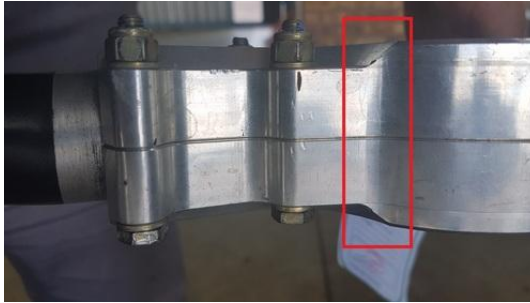
INSTRUCTIONS:	<ol style="list-style-type: none">1. Remove aircraft propeller and propeller hub in accordance with the currently applicable aircraft maintenance and Warp Drive installation and maintenance manuals.2. Following removal of the propeller hub carefully inspect the hub for cracks using penetrant dye or other appropriate NDT test equipment, paying special attention to the areas indicated in the photograph below.

3. If no evidence of cracking is found, re-assemble and re-fit propeller hub, blades and spinner in accordance with the currently applicable aircraft maintenance and Warp Drive installation and maintenance manuals.
4. If any cracks are found, The Airplane Factory should be notified and the hub replaced prior to the aircraft being placed back into service.
