## SERVICE BULLETIN

#0005

**SUBJECT:** Incorrect material used on guides which could lead to premature wear on pushrods

**MODELS AFFECTED:** All Sling LSA, Sling 2, Sling Taildragger, Sling 4 – Manufactured after January 2015

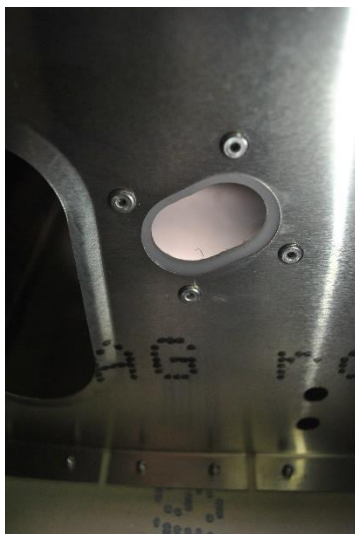
WINGS  
BOTH THESE GUIDES ARE CORRECT

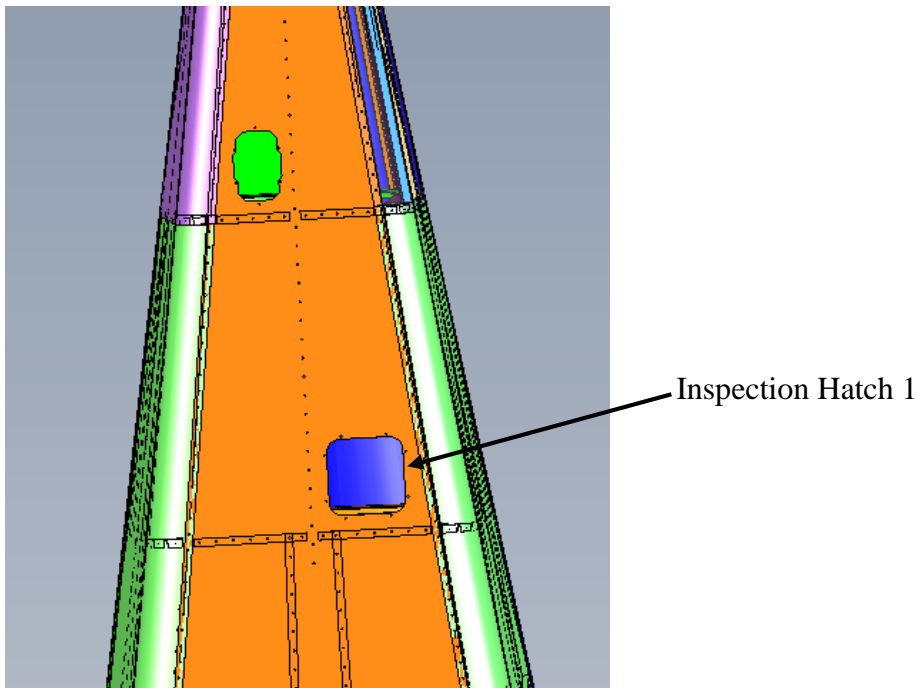
With reference to the above picture, inspection hatch 1 will need to be opened. This hatch is located on the bottom of the rear fuselage.

1. Unscrew all 8 screws and remove the hatch from the fuselage skin so as to gain access to the Pushrod located on the beam.
2. Visually inspect the pushrod for excessive wear. Visually inspect the pushrod guide for the correct material. The below pictures show the guide to be inspected.
