Sling Aircraft (Pty) Ltd
Registration no 2002/022837/07
Approved Maintenance Organisation AMO1264
Manufacturing Organisation M677

SERVICE BULLETIN

#0023

SUBJECT: Incorrect Nose Gear Bolt Replacement

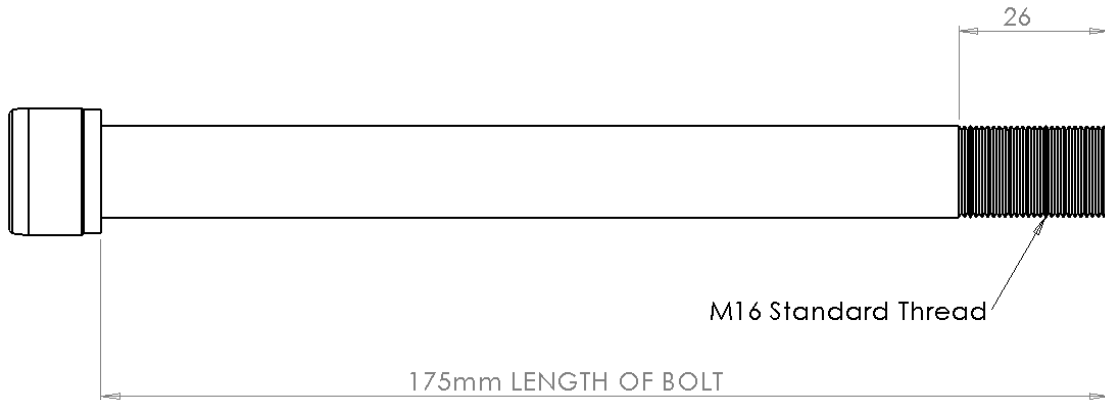
Figure 1: Correct Nose Gear Bolt thread length

The threaded section on the nose gear bolt provided to the affected aircraft is too long. This results in the threaded section of the bolt being loaded and may make the bolt more likely to fatigue and/or possibly break with a rough landing. This bolt needs to be replaced with one of the correct thread length to ensure that the thread does not get loaded.

Figure 1 shows the correct nose gear bolt dimensions. The nose gear bolt (HW-MCB-612-X-X-0) dimensions should be checked and if the bolt's thread length is incorrect it must be replaced with a new bolt of the correct dimensions. These bolts can be ordered from Sling Aircraft.
