## SERVICE BULLETIN

#0017

**SUBJECT:** Potential risk of shearing of control stop plate rivets

**MODELS AFFECTED:** Sling 4 and Sling 4 TSi aircraft

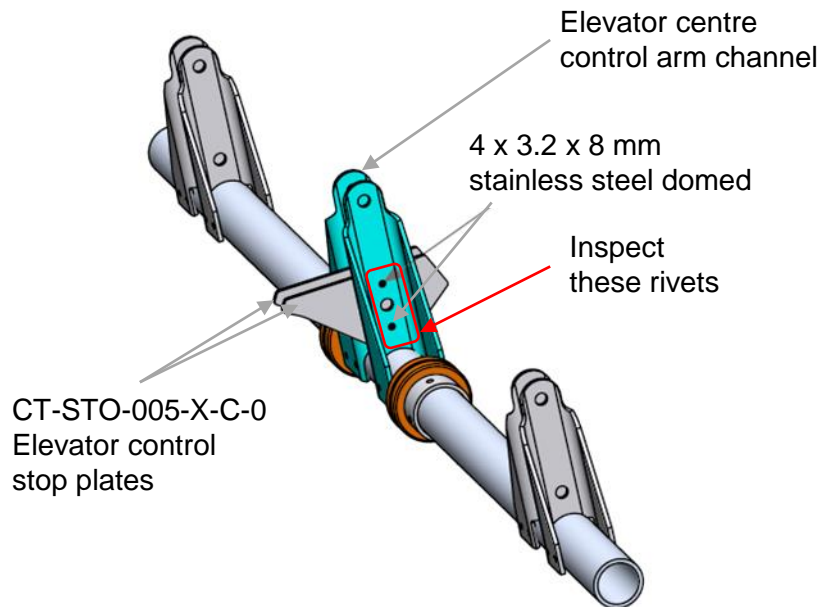
Figure 1 - Elevator control torque tube for Sling 4 and Sling 4 TSi aircraft

1. The rivets on the torque tube that need to be inspected are shown in Figure 1. The control stop plates (CT-STO-005-X-C-0) and elevator centre control arm channels are also shown in Figure 1.
2. Remove a front seat from the fuselage then use the 2 mm / 2.5 mm Allen key to remove the floor skin (refer to CF-SKN-016-R-C-0) shown in Figure 2.
3. The inspection region when the floor skin is removed is shown in Figure 3. Use the light source to determine if control stop rivets are aluminium or stainless steel. Use Figure 4 as a guide for making the distinction.
4. Alternatively (or in addition to using the light source) use a magnet to identify rivets. The mandrel of the aluminium rivet used is magnetic, so a magnet will attract to the aluminium rivet (see Figure 4).

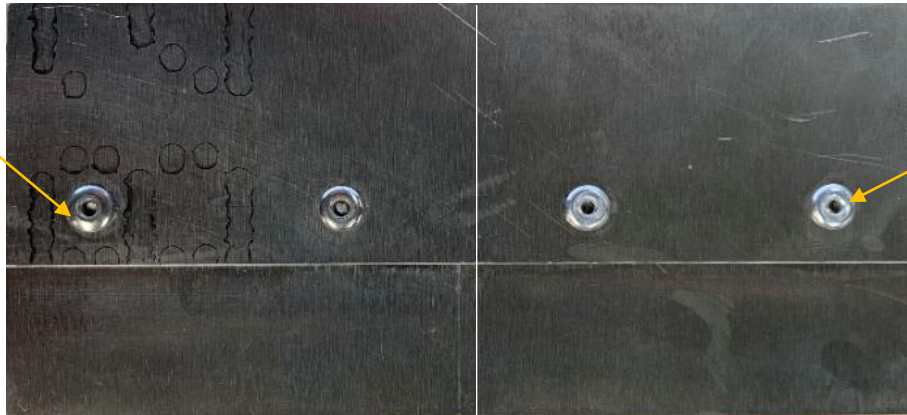
Figure 4 – Identification of stainless steel and aluminium rivets

Stainless steel  
(non-magnetic  
attraction)

Aluminium  
(magnetic  
attraction)

5. Should it be determined that the control stop rivets are stainless steel, no repair will be required, in which case the floor skin and seat can be re-installed.
6. However, should it be determined that rivets are aluminium, stainless steel rivets will need to be installed. Remove both front seats prior to repair so that the remedy can be applied to both control stop plates.
