**NOTIFICATION**

**#0002**

Wires overheating on Rotax 912 iS B-side voltage regulators

All Sling LSA and Sling 2 aircraft fitted with Rotax 912 iS engines.

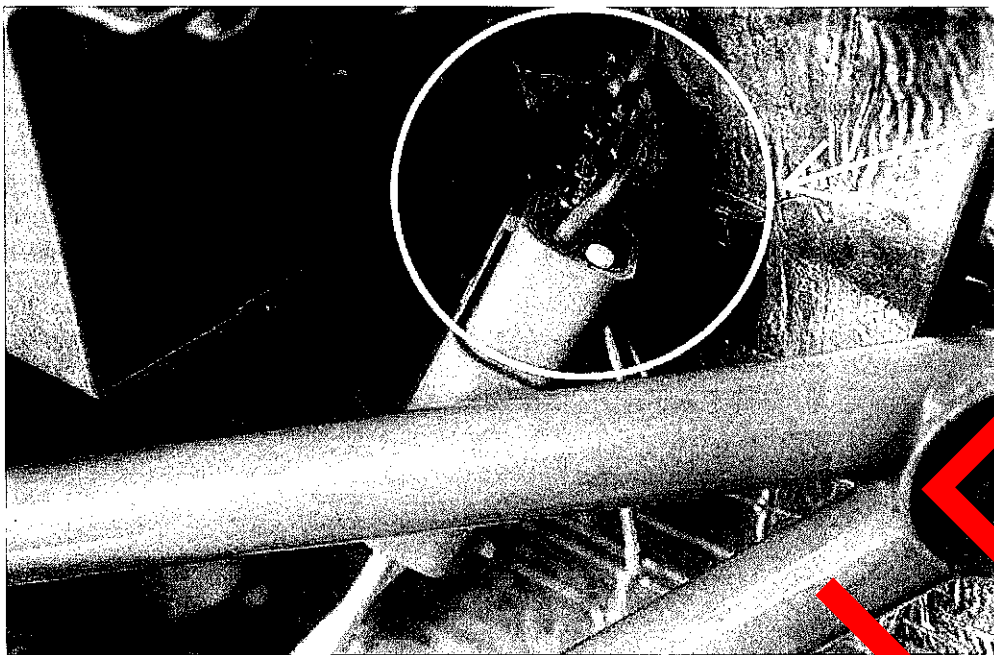
The B-side voltage regulator (which powers all auxiliary equipment such as instruments and lights) fitted to the Rotax 912 iS needs to have current drawn from it in order to remain cool. Should no current be drawn then the excess energy is dissipated through the wires and connectors which overheats them.

In the photograph below the discoloration is evident. Note the brown color of the brittle overheated wires.

Discolored Wires

Should melted wires be noticed it is recommended that the aircraft not be flown and The Airplane Factory, TAF distribute for the nearest Rotax Service Centre be contacted for assistance.

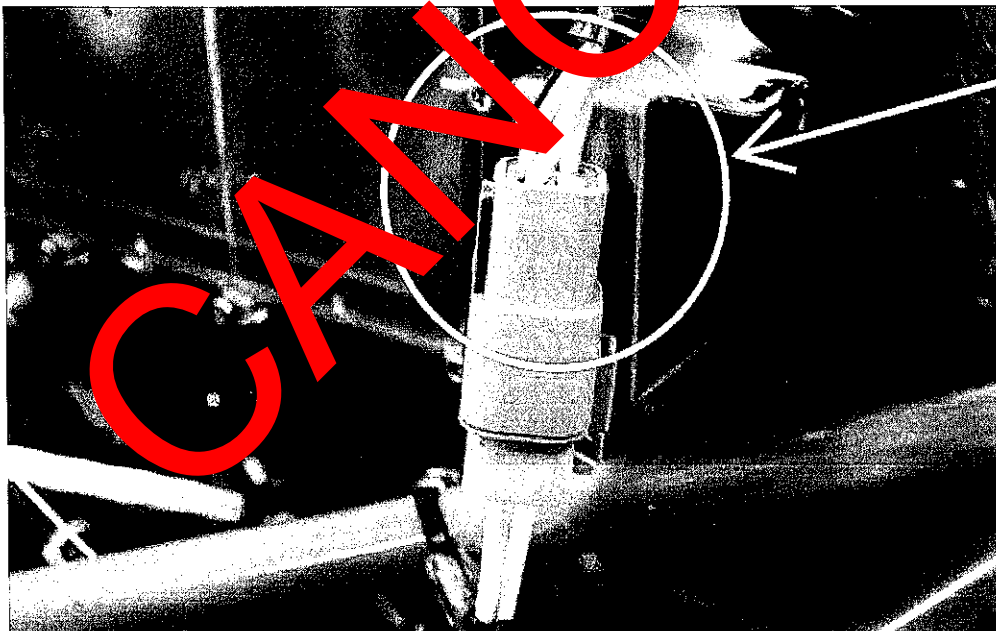
The photograph below indicates a normal voltage regulator connector plug.

Standard Color  
Wires
