THE AIRPLANE FACTORY (Pty) Ltd, Registration no 2002/022837/07

SAFETY ALERT

#0005 Revision 1

SUBJECT: Fuel pickup in the fuel tank. The new style fuel pickup inside the fuel tanks could

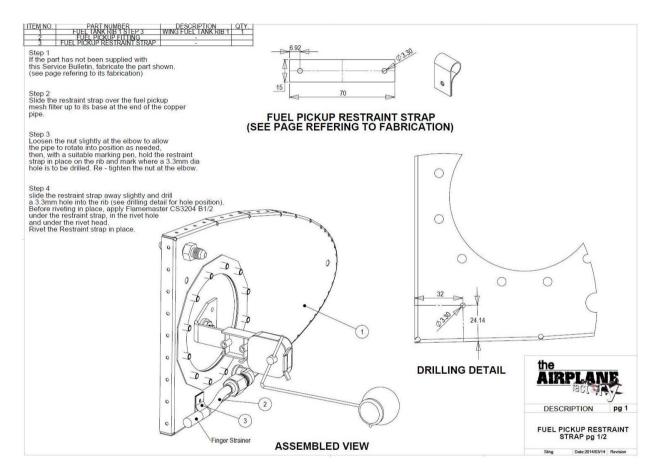
inadvertently be turned while installing fuel line fittings during assembly or maintenance. The pickup could be turned so that the pickup is facing upwards which means that up to 12 litres (3 US gallons) unusable fuel is left in the tank.

If the tank pickup is of the new design, look first for the single rivet in the corner as shown in the "DRILLING DETAIL" in the attached drawing. If the rivet is there it

PURPOSE: A small P clamp riveted to the fuel tank rib to be fitted in order to prevent the fuel

pickup from turning upwards in the fuel tank.

Be sure to use an air drill because an electric drill could cause a fire.
