SERVICE BULLETIN

#0004 Revision 1

SUBJECT: Placement of the ELT antenna

MODELS AFFECTED: All Sling LSA, Sling 2, Sling 2 Taildragger & Sling 4 aircraft where

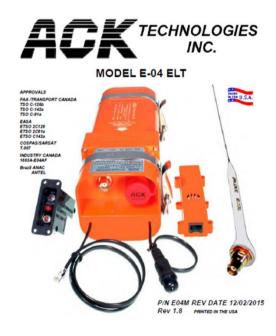
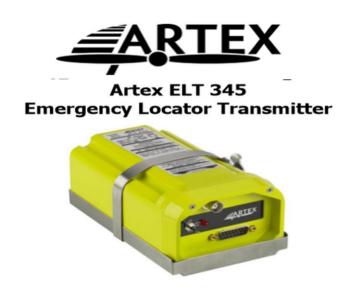
Figure 1

Note: As of 14 July 2020, the **ACK E-04** ELT was replaced with the **ARTEX 345** ELT. The **ARTEX 345** ELT is mounted in a new location within the empennage fairing. This location is the preferred mounting position recommended by Sling Aircraft to ensure compliance with requirements for an externally mounted antenna. The two different ELT options are shown in Figure 1.

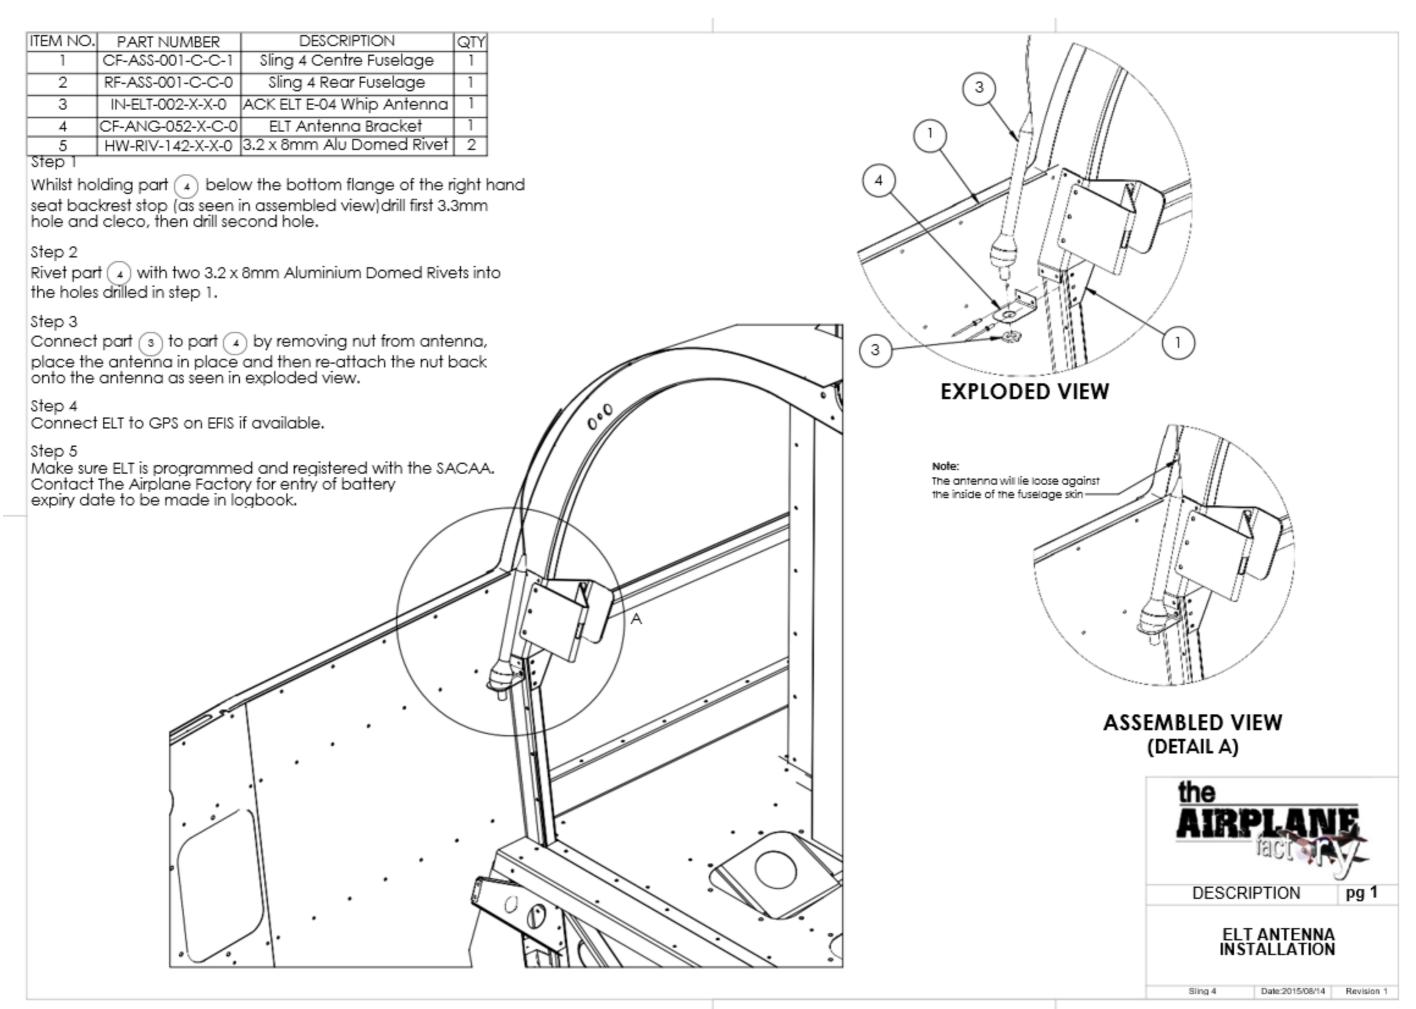
If the **ACK E-04** ELT antenna is mounted in any place other than what is stipulated in this service bulletin, then this service bulletin will apply. The installation instructions in Figure 2 on the following page illustrate the correct installation.
