SERVICE BULLETIN

#0014 Revision 2

SUBJECT: Rivet replacement along fuselage main spar carry-through and on upper and lower inboard wing skins

MODELS AFFECTED: All Sling aircraft manufactured before the effective date (04/09/2019)

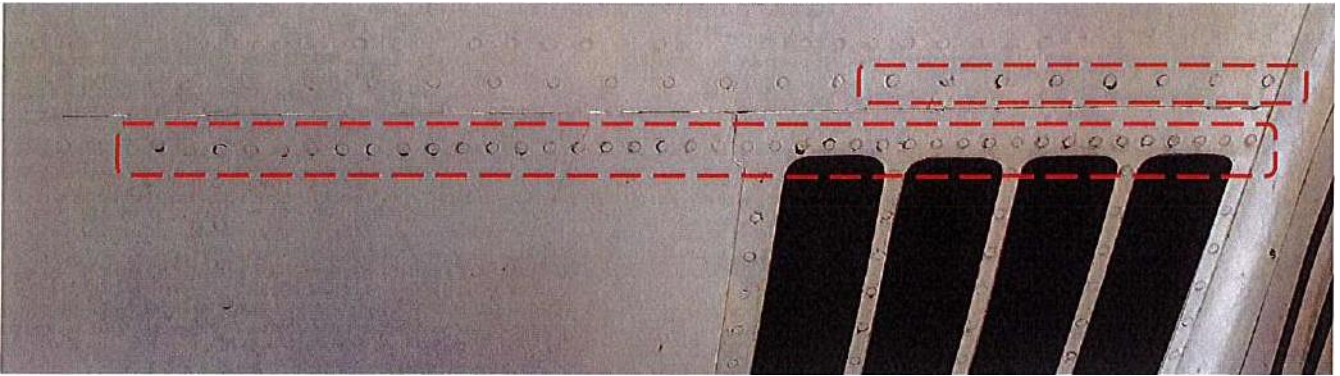
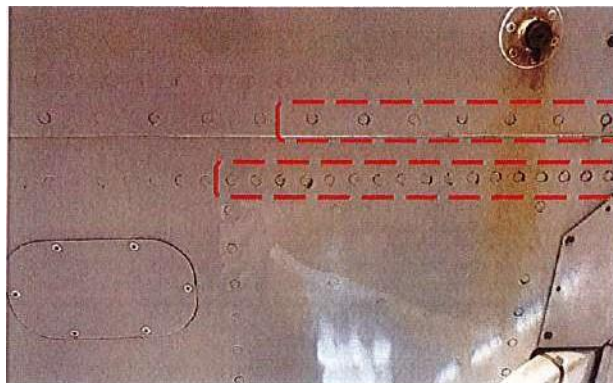
Figure I - Paint cracking around rivets on Sling 2 wing

In aircraft, fretting may occur when rivets loosen due to vibration and/or flexing allowing slight motion between skin mating surfaces.

In some Sling aircraft, an indication of this condition is paint cracking around the rivets. The affected regions are usually located on the underside of the fuselage along the man spar carry-through and on upper and lower inboard wing skins. Figure I shows paint cracking on the inboard skins of a Sling 2 aircraft.

Upper wing skin

Lower wing skin

To minimise fretting, rivets in the affected areas should be replaced with Avinox stainless steel rivets (Part number BE61-00512).

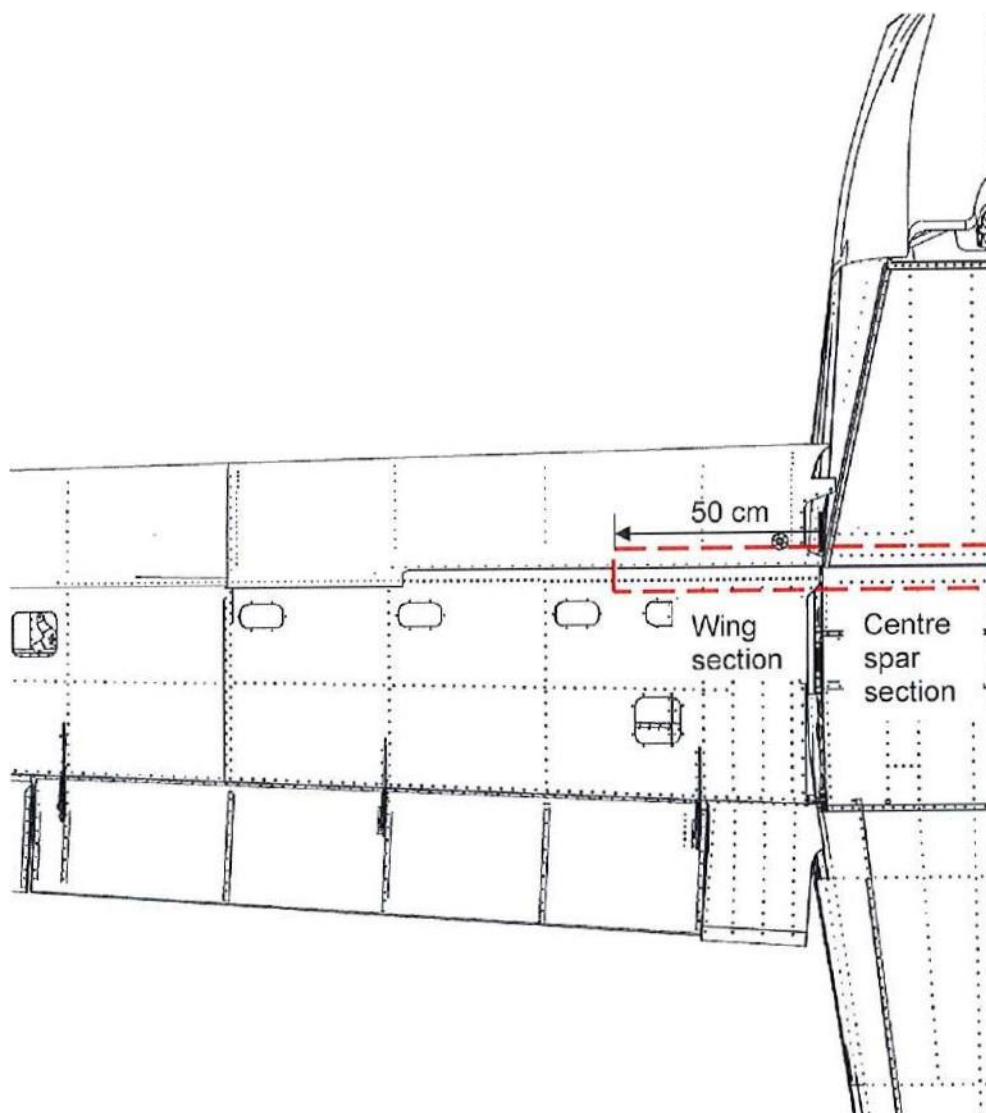
Figure 2 — Region of rivet replacement on the underside of starboard (right) wing

2. On the fuselage (of Sling TSi, Sling 2 and Sling 4 aircraft), this region is along the two rows of rivets that attach the underside centre fuselage skin to the centre spar (see Figure 2).

3. Figure 2 shows one half of the affected region on the underside of the starboard wing and fuselage and Figure 3 shows half the affected region on the upper starboard wing. The quantity of rivets recommended should cover these regions sufficiently.

5. Ensure that rivet removal is complete on the top of the wing before starting with the underside.
6. Using the powered drill with the 4 mm drill bit, drill the heads off rivets in the affected regions indicated in Figure 2 and 3 (specifically Figure 4 for Sling 2 and Figure 5 for Sling 4 wings). If rivets are filled, indent the centre of the rivet head with a centre punch and hammer before drilling.

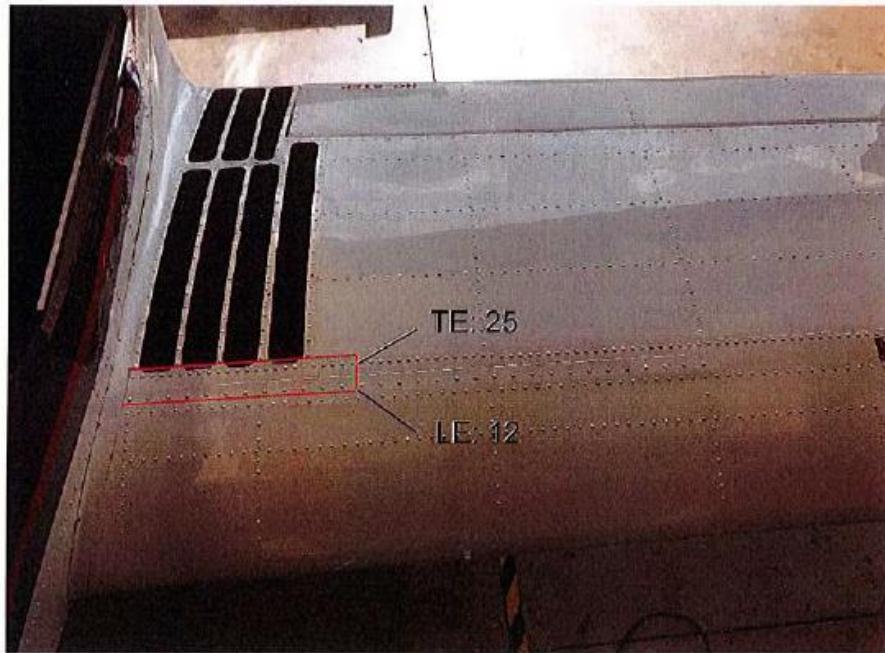
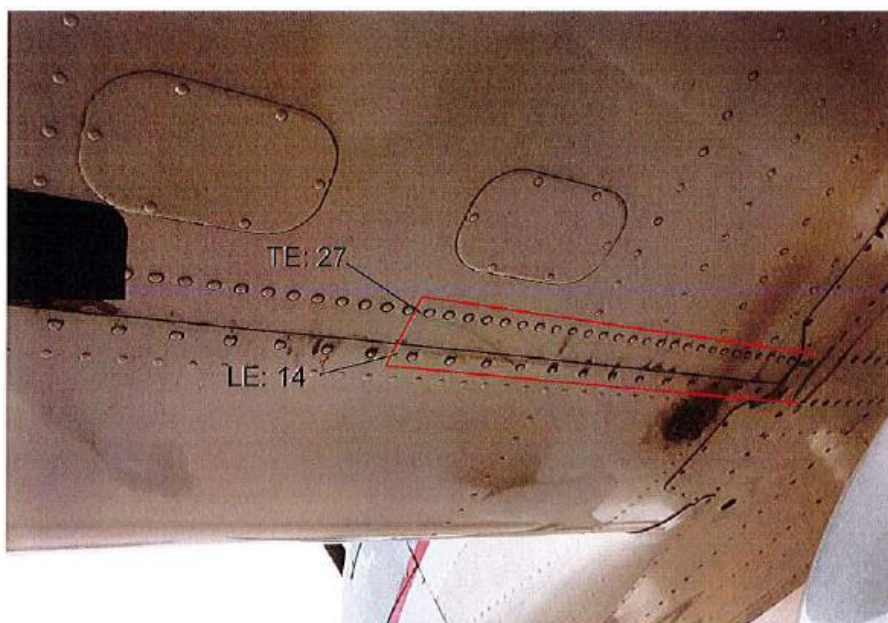
Figure 4 - Number of rivets to replace on Sling 2 and Sling LSA wings

At approximately 50cm (spanwise distance) from the wing root, on the Sling 2 wings, the rivets to be replaced are 12 on the front section (leading edge) and 25 on rear section (trailing edge) of the upper wing spar. On the underside of the Sling 2 wing, the rivets to be replaced are 14 on the leading edge and 27 on the trailing edge as shown in Figure 4.

Hence, the total number of rivets, for both wings = $[(12 + 25) + (14 + 27)] \times 2$ 156 (wings only). The number of rivets along the centre spar carry-through under the fuselage 62 (centre spar only) In total: (156 + 62) 218 rivets (Sling 2)

1. On the top and underside surfaces of both wings (of Sling 2 and Sling 4 aircraft only), the region where rivets should be replaced is along the wing main spar, a spanwise distance of approximately 50cm measured from the Wing root (see Figure 4 and Figure 5).

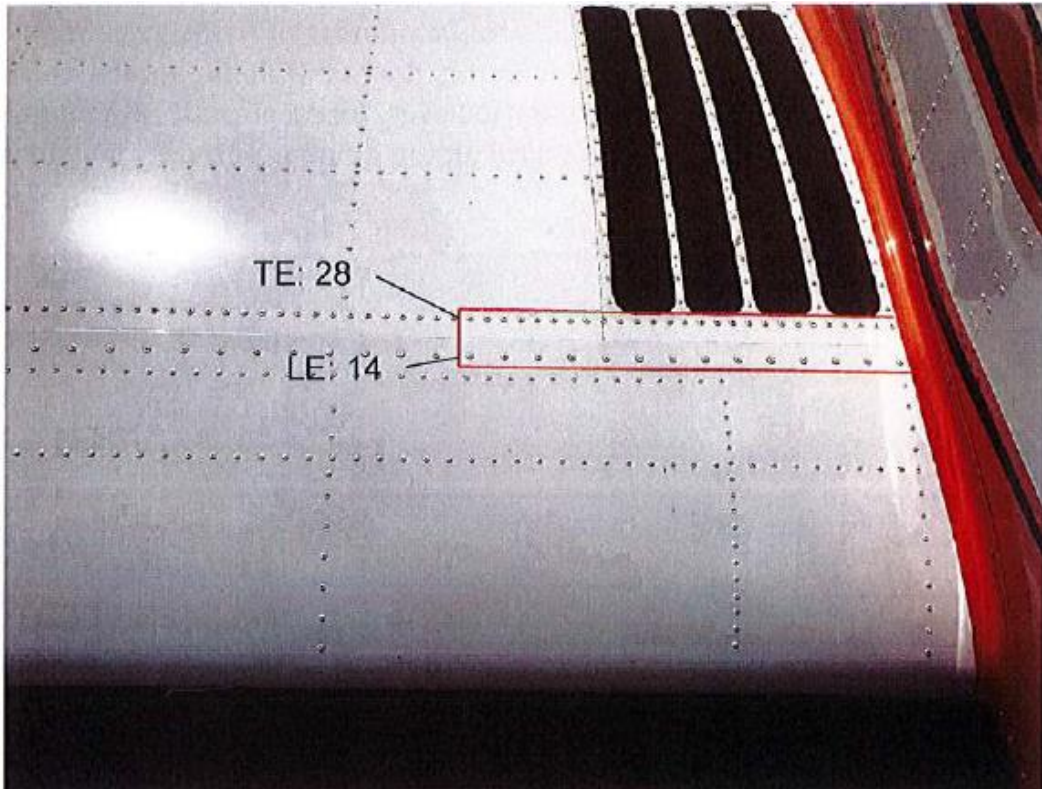
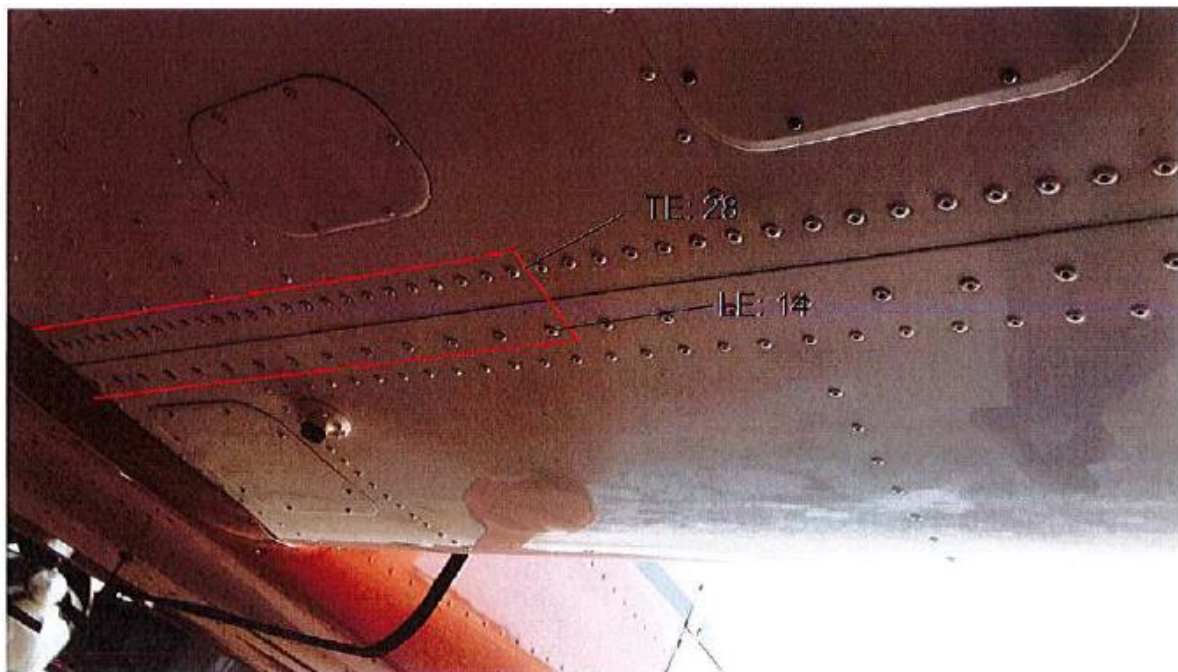
Figure 5 - Number of rivets to replace on Sling 4 wings

As illustrated below, on the Sling 4 wings, the rivets to be replaced are 14 on the front section (leading edge) and 28 on rear section (trailing edge) of the upper wing spar. On the underside of the Sling 4 wing, the rivets to be replaced are again 14 on the leading edge and 28 on the trailing edge. Hence, the total number of rivets, for both wings = $[(14 + 28) + (14 + 28)] \times 2$ 168 (wings only). The number of rivets along the centre spar carry-through under the fuselage 62 (centre spar only). In total: (168 + 62) 230 rivets (Sling 4)
