SERVICE BULLETIN

#0005 Revision 1

SUBJECT: Incorrect material used on guides which could lead to premature wear on pushrods

MODELS AFFECTED: All Sling LSA, Sling 2, Sling Taildragger, Sling 4 – Manufactured after January 2015 up until the effective date (03/09/2015).

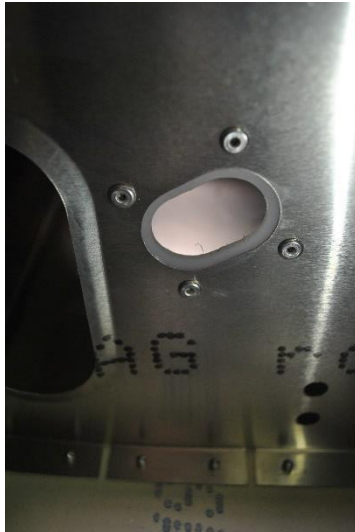
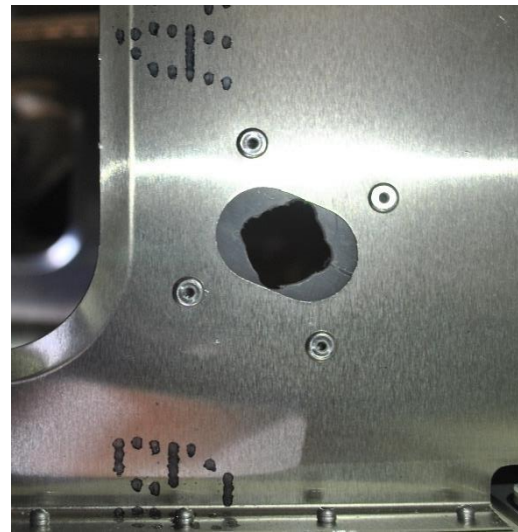
WINGS
BOTH THESE GUIDES ARE CORRECT

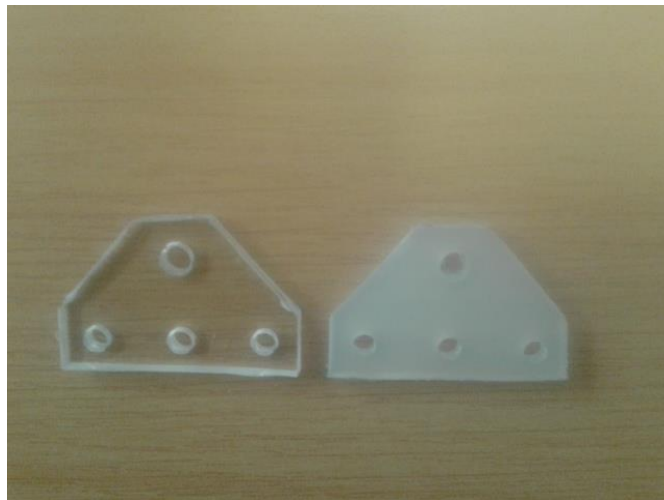
The pictures below are purely for illustration purposes of showing the incorrect and correct material. The material on the left is incorrect and the material on the right is correct.
