SERVICE BULLETIN

#0013 Revision 1

RELEASE DATE: 19 August 2025
REASON FOR REVISION 1: Update to list of affected models
EFFECTIVE DATE: 8 June 2018
SUBJECT: Rudder Pedal Stop Replacement
MODELS AFFECTED: Sling LSA and Sling 2 - SIN 001-130 (Inclusive)
Sling 4 - SIN 001 - 015 (Inclusive)
Aircraft manufactured before the effective date (08/06/2018) not included within the serial numbers above, please comply with Note 2 below.
COMPLIANCE TIME: Next scheduled mandatory periodic inspection ("MPI")

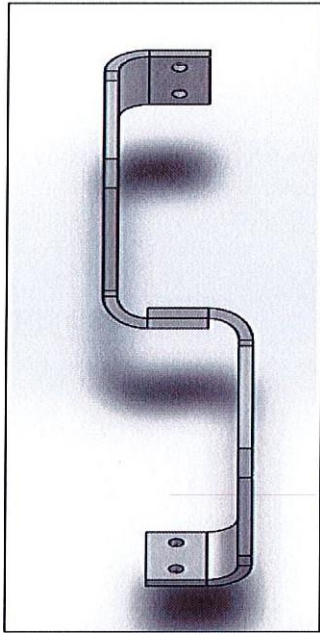
To prevent failure of the rudder stops due to excessive force being applied to the rudder pedals.

Figure 4 — Old pedal stop assembly

6. Completely remove the rudder control stop on right-hand side by removing the AN3 nut with a 3/8" spanner/ratchet and AN4 nut with 7/16" spanner/ratchet.

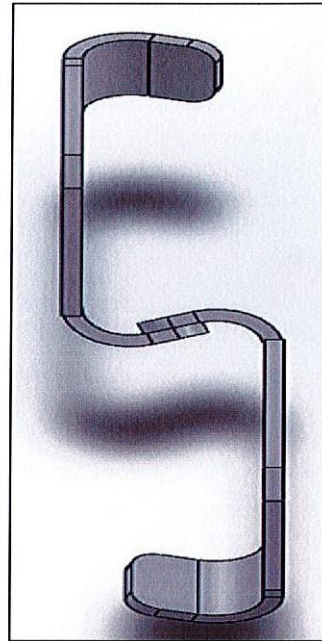
Figure 5 — New pedal stop assembly

This Service Bulletin requires that the change be made to all affected flying aircraft during the next MPI immediately after 8 June 2018. In addition, the change should be applied to all affected kit-built aircraft still under construction prior to first flight. The change requires the rudder control stop with the part numbers CT-STO-004X-A-O, CT-STO-004-X-A-1, CT-STO-004-X-C-O and CT-STO-004-X-C-1 to be replaced by the modified rudder control stop with the part number CT-STO-004-X-A-3 or CT-STO-004-X-A-4 (To be requested from your local distributor).

9. Remove the rudder control stop and install new control stop (CT-STO-004-X-A-3 or CT-STO-004-X-A-4) onto the pilot punch.
10. Reinstall bolts through control stops - using the AN3 bolt push the 4mm pilot punch outwards, until punch falls out, continue the same method with the AN4 bolt and 6mm pilot punch.
