## **SERVICE BULLETIN**

#0017 Revision 1

**SUBJECT:** Potential risk of shearing of control stop plate rivets

**MODELS AFFECTED:** Sling 4 and Sling 4 TSi aircraft manufactured before the effective date (01/07/2020)

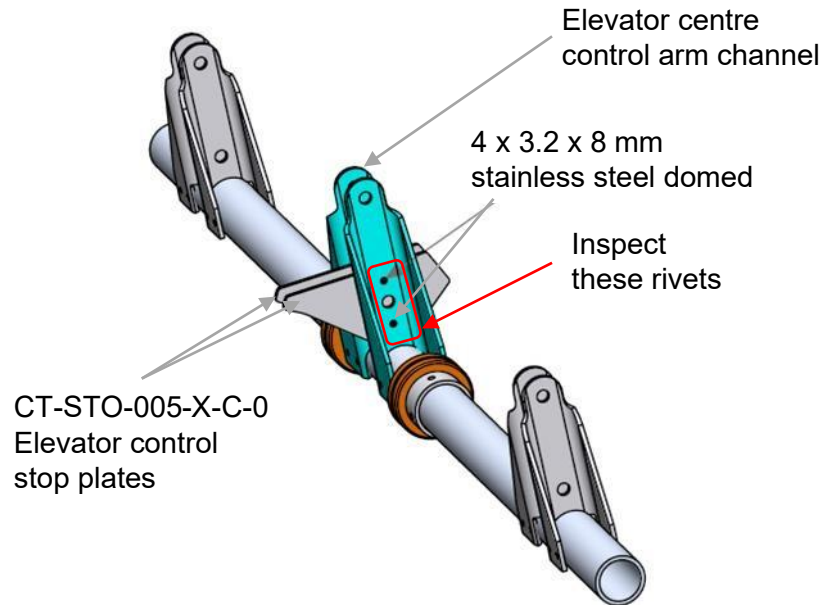
Figure 1 - Elevator control torque tube for Sling 4 and Sling 4 TSi aircraft

1. The rivets on the torque tube that need to be inspected are shown in Figure 1. The control stop plates (CT-STO-005-X-C-0) and elevator centre control arm channels are also shown in Figure 1.

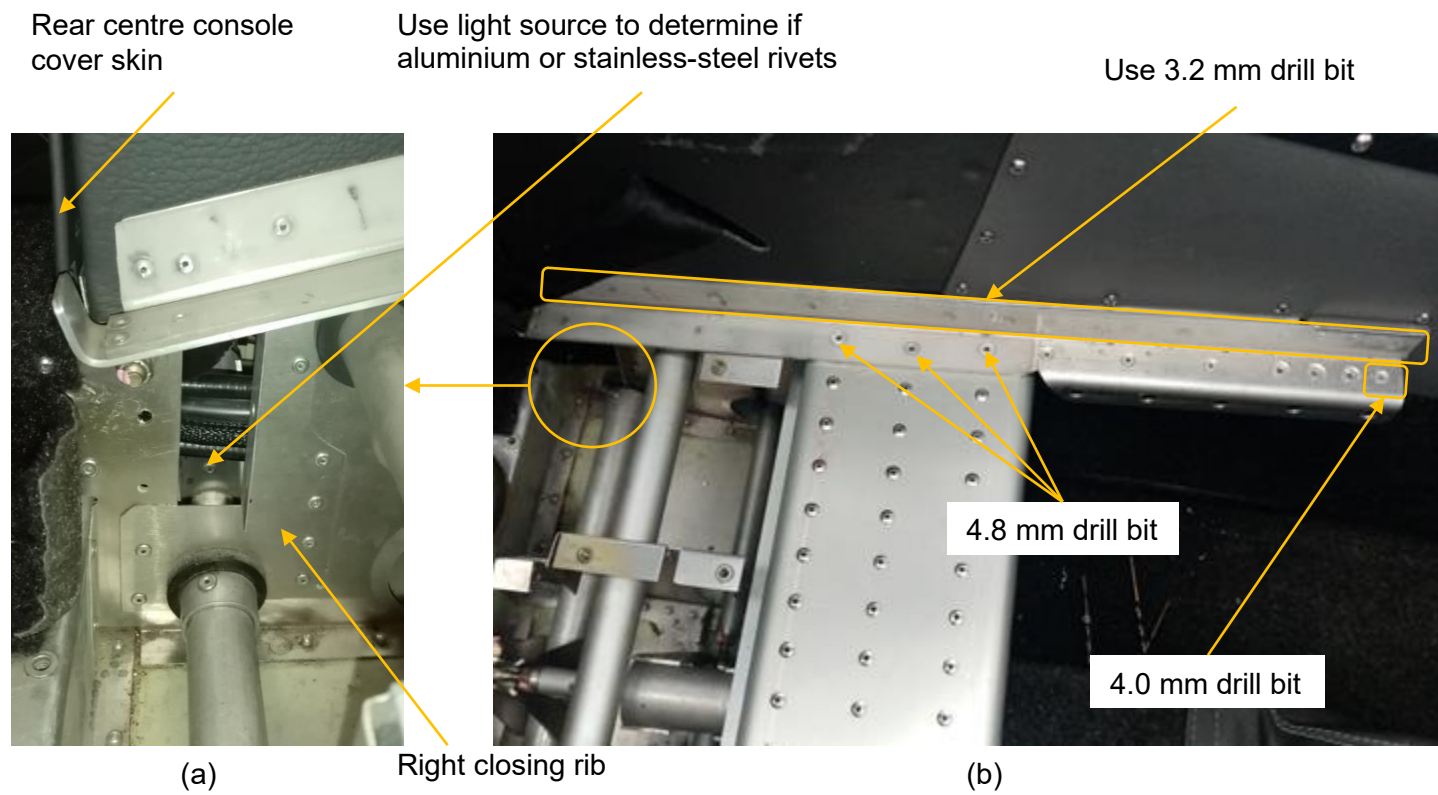
Figure 3 - Region of inspection area and seat rail

2. Remove a front seat from the fuselage then use the 2 mm / 2.5 mm Allen key to remove the floor skin (refer to CF-SKN-016-R-C-0) shown in Figure 2.
3. The inspection region when the floor skin is removed is shown in Figure 3. Use the light source to determine if control stop rivets are aluminium or stainless steel. Use Figure 4 as a guide for making the distinction.

7. Drill the heads off the countersunk rivets shown in Figure 3(b) with the angle drill (using 3.2 and 4.8 mm drill bits) to remove seat rails.
8. Remove and retain all M3 / M4 screws on the aft section of the centre console to separate it from the forward section as shown in Figure 5(a).

20. Return the seat rails, including the plastic plates, using clecos to align the holes before riveting. Use the hand riveter, two 4.0 x 10 mm and six 4.8 x 15 mm countersunk aluminium rivets to assemble the seat rails. In addition, install the (18) 3.2 x 10 countersunk aluminium rivets on the upper rails (see Figure 3(b)).

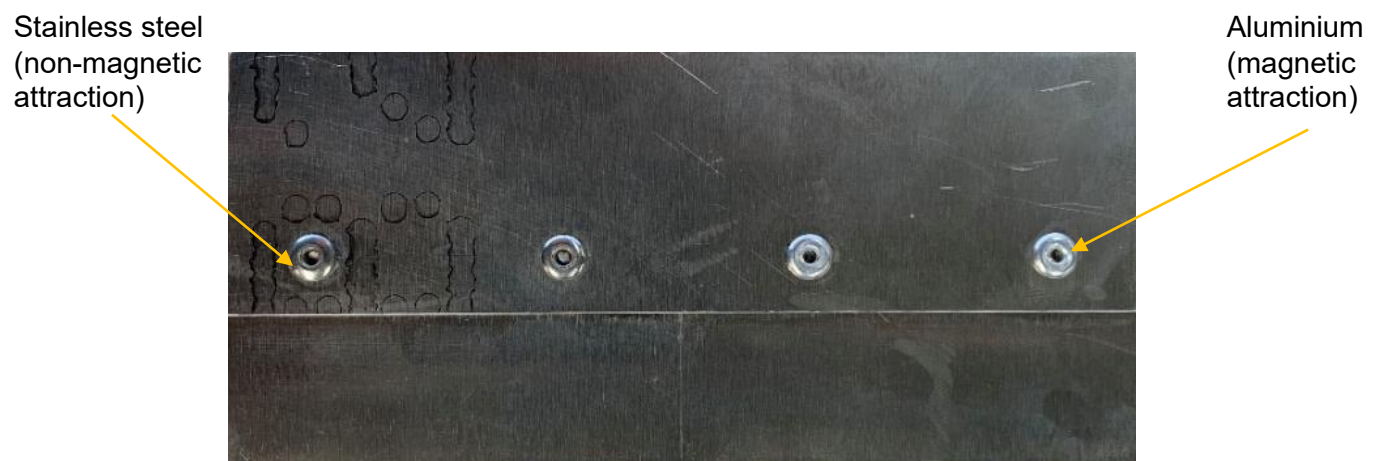
Figure 4 – Identification of stainless steel and aluminium rivets

4. Alternatively (or in addition to using the light source) use a magnet to identify rivets. The mandrel of the aluminium rivet used is magnetic, so a magnet will attract to the aluminium rivet (see Figure 4).
