NOTIFICATION

#0002

SUBJECT: Wires overheating on Rotax 912 iS B-side voltage regulators

MODELS AFFECTED: All Sling LSA and Sling 2 aircraft fitted with Rotax 912 iS engines.

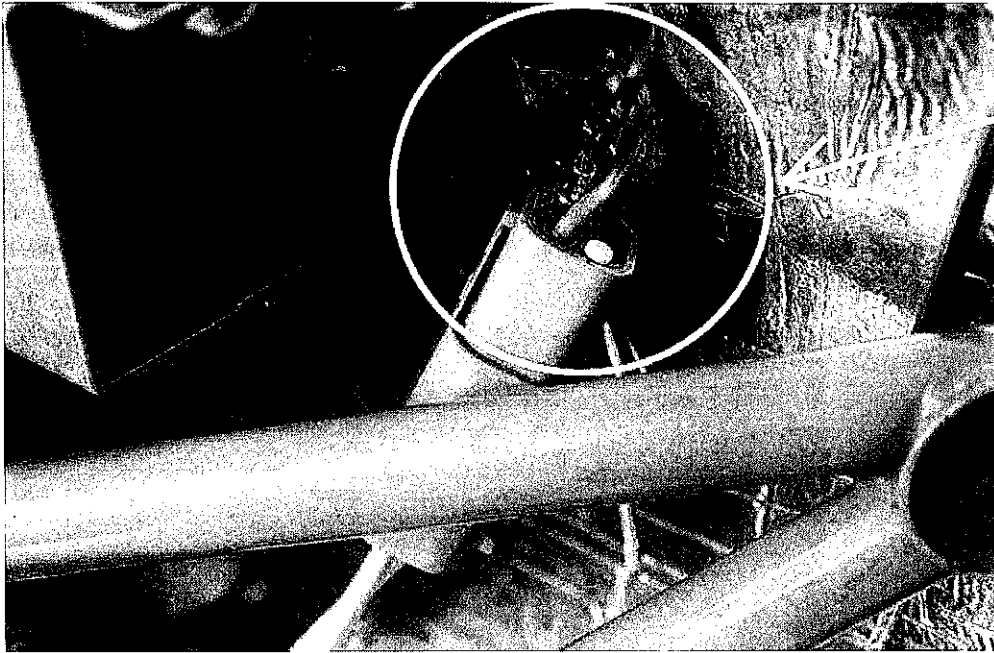
The B-side voltage regulator (which powers all auxiliary equipment such as instruments and lights) fitted to the Rotax 912 iS needs to have current drawn from it in order to remain cool. Should no current be drawn then the excess energy is dissipated through the wires and connectors which overheats them.

In the photograph below the discoloration is evident. Note the brown color of the brittle overheated wires.

Discolored Wires

Should melted wires be noticed, it is recommended that the aircraft not be flown and The Airplane Factory, TAF distributor or the nearest Rotax Service Centre be contacted for assistance.

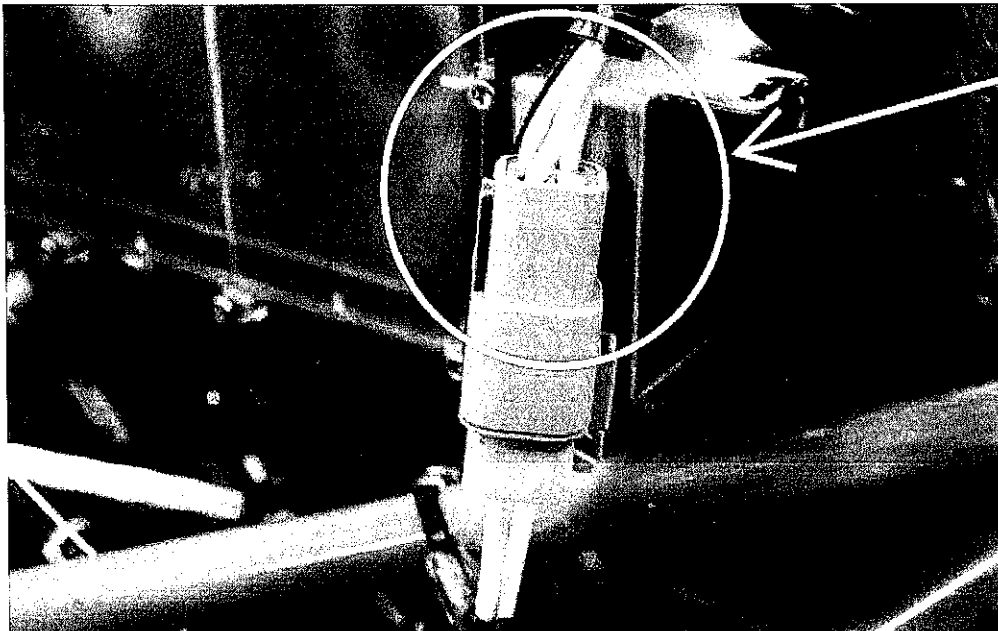
The photograph below indicates a normal voltage regulator connector plug.

Standard Color
Wires
