**Sling Aircraft (Pty) Ltd**  
**Registration no 2002/022837/07**  
Approved Maintenance Organisation AMO1264  
Manufacturing Organisation M677

## NOTIFICATION

#0011

**SUBJECT:** Throttle cable inspection

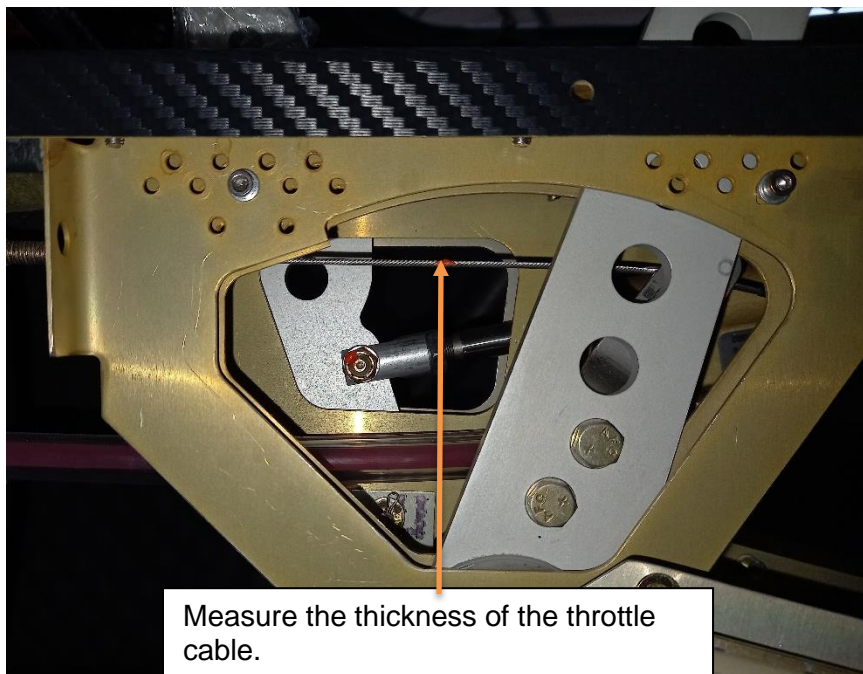
*Figure 1: Throttle cable to be measured*

It was discovered that 2mm throttle cables installed on a limited number of aircraft may pose a risk of jamming. Any 2mm thick throttle cable that has been installed must be replaced with a 1.5mm cable. If the 2mm cable is not replaced with the 1.5mm cable there is the potential for the throttle cable to stick, resulting in reduced throttle control/travel.

- Step 1. Remove the centre console side inspection panel, on the pilot (left) side of the aircraft. The front seat may need to be removed in order to make removing this panel easier. To do so follow Step 2.
- Step 2. Remove the front seat on the pilot (left) side of the aircraft. Refer to Section 4.3.2.1 in the Sling 2 maintenance manual (DC-MAM-002-X-B).
- Step 3. Once the panel has been removed, use a vernier calliper to measure the throttle cable thickness. Refer to *Figure 1*.

If the cable is found to be a 2mm cable and not a 1.5mm cable, replace the cable with a 1.5mm cable. If the correct cable is installed, reinstall the inspection hatch and front seat.

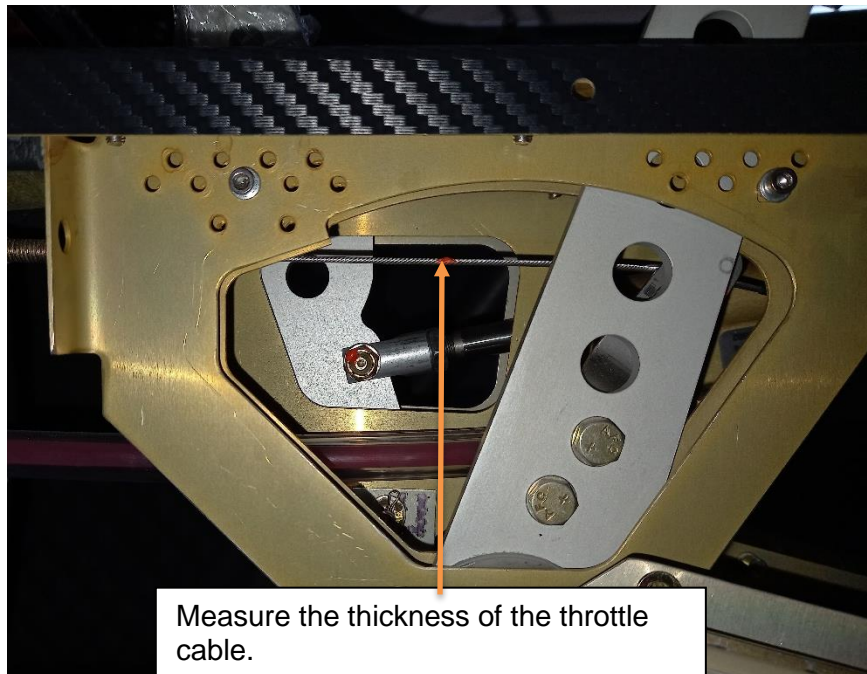
*Figure 2: Throttle cable to be measured*

- Step 1. Remove the centre console side inspection panel, on the pilot (left) side of the aircraft. The front seat may need to be removed in order to make removing this panel easier. To do so follow Step 2.
- Step 2. Remove the front seat on the pilot (left) side of the aircraft. Refer to Section 4.2.2.1 in the Sling 4 TSi maintenance manual (DC-MAM-001-X-F).
- Step 3. Once the panel has been removed, use a vernier calliper to measure the throttle cable thickness. Refer to Figure 2.

If the cable is found to be a 2mm cable and not a 1.5mm cable, replace the cable. If the correct cable is installed, reinstall the inspection hatch and front seat.
