NOTIFICATION

#0009

SUBJECT: Static Longitudinal Stability – Permitted Removal of Elevator Centre Balance Weights.
Optional modification to be referred to as “Sling 4 TS*i* Optional Elevator Centre Balance Weight Removal Modification”

MODELS AFFECTED: Sling 4 TS*i* (All)

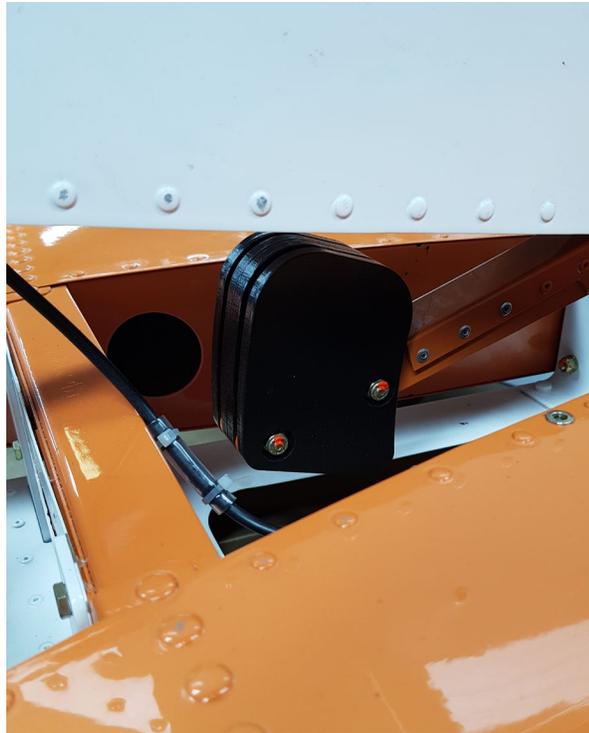
Figure 1 Elevator centre balance weight visible after removing empennage fairing

1. Ensure the master switch is off.
2. Remove the empennage fairing.
 - a. With the 4mm hex key, by removing all 4mm button screws fastening the fairing to the rear fuselage.
 - b. Once all button screws are removed, pull the fairing forwards and upwards, away from the empennage. Be mindful that the fairing can scratch paintwork if removed incorrectly.

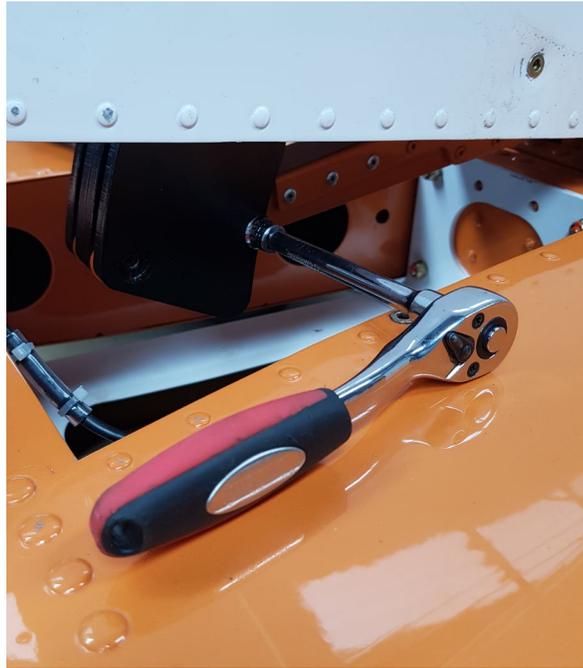
Figure 2 Removal of the balance weight bolts

3. Remove the balance weight plates
 - a. Once fairing is removed, remove the two 10mm bolts that fasten the weight plates with the 10mm hex socket, extension bar and ratchet handle/sliding bar.

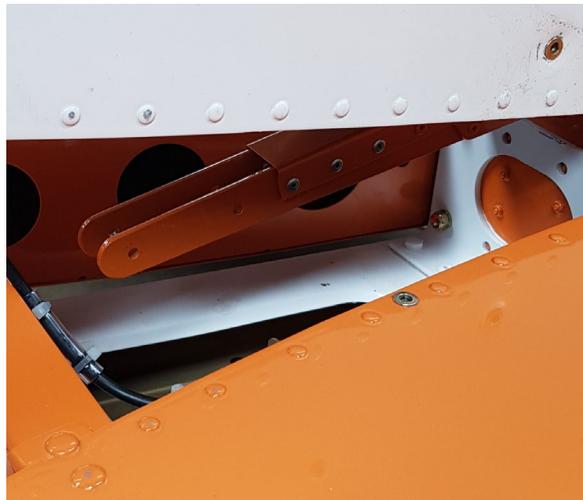
Figure 3 Balance weight arm after weight removal

4. Replace the empennage fairing.
 - a. Similar to when removed, reinstall the fairing from the front. Be mindful of getting the lower fingers of the fairing underneath the horizontal stabilizer.
 - b. Reinstall all 4mm cap screws.

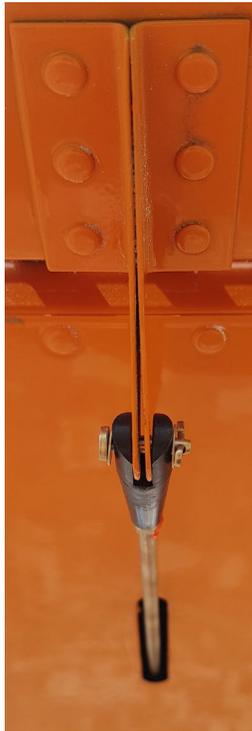
Figure 4 Trim arm with clevis, split pin and pin visible

1. Remove the split pin, that secures the clevis/trim tab connecting pin, with long/needle-nose pliers.

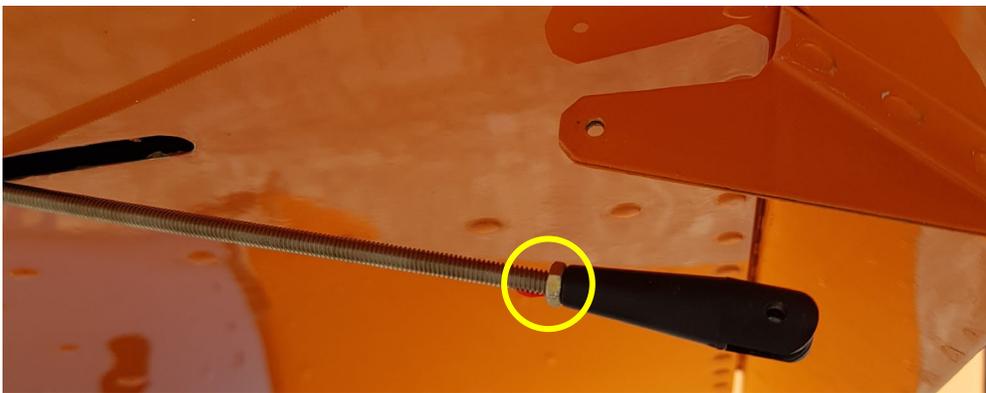
Figure 5 Trim arm clevis locking nut

2. Remove the clevis/trim tab connecting pin.
3. Loosen the $\frac{1}{4}$ " nut, with the appropriate wrench, and turn the nut such that there is at least a 10mm gap between the nut and plastic clevis.

4. Turn the clevis a full 3 revolutions clockwise (inwards).
5. Tighten the locking nut against the clevis, without letting the clevis rotate.
6. Re-insert the clevis/trim tab control horn pin.
7. Insert a new split pin and secure in place.
