**NOTIFICATION**

#0008

**RELEASE DATE:** 04/06/2021  
**EFFECTIVE DATE:** 04/06/2021  
**SUBJECT:** Potential risk of trim tab motor disconnecting from elevator skin  
**MODELS AFFECTED:** All Sling aircraft delivered prior to October 2020  
**COMPLIANCE TIME:** During pre-flight inspection

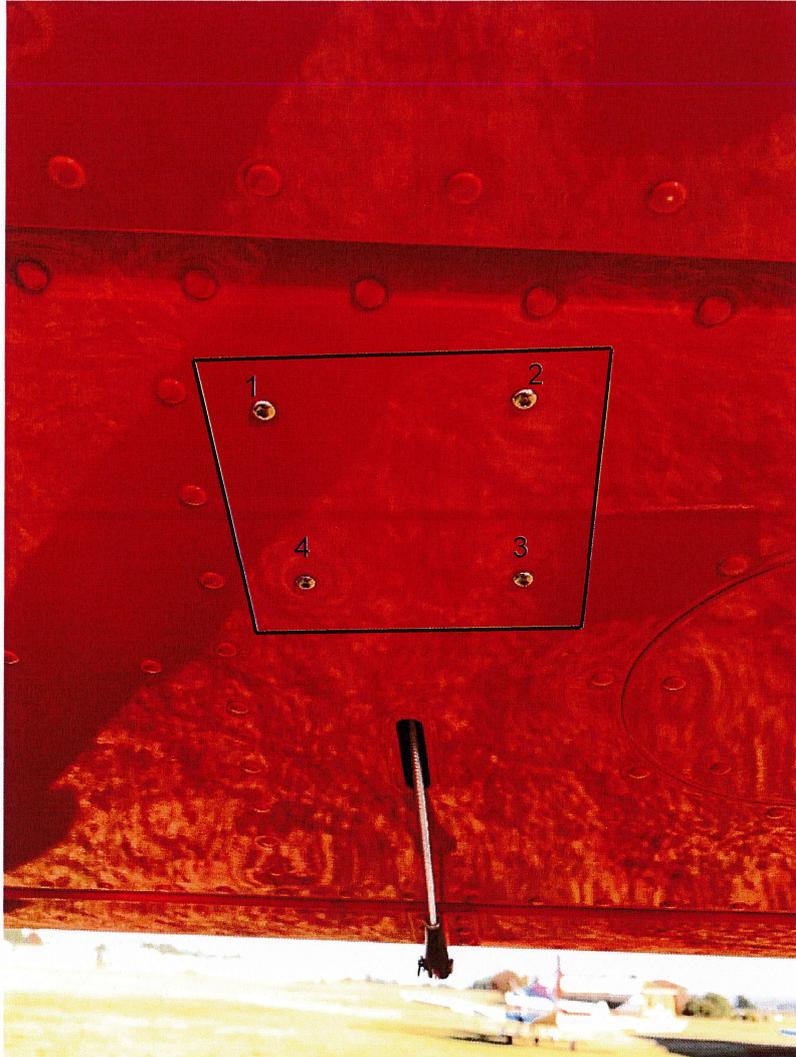
- a) The trim tab motor is secured to the elevator skin with four M3x10mm button head screws. Check that all four screws are present as shown in Figure 1.

Figure 1: Ensure all four attaching screws are present

- b) Missing screws must be re-installed with Loctite 222.
- c) In the unlikely event that missing screws result from rivnut failure (such as the rivnuts(s) breaking off from the trim motor flange), rivnuts must be replaced with 8-32 single lug anchor nuts, provided the trim motor flange is absent of damage that would prevent re-use.

- e) For aircraft produced after October 2020, the M3 rivnuts and M3x10mm button head screws have been superseded by 8-32 single lug anchor nuts and 8-32 x 1/2" stainless steel machine screws, respectively, to reduce the risk of trim motor disconnection.
