NOTIFICATION

#0013

SUBJECT: Approval of use of Rotax cover plate to seal hydraulic constant speed governor drive attachment face on Rotax 915 iS-3-A engines.

MODELS AFFECTED: All Sling aircraft fitted or to be fitted with the Rotax 915 iS-3-A engine, and in which no hydraulic governor is used / to be used.

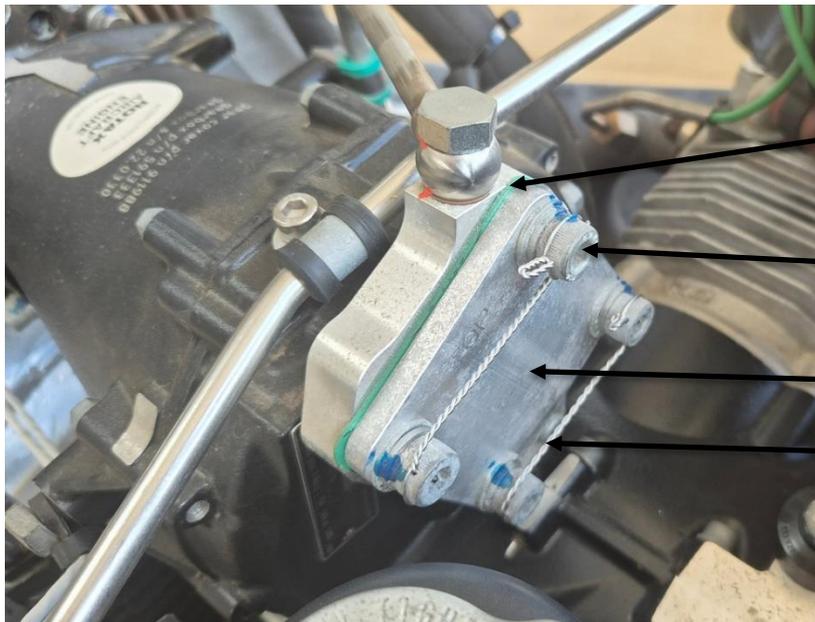
FIG A

The ROTAX 915iS-3-A engine is supplied with an hydraulic constant speed governor drive designed for controlling hydraulically adjustable propellers. Such engines are supplied by the manufacturer with a “cover plate” for factory test running, transport, handling and protection of the drive (see Fig A).

- If the cover plate is fitted with bolts which are drilled for wire-locking and lock wire has been fitted (as in Fig 1), the installation can be considered satisfactory;

- If the cover plate has been fitted with a flat AND a split washer, the bolts should be checked for the correct torque, namely 24Nm (18 ft.lb) and torque seal applied. When correctly torqued the installation can be considered satisfactory;

- If the cover plate has been fitted with only flat washers (unlikely), then the bolts should be removed, cleaned, reinstalled using Loctite 243 to ensure that they do not vibrate loose, torqued to 24Nm (18 ft.lb) and torque seal applied. Once correctly torqued the installation can be considered satisfactory;

- If there is any leakage of oil from around the cover plate the cover plate should be removed, cleaned, fitted with a new gasket if the existing gasket is damaged, and reinstalled with wire-locking, split washers or Loctite 243 to prevent loosening, as the case may be. Once re-installed in accordance with these instructions the installation can be considered satisfactory.
