**Sling Aircraft (Pty) Ltd**  
**Registration no 2002/022837/07**  
Approved Maintenance Organisation AMO1264  
Manufacturing Organisation M677

## NOTIFICATION

#0011

**SUBJECT:** Throttle cable inspection

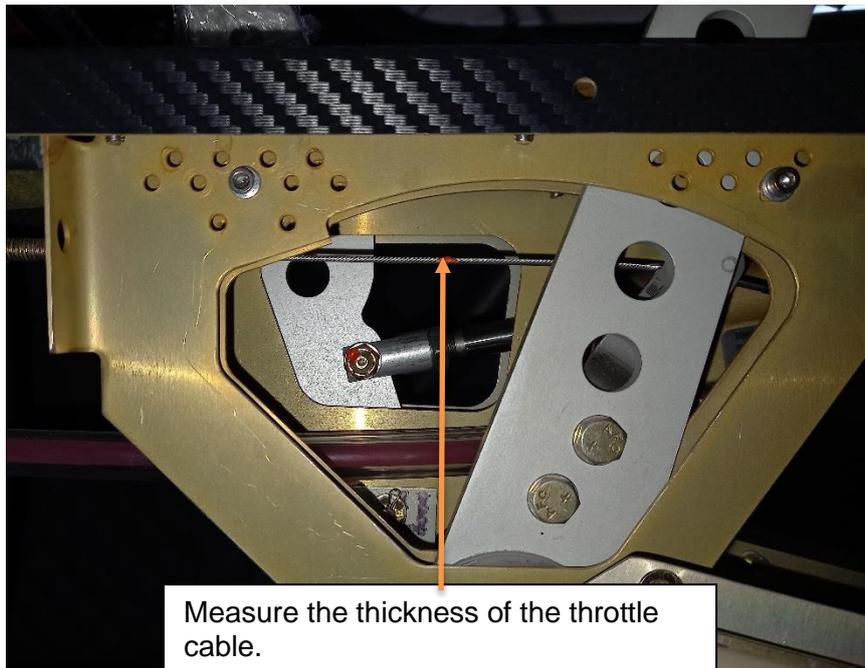
- Step 1. Remove the centre console side inspection panel, on the pilot (left) side of the aircraft. The front seat may need to be removed in order to make removing this panel easier. To do so follow Step 2.
- Step 2. Remove the front seat on the pilot (left) side of the aircraft. Refer to Section 4.3.2.1 in the Sling 2 maintenance manual (DC-MAM-002-X-B).
- Step 3. Once the panel has been removed, use a vernier calliper to measure the throttle cable thickness. Refer to *Figure 1*.

*Figure 1: Throttle cable to be measured*

If the cable is found to be a 2mm cable and not a 1.5mm cable, replace the cable with a 1.5mm cable. If the correct cable is installed, reinstall the inspection hatch and front seat.
