NOTIFICATION

#0011

SUBJECT: Throttle cable inspection

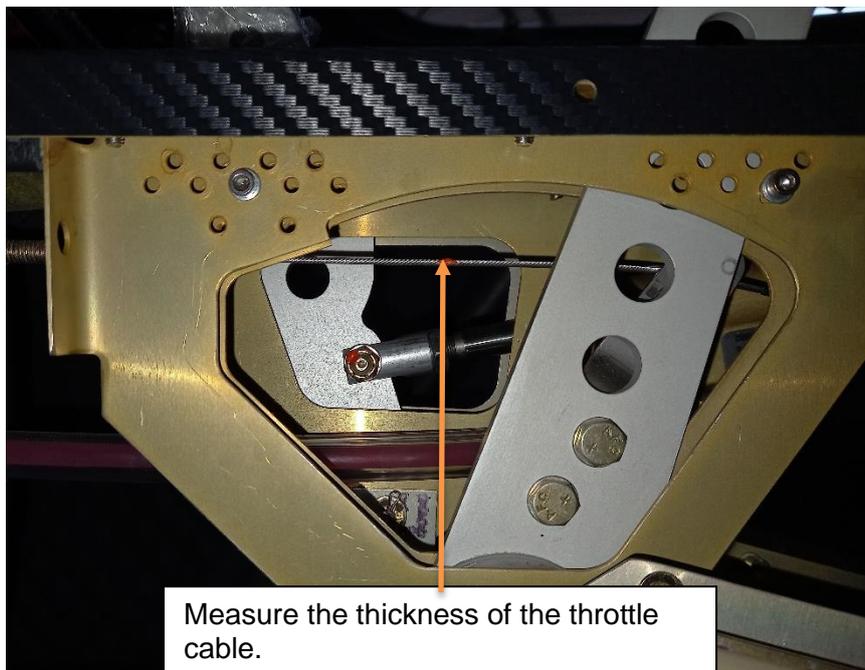
Figure 1: Throttle cable to be measured

It was discovered that 2mm throttle cables installed on a limited number of aircraft may pose a risk of jamming. Any 2mm thick throttle cable that has been installed must be replaced with a 1.5mm cable. If the 2mm cable is not replaced with the 1.5mm cable there is the potential for the throttle cable to stick, resulting in reduced throttle control/travel.

- Step 1. Remove the centre console side inspection panel, on the pilot (left) side of the aircraft. The front seat may need to be removed in order to make removing this panel easier. To do so follow Step 2.
- Step 2. Remove the front seat on the pilot (left) side of the aircraft. Refer to Section 4.3.2.1 in the Sling 2 maintenance manual (DC-MAM-002-X-B).
- Step 3. Once the panel has been removed, use a vernier calliper to measure the throttle cable thickness. Refer to *Figure 1*.

If the cable is found to be a 2mm cable and not a 1.5mm cable, replace the cable with a 1.5mm cable. If the correct cable is installed, reinstall the inspection hatch and front seat.

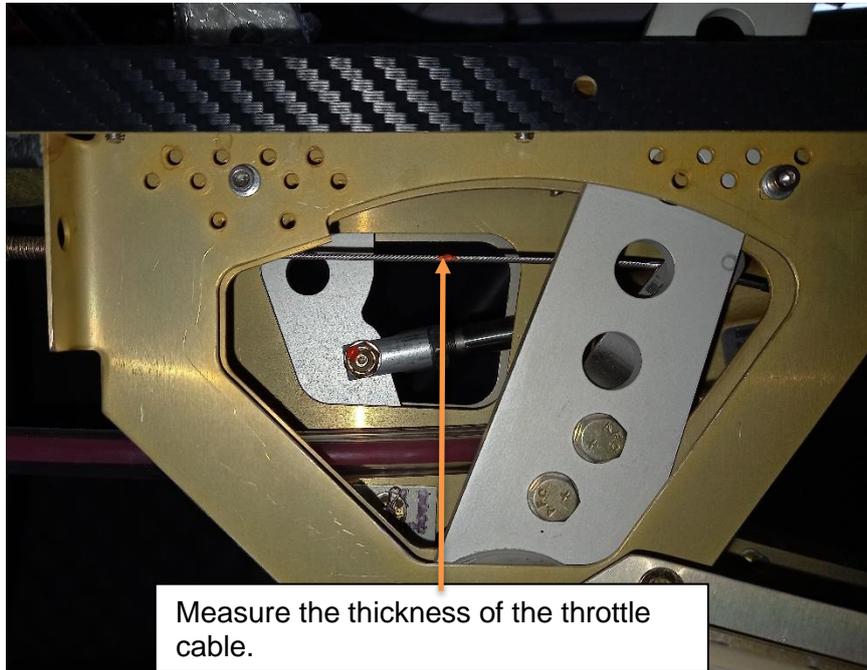
Figure 2: Throttle cable to be measured

- Step 1. Remove the centre console side inspection panel, on the pilot (left) side of the aircraft. The front seat may need to be removed in order to make removing this panel easier. To do so follow Step 2.
- Step 2. Remove the front seat on the pilot (left) side of the aircraft. Refer to Section 4.2.2.1 in the Sling 4 TSi maintenance manual (DC-MAM-001-X-F).
- Step 3. Once the panel has been removed, use a vernier calliper to measure the throttle cable thickness. Refer to Figure 2.

If the cable is found to be a 2mm cable and not a 1.5mm cable, replace the cable. If the correct cable is installed, reinstall the inspection hatch and front seat.
