**Sling Aircraft (Pty) Ltd**  
**Registration no 2002/022837/07**  
Approved Maintenance Organisation AMO1264  
Manufacturing Organisation M677

## NOTIFICATION

#0008

**SUBJECT:** Potential risk of trim tab motor disconnecting from elevator skin

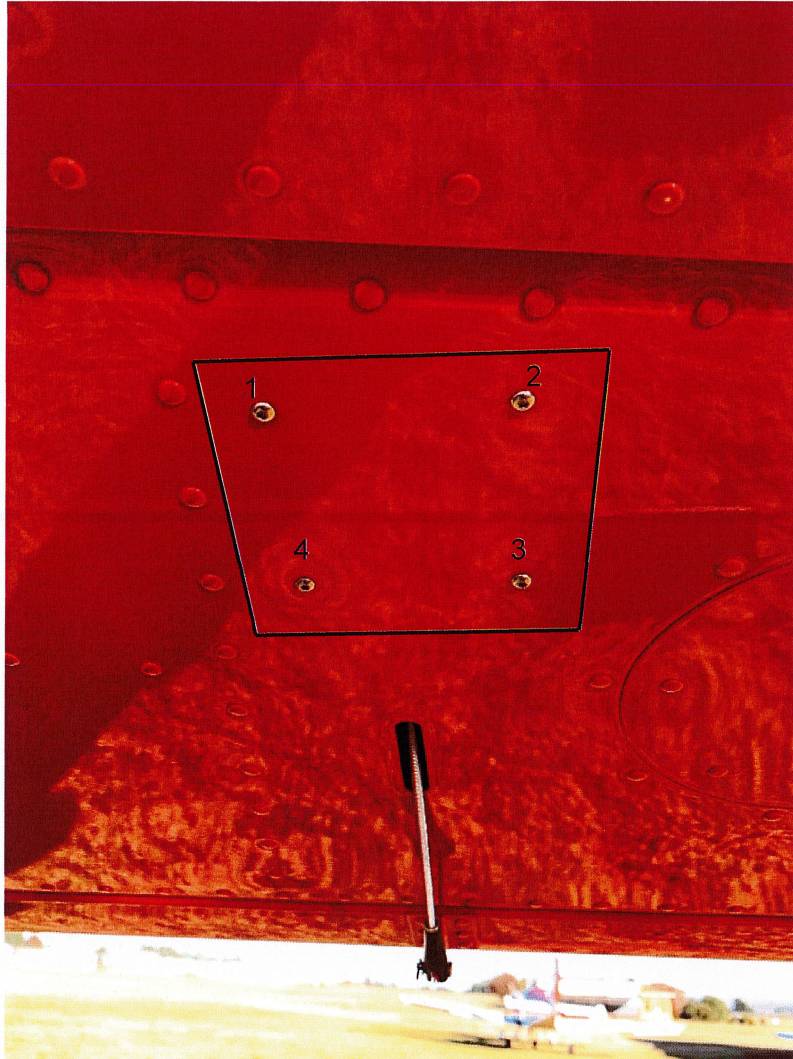
- a) The trim tab motor is secured to the elevator skin with four M3x10mm button head screws. Check that all four screws are present as shown in Figure 1.

Figure 1: Ensure all four attaching screws are present

- b) Missing screws must be re-installed with Loctite 222.
- c) In the unlikely event that missing screws result from rivnut failure (such as the rivnuts(s) breaking off from the trim motor flange), rivnuts must be replaced with 8-32 single lug anchor nuts, provided the trim motor flange is absent of damage that would prevent re-use.

- e) For aircraft produced after October 2020, the M3 rivnuts and M3x10mm button head screws have been superseded by 8-32 single lug anchor nuts and 8-32 x 1/2" stainless steel machine screws, respectively, to reduce the risk of trim motor disconnection.
