**Sling Aircraft (Pty) Ltd**  
**Registration no 2002/022837/07**  
Approved Maintenance Organisation AMO1264  
Manufacturing Organisation M677

## **SAFETY ALERT**

#0013

**SUBJECT:** HW Front Seat Recline Stopper

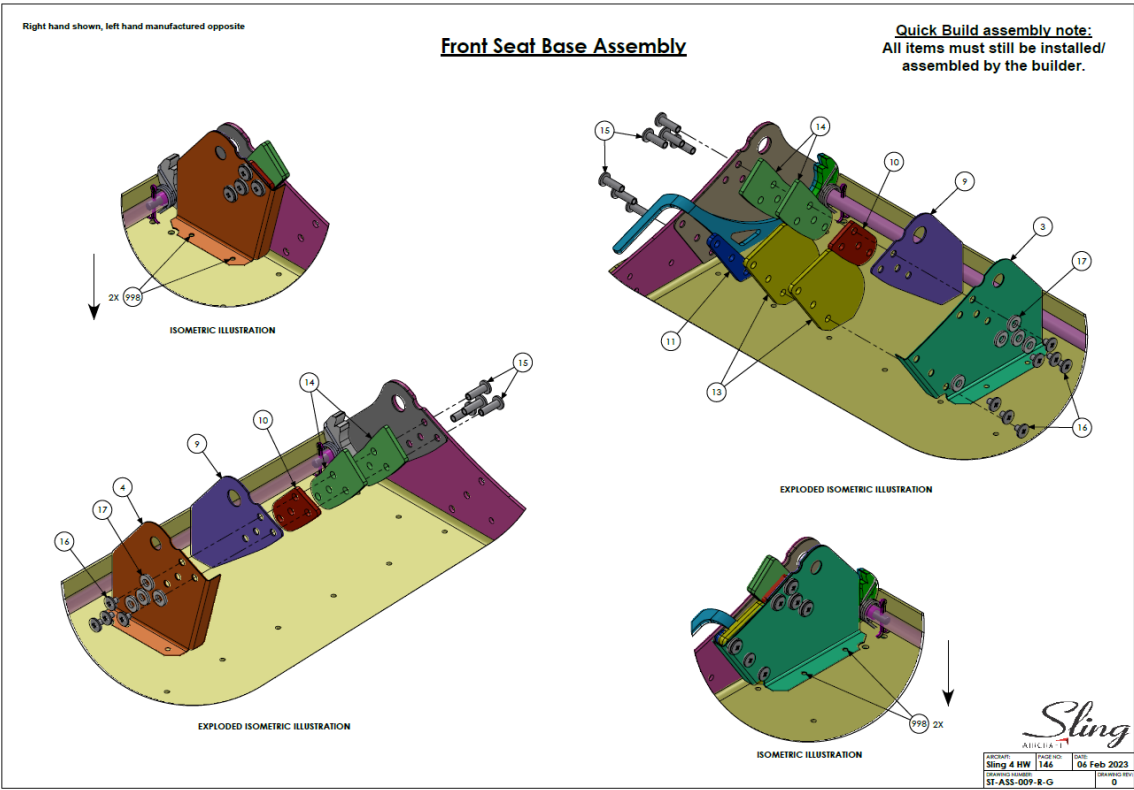
Figure 2: Obsolete Assembly Instructions (Detailed)

Instances have been reported where the seat backrest recline mechanism failed, causing the seatback to unexpectedly and suddenly recline. Pilots are advised to remain aware of this possibility and to avoid pulling backward on the control sticks should a backrest failure occur in flight.

- Step 2: Using a Phillips screwdriver, remove the screws (Item 15 & 16) on both sides of the seat as shown in Figure 2.
- Step 3: Also remove items 10 (qty 2), 11 (qty 1), 13 (qty 2), and 14 (qty 4), as shown in Figure 2.

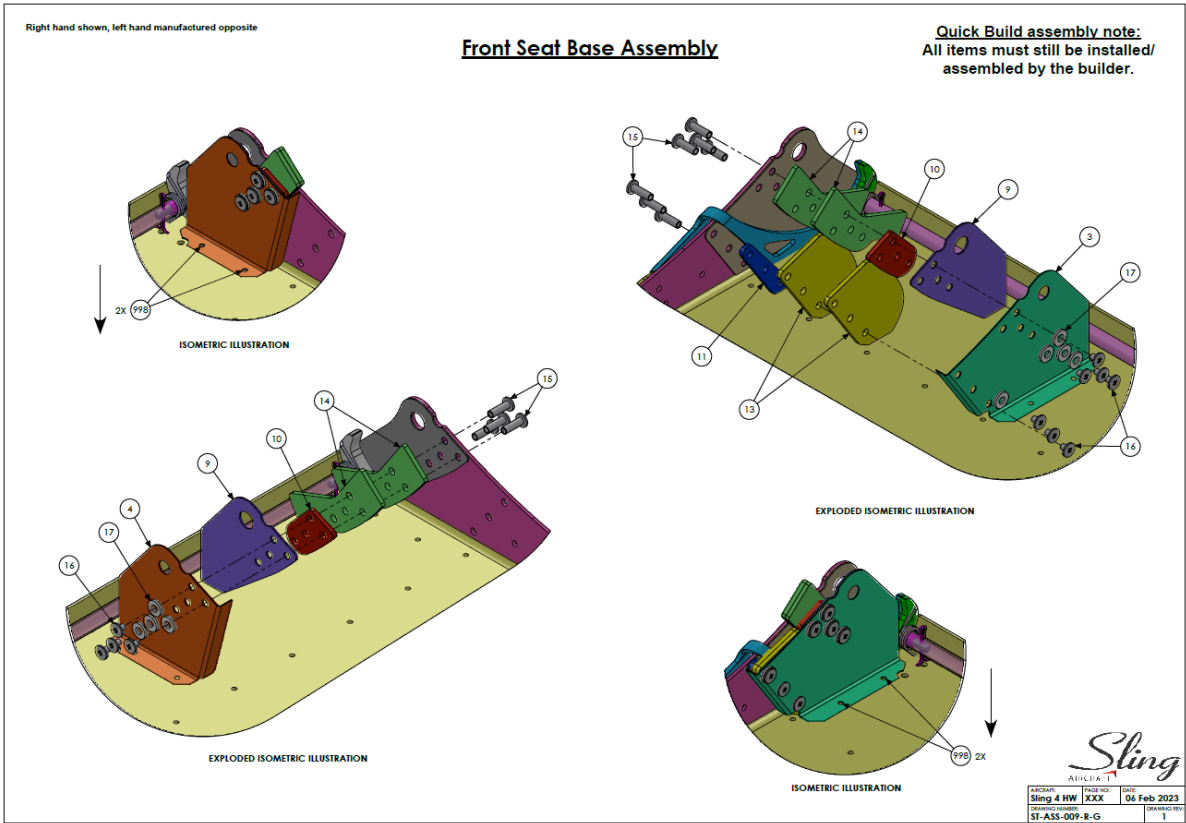
Figure 4: Revised Assembly Instructions (Detailed)

At present, Sling does not deem a complete redesign of the seat recline mechanism necessary. However, the installation of a permanent stop limiting the seat recline to the third adjustable position is required to effectively mitigate the risk.

- Step 4: Install the new backrest stopper plates (revised Item 14) with the previously removed Items 10, 11 and 13 as shown in Figure 4.
- Step 5: Reinstall and securely tighten all screws (item 15 & 16). Use Loctite 243 (blue) to secure screws.
- Step 6: Repeat the procedure on the opposite front seat.
