**Sling Aircraft (Pty) Ltd**  
**Registration no 2002/022837/07**  
Approved Maintenance Organisation AMO1264  
Manufacturing Organisation M677

## SERVICE BULLETIN

#0023

**SUBJECT:** Incorrect Nose Gear Bolt Replacement

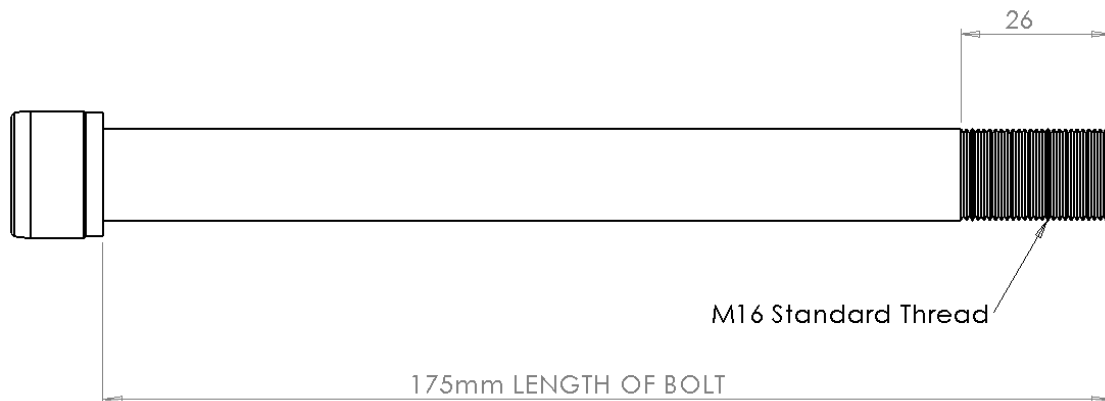
Figure 1: Correct Nose Gear Bolt thread length

The threaded section on the nose gear bolt provided to the affected aircraft is too long. This results in the threaded section of the bolt being loaded and may make the bolt more likely to fatigue and/or possibly break with a rough landing. This bolt needs to be replaced with one of the correct thread length to ensure that the thread does not get loaded.

Figure 1 shows the correct nose gear bolt dimensions. The nose gear bolt (HW-MCB-612-X-X-0) dimensions should be checked and if the bolt's thread length is incorrect it must be replaced with a new bolt of the correct dimensions. These bolts can be ordered from Sling Aircraft.
