**THE AIRPLANE FACTORY (Pty) Ltd, Registration no 2002/022837/07**  
Hangar 8 Tedderfield Airpark, Nettleton Road, Eikenhof, 1872, Johannesburg South  
PO Box 308, Eikenhof, 1872, South Africa. Tel: +27 (0) 11 948 9898 Fax: +27 (0) 86 632 4493  
E-mail: sales@airplanefactory.co.za Web: www.airplanefactory.co.za  
Approved Maintenance Organisation AMO1264 Manufacturing Organisation M677

## SERVICE BULLETIN

#008

<b>TITLE:</b>	Inspection of propeller hub – ground adjustable Warp Drive propellers
<b>RELEASE DATE:</b>	10 November 2016
<b>EFFECTIVE DATE:</b>	10 November 2016
<b>REASON:</b>	Risk of failure of propeller hub in ground adjustable Warp Drive propeller systems fitted to Rotax 912 iS engines.
<b>DESCRIPTION:</b>	This Service Bulletin provides instructions for the removal of the propeller and hub for purposes of, and the inspection of, the propeller hub on ground adjustable Warp Drive propeller systems fitted to aircraft with Rotax 912 iS engines.
<b>MODELS AFFECTED:</b>	All Sling LSA and Sling 2 aircraft fitted with a Rotax 912 iS engine and a ground adjustable Warp Drive propeller.
<b>COMPLIANCE TIME:</b>	At each 100 hour or 12 month (annual-type) inspection.
<b>TYPE OF MAI

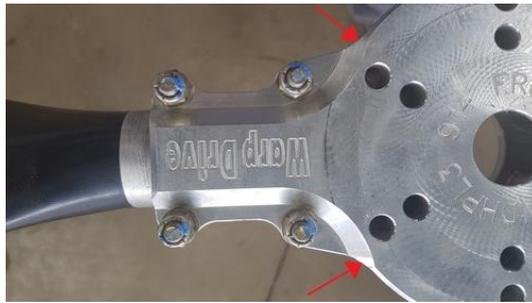
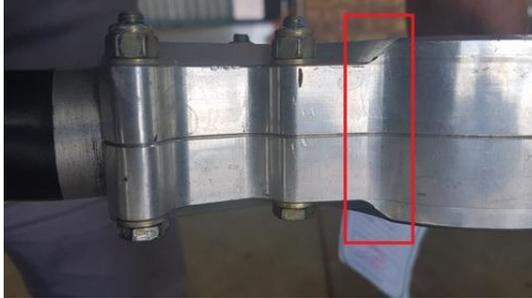
<b>INSTRUCTIONS:</b>	<ol style="list-style-type: none"><li>1. Remove aircraft propeller and propeller hub in accordance with the currently applicable aircraft maintenance and Warp Drive installation and maintenance manuals.</li><li>2. Following removal of the propeller hub carefully inspect the hub for cracks using penetrant dye or other appropriate NDT test equipment, paying special attention to the areas indicated in the photograph below.</li></ol>

3. If no evidence of cracking is found, re-assemble and re-fit propeller hub, blades and spinner in accordance with the currently applicable aircraft maintenance and Warp Drive installation and maintenance manuals.
4. If any cracks are found, The Airplane Factory should be notified and the hub replaced prior to the aircraft being placed back into service.
