**Sling Aircraft (Pty) Ltd**  
**Registration no 2002/022837/07**  
Approved Maintenance Organisation AMO1264  
Manufacturing Organisation M677

## SERVICE BULLETIN

#0019

**SUBJECT:** Throttle cable replacement to prevent potential loss of engine power control

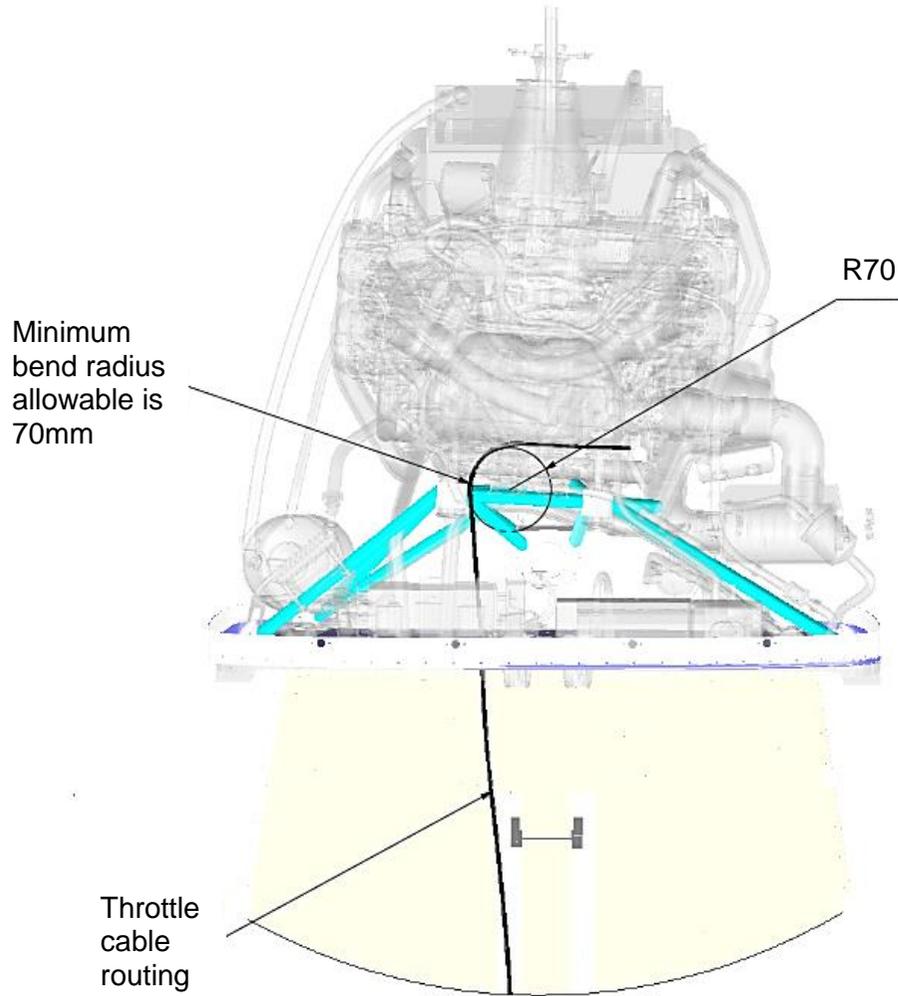
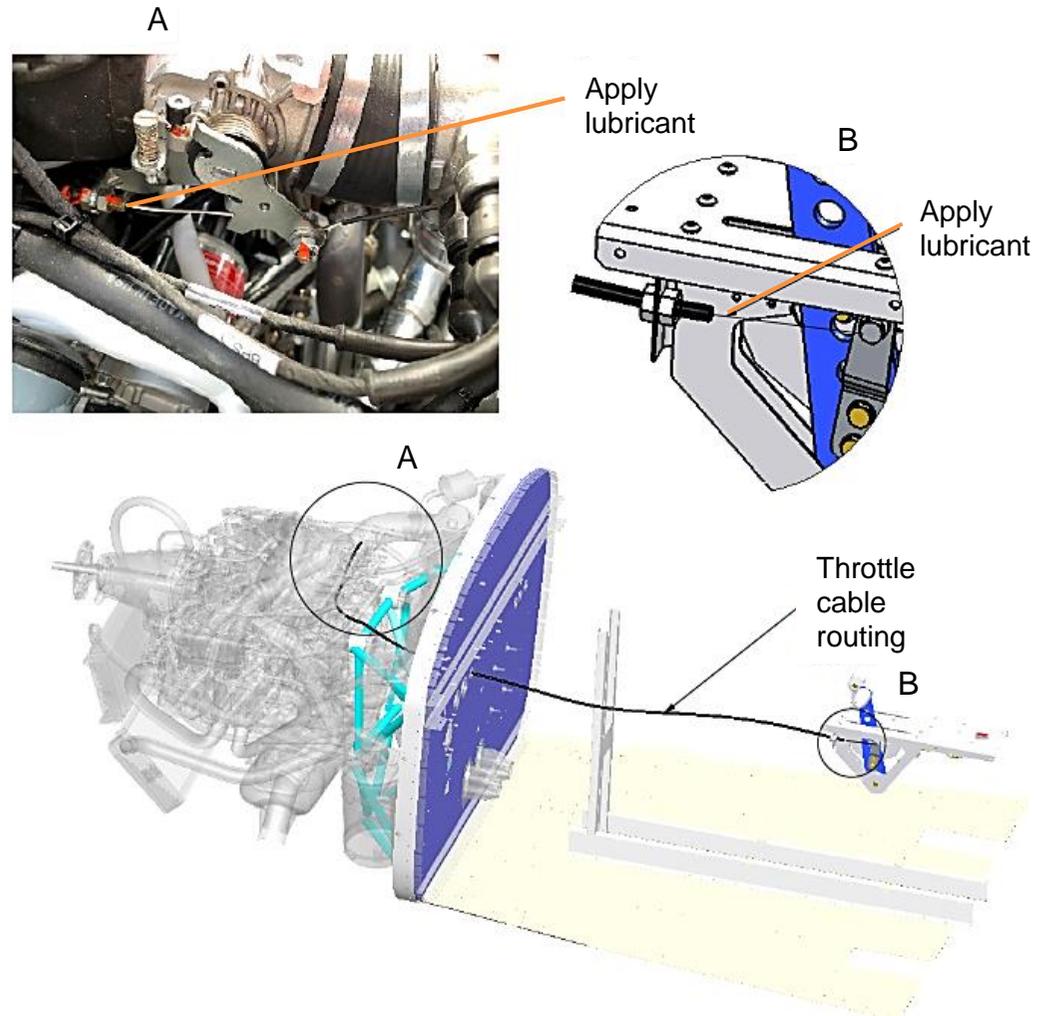
Figure 1: Installation guide and lubrication requirements

- or inner cable fraying.
- c) Check that the bolt (A), shown in Figure 2, which attaches the inner stainless-steel cable to the throttle link, can swivel freely.
- d) Verify that the throttle cable is routed such that the minimum bend radius is 70mm as shown in Figure 1.
- e) Lubricate both ends of the throttle cable as shown in Figure 1. Hold the aerosol straw into the end fitting (in the direction indicated by the arrows in Figure 1) then apply the lubricant; moving the throttle knob forward and aft to guide the lubricant into the fitting.
- f) Verify that the inner cable does not kink as shown in Figure 2.

- a) Remove the top engine cowling.
- b) Hold the aerosol straw into the end fitting on the engine side (in the direction indicated by the arrows in Figure 1) then apply the lubricant; moving the throttle knob in the cabin forward and aft to guide the lubricant into the fitting.
- c) Wrap a rag / paper towel around the cable end to force the lubricant into the sheath.

- a) If this malfunction has occurred in flight, replace the throttle cable before the next flight. Contact [Airworthiness@slingaircraft.com](mailto:Airworthiness@slingaircraft.com) or [Technical@slingaircraft.com](mailto:Technical@slingaircraft.com) for the Service Bulletin kit.
- b) The reinstalled cable should meet routing and lubrication requirements shown in Figure 1.

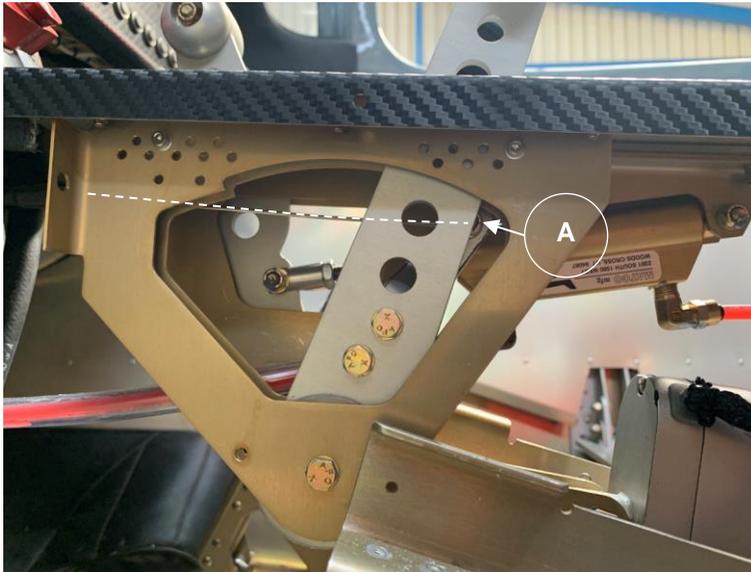
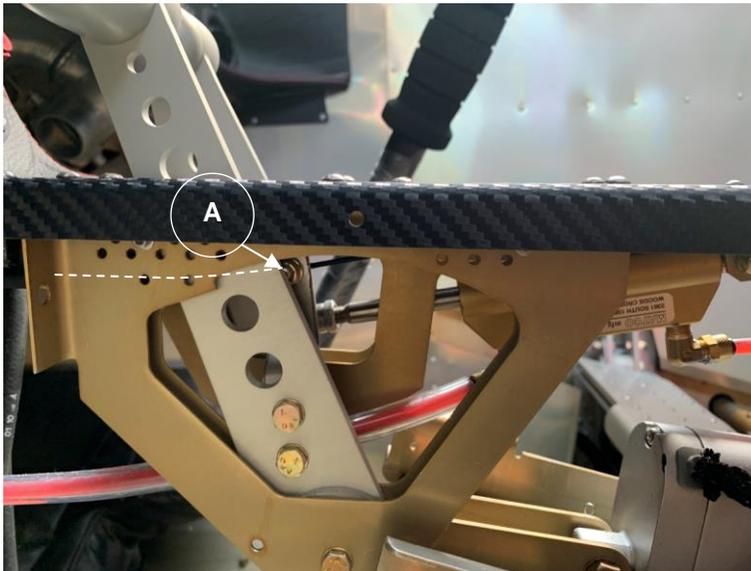
Figure 2: Inspect inner cable for kinking

Acceptable

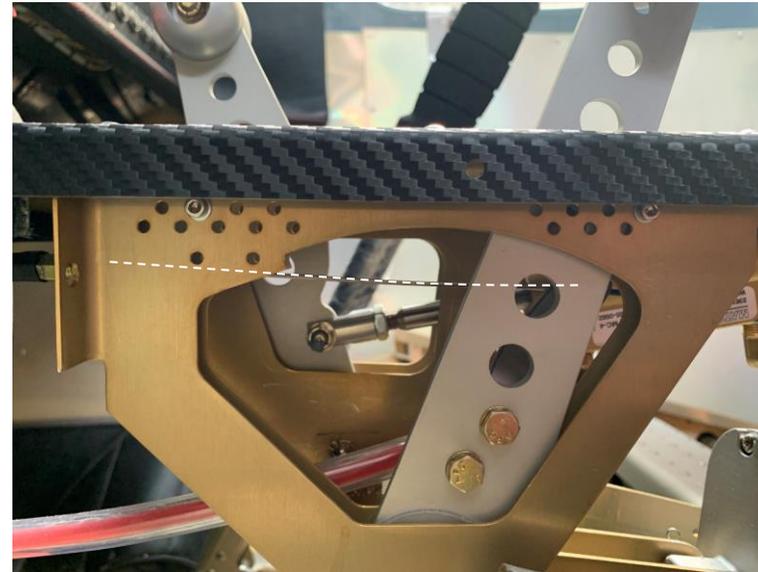
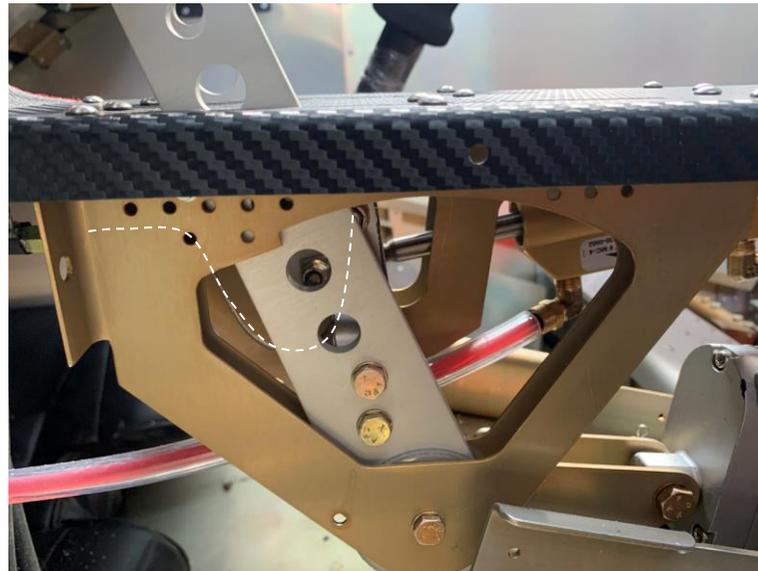
Unacceptable
