SERVICE BULLETIN

#0005

SUBJECT: Incorrect material used on guides which could lead to premature wear on pushrods

MODELS AFFECTED: All Sling LSA, Sling 2, Sling Taildragger, Sling 4 – Manufactured after January 2015

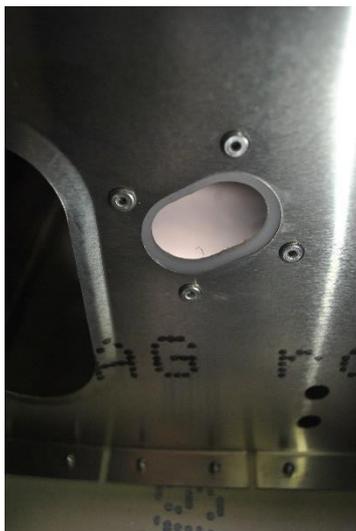
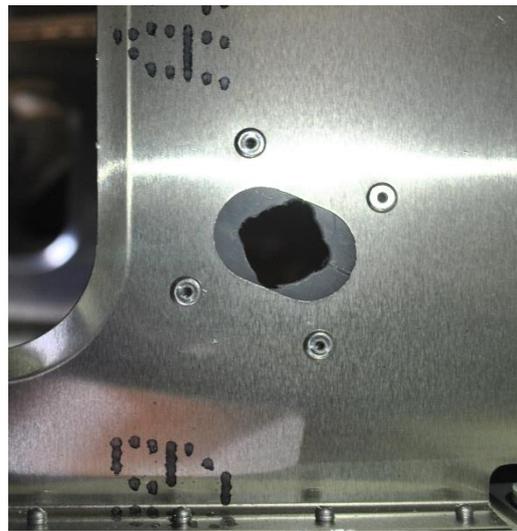
WINGS
BOTH THESE GUIDES ARE CORRECT

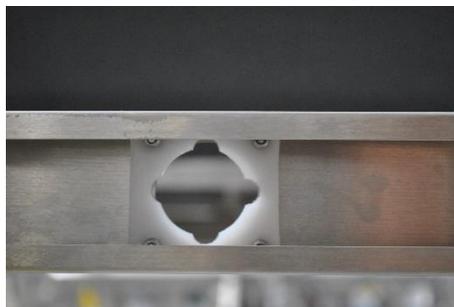
1. Unscrew all 8 screws and remove the hatch from the fuselage skin so as to gain access to the Pushrod located on the beam.
2. Visually inspect the pushrod for excessive wear. Visually inspect the pushrod guide for the correct material. The below pictures show the guide to be inspected.

3. If the guide does not conform to the specification mentioned on the first page of this service bulletin the next steps need to be carried out.
4. Using a 3.2x8mm drill bit, de-rivet the four rivets that attach the guide to the beam.
5. Slide the guide to an easier position so as to cut it off the pushrod.
6. Neatly cut the new guide with a Stanley blade so as to flex it over the pushrod, slide it back towards the beam. The picture below shows where to cut the guide.

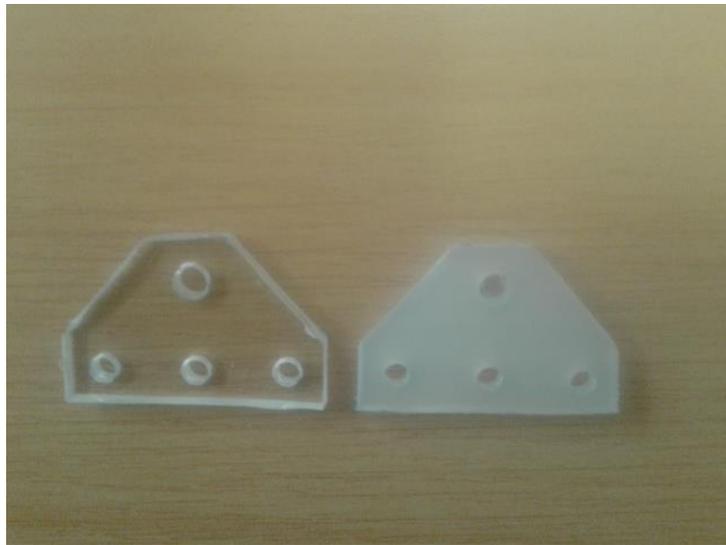
The pictures below are purely for illustration purposes of showing the incorrect and correct material. The material on the left is incorrect and the material on the right is correct.
