**SERVICE BULLETIN**

#0014 Revision 1

**SUBJECT:** Rivet replacement along fuselage main spar carry-through and on upper and lower inboard wing skins

**MODELS AFFECTED:** All Sling aircraft

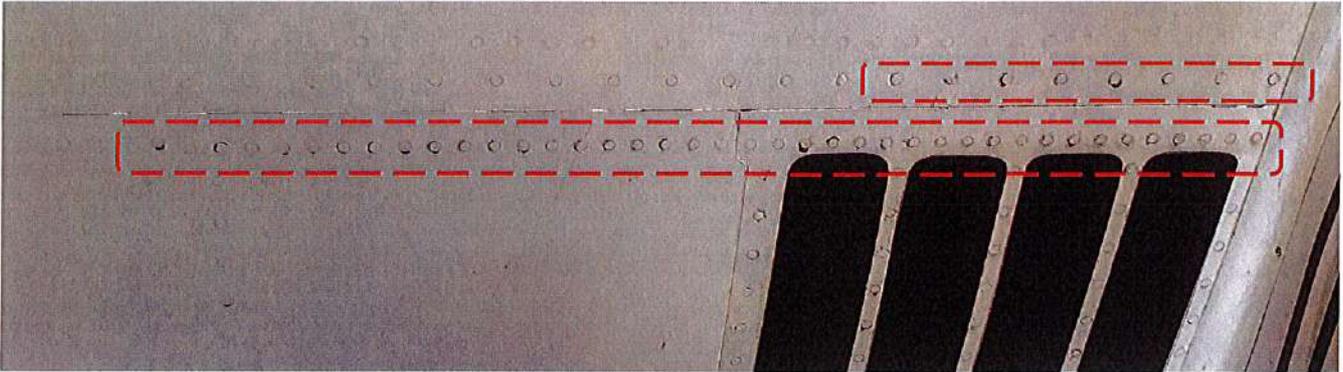
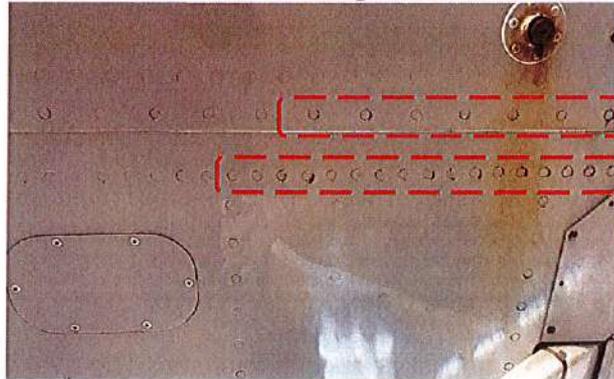
Figure 1 - Paint cracking around rivets on Sling 2 wing

In aircraft, fretting may occur when rivets loosen due to vibration and/or flexing allowing slight motion between skin mating surfaces.

In some Sling aircraft, an indication of this condition is paint cracking around the rivets. The affected regions are usually located on the underside of the fuselage along the main spar carry-through and on upper and lower inboard wing skins. Figure 1 shows paint cracking on the inboard skins of a Sling 2 aircraft.

To minimise fretting, rivets in the affected areas should be replaced with Avinox stainless steel rivets (Part number BE61-00512).

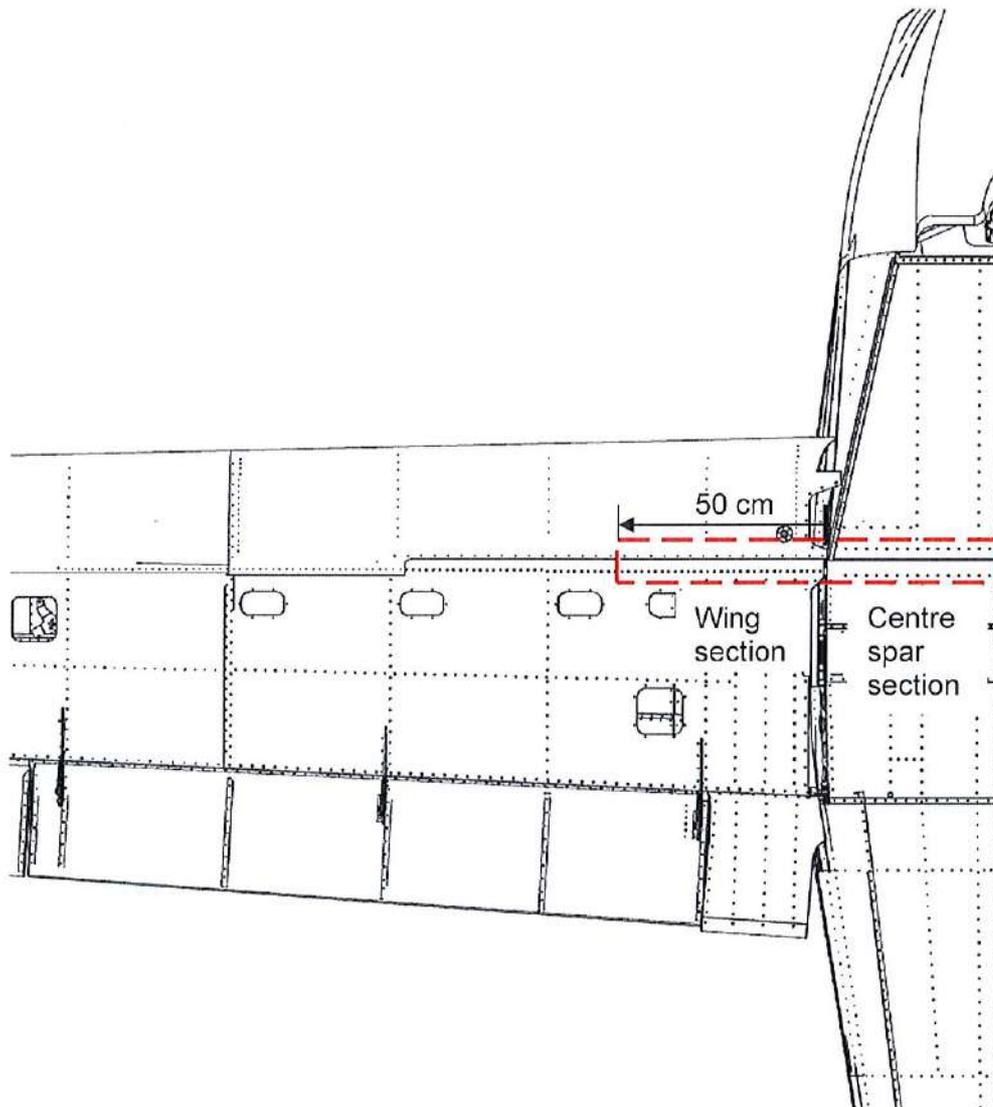
Figure 2 – Region of rivet replacement on the underside of starboard (right) wing

2. On the fuselage (of Sling TSi, Sling 2 and Sling 4 aircraft), this region is along the two rows of rivets that attach the underside centre fuselage skin to the centre spar (see Figure 2).

The Figure 2 and 3 indicate the regions where rivets should be replaced on the aircraft. The rivets for the Sling TSi are replaced only on the centre spar carry-through under the fuselage.

5. Ensure that rivet removal is complete on the top of the wing before starting with the underside.
6. Using the powered drill with the 4 mm drill bit, drill the heads off rivets in the affected regions indicated in Figure 2 and 3 (specifically Figure 4 for Sling 2 and Figure 5 for Sling 4 wings). If rivets are filled, indent the centre of the rivet head with a centre punch and hammer before drilling.

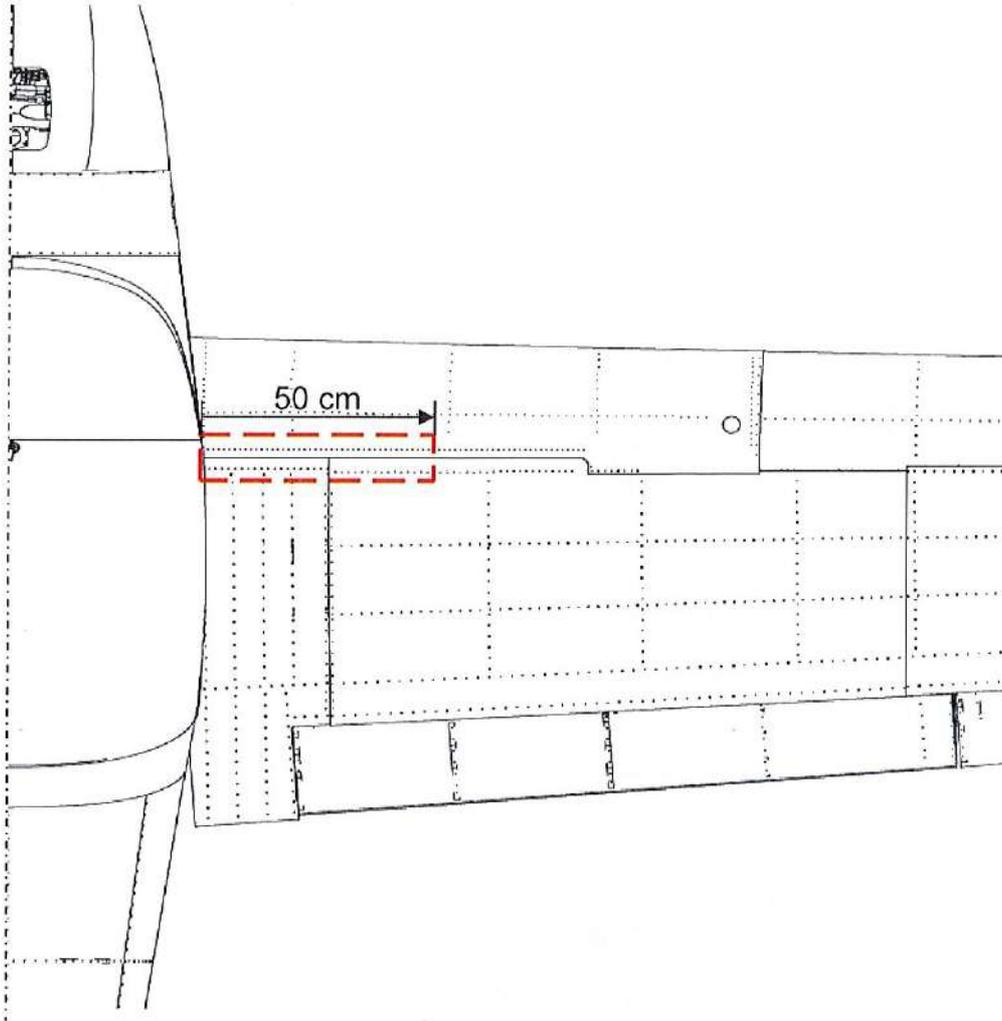
Figure 3 – Region of rivet replacement on the upper skin of starboard (right) wing

3. Figure 2 shows one half of the affected region on the underside of the starboard wing and fuselage and Figure 3 shows half the affected region on the upper starboard wing. The quantity of rivets recommended should cover these regions sufficiently.

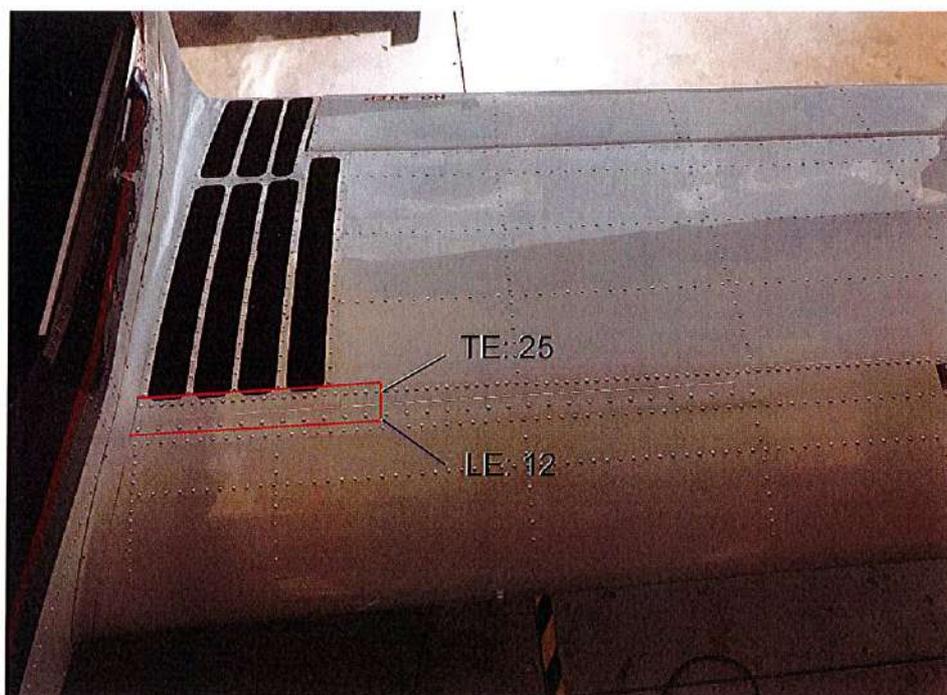
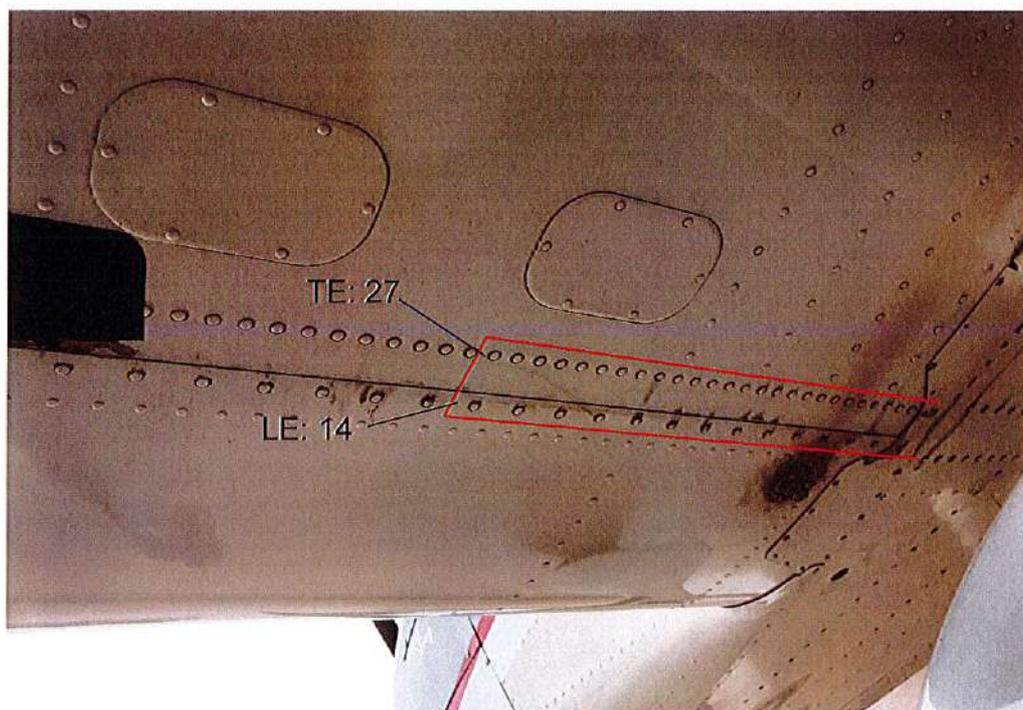
Figure 4 - Number of rivets to replace on Sling 2 and Sling LSA wings

At approximately 50cm (spanwise distance) from the wing root, on the Sling 2 wings, the rivets to be replaced are 12 on the front section (leading edge) and 25 on rear section (trailing edge) of the upper wing spar. On the underside of the Sling 2 wing, the rivets to be replaced are 14 on the leading edge and 27 on the trailing edge as shown in Figure 4.

Hence, the total number of rivets, for both wings =  $[(12 + 25) + (14 + 27)] \times 2 \rightarrow 156$  (wings only).

In total:  $(156 + 62) \rightarrow 218$  rivets (Sling 2)

1. On the top and underside surfaces of both wings (of Sling 2 and Sling 4 aircraft only), the region where rivets should be replaced is along the wing main spar, a spanwise distance of approximately 50cm measured from the wing root (see Figure 4 and Figure 5).

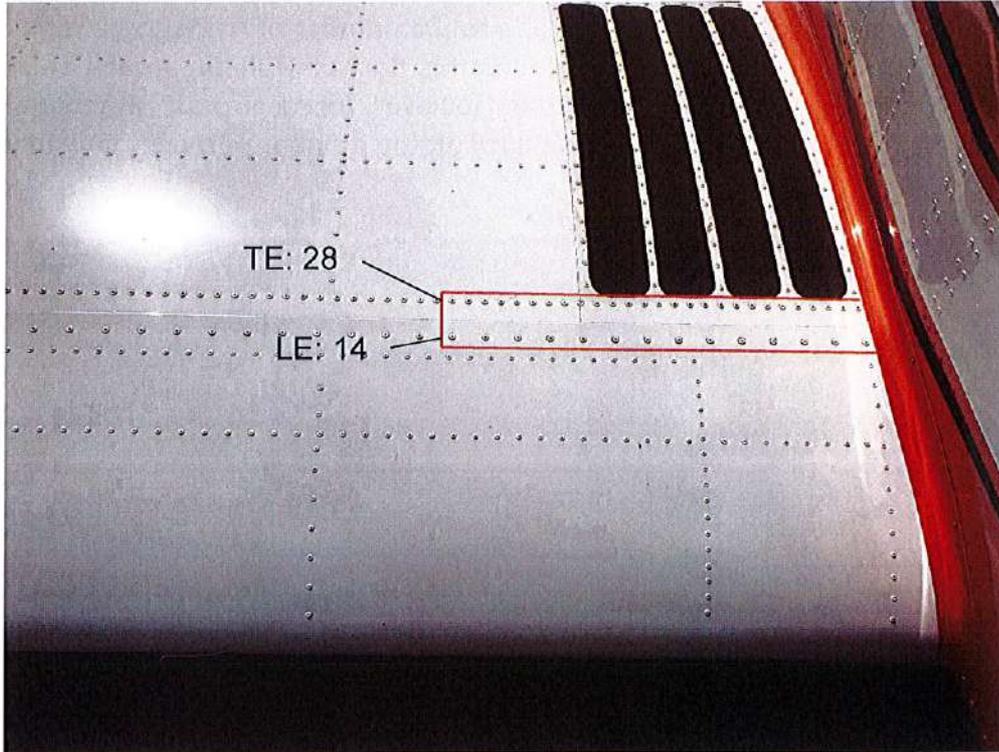
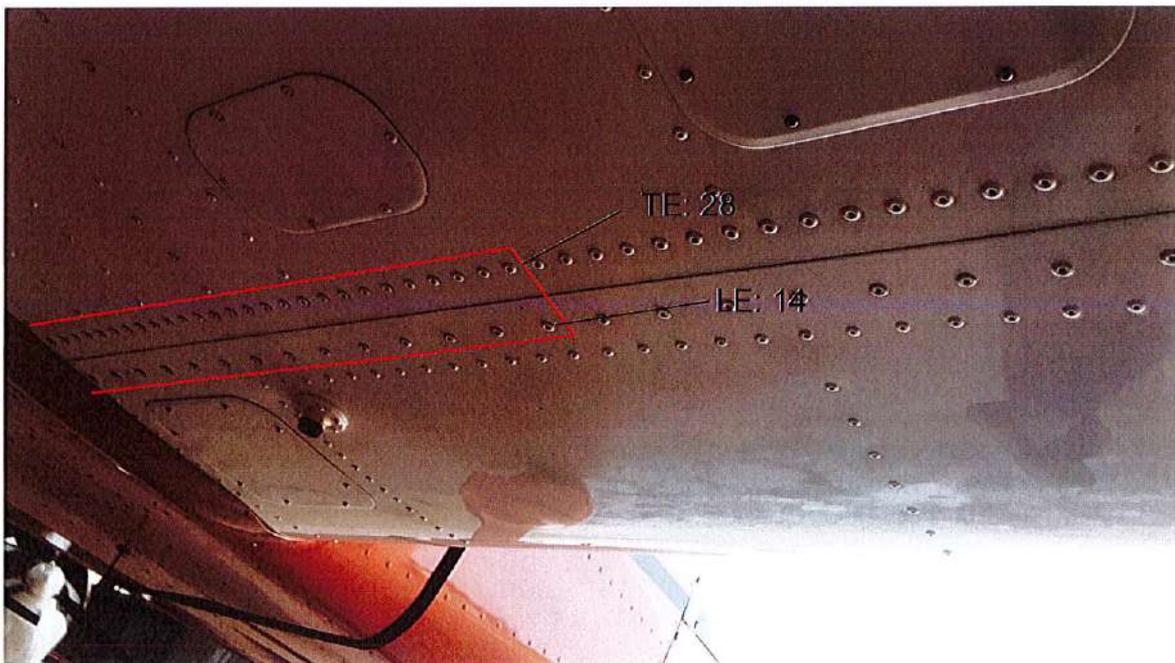
Figure 5 - Number of rivets to replace on Sling 4 wings

As illustrated below, on the Sling 4 wings, the rivets to be replaced are 14 on the front section (leading edge) and 28 on rear section (trailing edge) of the upper wing spar. On the underside of the Sling 4 wing, the rivets to be replaced are again 14 on the leading edge and 28 on the trailing edge. Hence, the total number of rivets, for both wings =  $[(14 + 28) + (14 + 28)] \times 2 \rightarrow 168$  (wings only). The number of rivets along the centre spar carry-through under the fuselage  $\rightarrow 62$  (centre spar only). In total:  $(168 + 62) \rightarrow 230$  rivets (Sling 4)
