## SERVICE BULLETIN

#0010

**SUBJECT:** Amendment to the Sling 2 and Sling 4 Series Annual Inspection

**PURPOSE:** To inspect Rib 601 within the airframe for material thickness and Cracks.

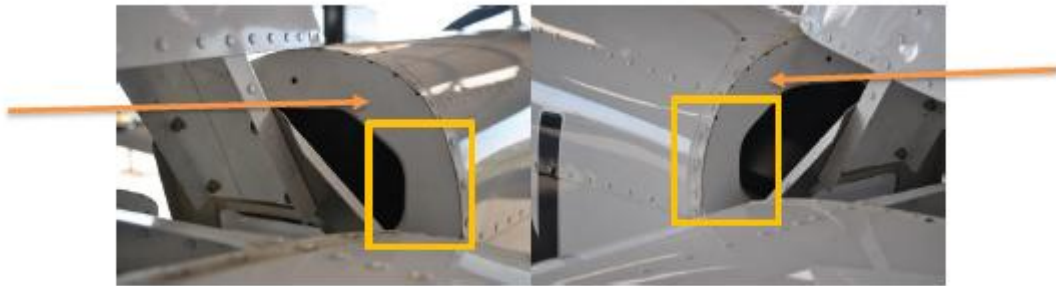
1. With reference to the below pictures, the areas within the yellow boxes on Rib 601 need to be inspected. On Airplane models affected Rib 601 should first be measured for material thickness. If the rib material thickness measures 0.64mm the Service Bulletin needs to be complied with. With a material thickness of 0.8mm this Service Bulletin no longer needs to be complied with. An entry should be made in the logbook stating the Rib 601 meets the material thickness requirement and no further action is necessary.

2. Affected airplanes, the rib should be replaced at 2000 hours as a mandatory requirement, however it should be inspected annually and be replaced immediately if a crack is noticed, after which there would be no further requirement for inspection. Should the rib be satisfactory and without any cracks within the 2000 hour period an entry should be made in the logbook that this Service Bulletin has been complied with and has been found satisfactory.

3. Should the rib fail the inspection for cracks being found, the entire rib 601 component will need to be replaced with thicker and stronger material which can be ordered through The Airplane Factory Store.
4. If the rib has failed the inspection the next steps will need to be followed in order to remove and replace the rib.
5. Using the two 3/8" spanners you will need to loosen the two bolts that attach the rudder cables to the rudder. With reference to the below picture, loosen the bolts that are within the yellow circles.
