SERVICE BULLETIN

#0005

SUBJECT: Incorrect material used on guides which could lead to premature wear on pushrods

MODELS AFFECTED: All Sling LSA, Sling 2, Sling Taildragger, Sling 4 – Manufactured after January 2015

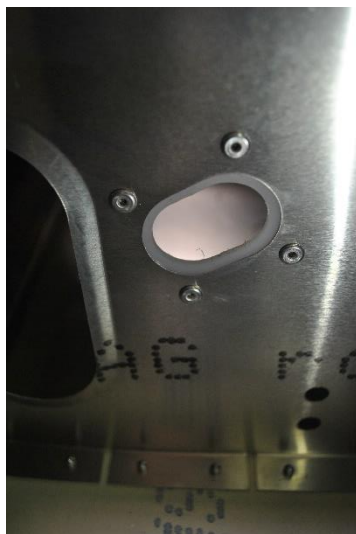
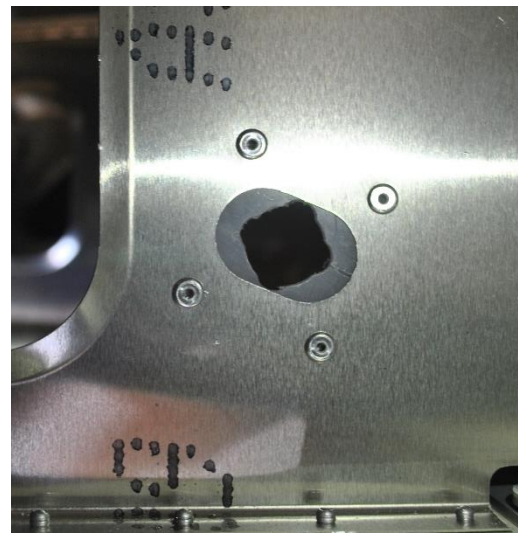
WINGS
BOTH THESE GUIDES ARE CORRECT

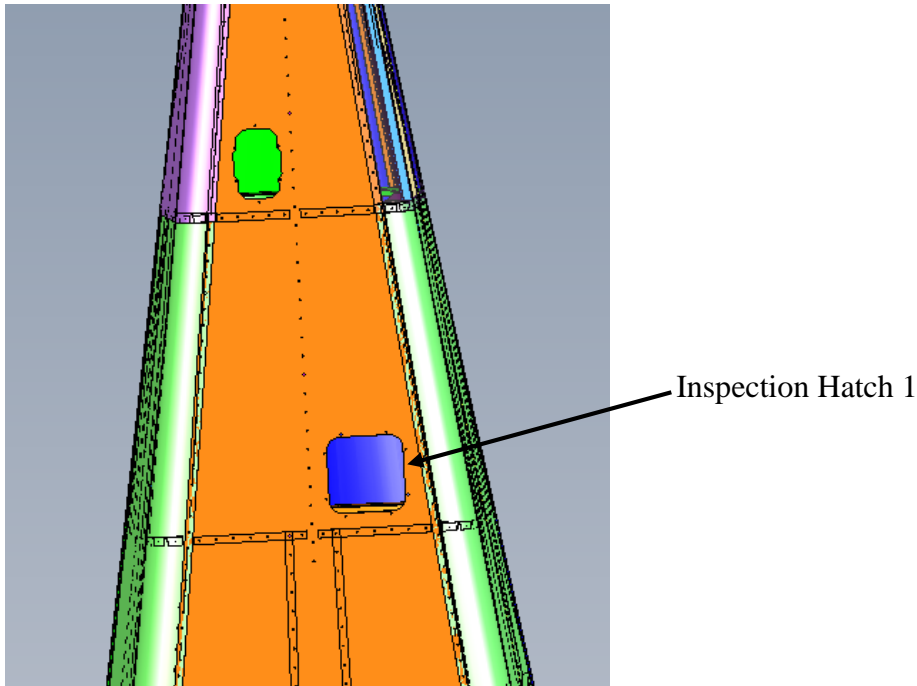
With reference to the above picture, inspection hatch 1 will need to be opened. This hatch is located on the bottom of the rear fuselage.

1. Unscrew all 8 screws and remove the hatch from the fuselage skin so as to gain access to the Pushrod located on the beam.
2. Visually inspect the pushrod for excessive wear. Visually inspect the pushrod guide for the correct material. The below pictures show the guide to be inspected.

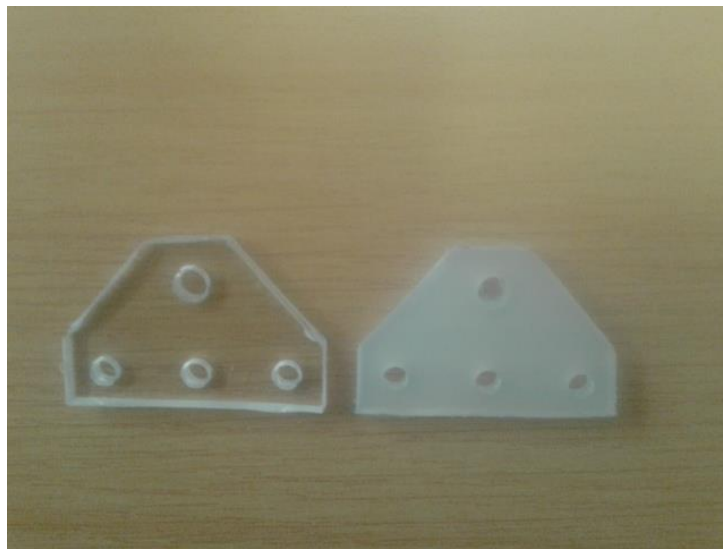
The pictures below are purely for illustration purposes of showing the incorrect and correct material. The material on the left is incorrect and the material on the right is correct.
