**Sling Aircraft (Pty) Ltd**  
Registration no 2002/022837/07  
Approved Maintenance Organisation AMO1264  
Manufacturing Organisation M677

## SERVICE BULLETIN

#0017

**SUBJECT:** Potential risk of shearing of control stop plate rivets

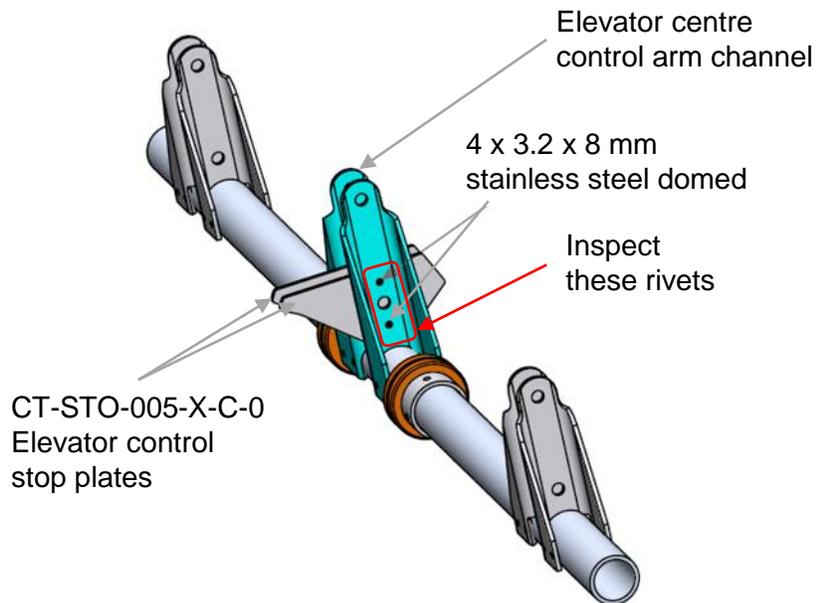
Figure 1 - Elevator control torque tube for Sling 4 and Sling 4 TSi aircraft

1. The rivets on the torque tube that need to be inspected are shown in Figure 1. The control stop plates (CT-STO-005-X-C-0) and elevator centre control arm channels are also shown in Figure 1.
2. Remove a front seat from the fuselage then use the 2 mm / 2.5 mm Allen key to remove the floor skin (refer to CF-SKN-016-R-C-0) shown in Figure 2.
3. The inspection region when the floor skin is removed is shown in Figure 3. Use the light source to determine if control stop rivets are aluminium or stainless steel. Use Figure 4 as a guide for making the distinction.
4. Alternatively (or in addition to using the light source) use a magnet to identify rivets. The mandrel of the aluminium rivet used is magnetic, so a magnet will attract to the aluminium rivet (see Figure 4).

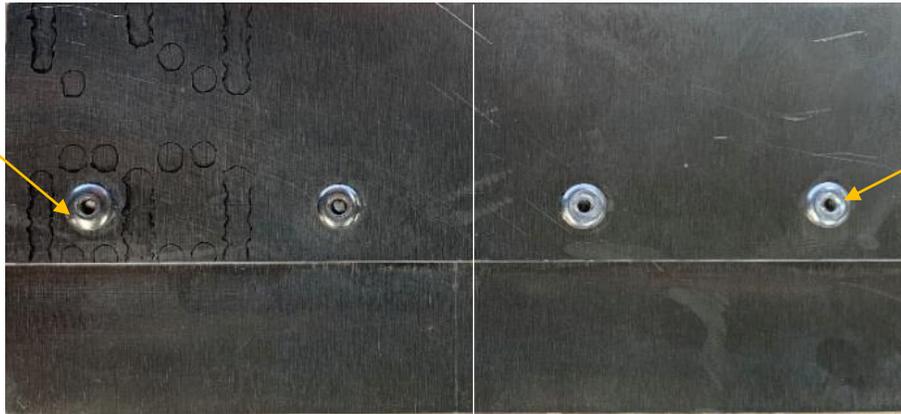
Figure 4 – Identification of stainless steel and aluminium rivets

Stainless steel  
(non-magnetic  
attraction)

Aluminium  
(magnetic  
attraction)

5. Should it be determined that the control stop rivets are stainless steel, no repair will be required, in which case the floor skin and seat can be re-installed.
6. However, should it be determined that rivets are aluminium, stainless steel rivets will need to be installed. Remove both front seats prior to repair so that the remedy can be applied to both control stop plates.
