SERVICE BULLETIN #0002 (rev. 2)

RELEASE DATE: 11/02/2021
EFFECTIVE DATE: 11/02/2021
SUBJECT: Reinforcement of the upper join between the centre and rear fuselages
MODELS AFFECTED: rev. 1 – Sling 4 and Sling 4 TSi (*all from SN#001 to SN#060*)
rev. 2 – Sling 4 and Sling 4 TSi (*all from SN#001 to SN#060 and non-parachute versions from SN#060 to #306*)
COMPLIANCE TIME: At the next MPI (*Mandatory Periodic Inspection*)
LABOUR TIME: Inspection only: 0.25 hours
Inspection & Repair: 2 hours

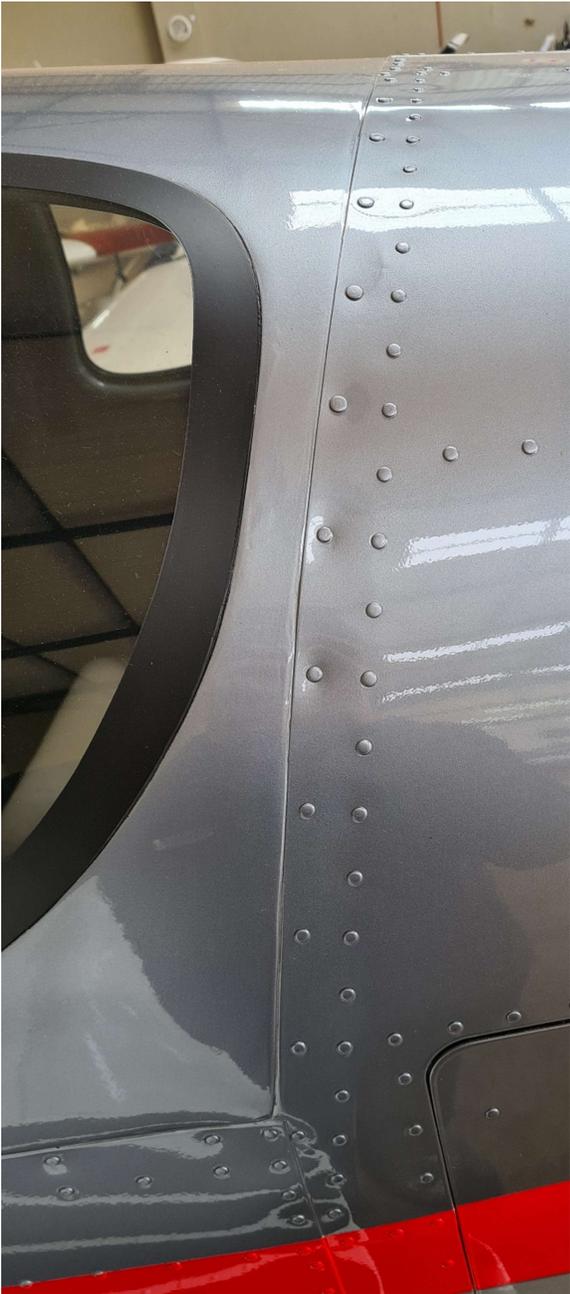
FIGURE 1 | INCORRECT SPACING

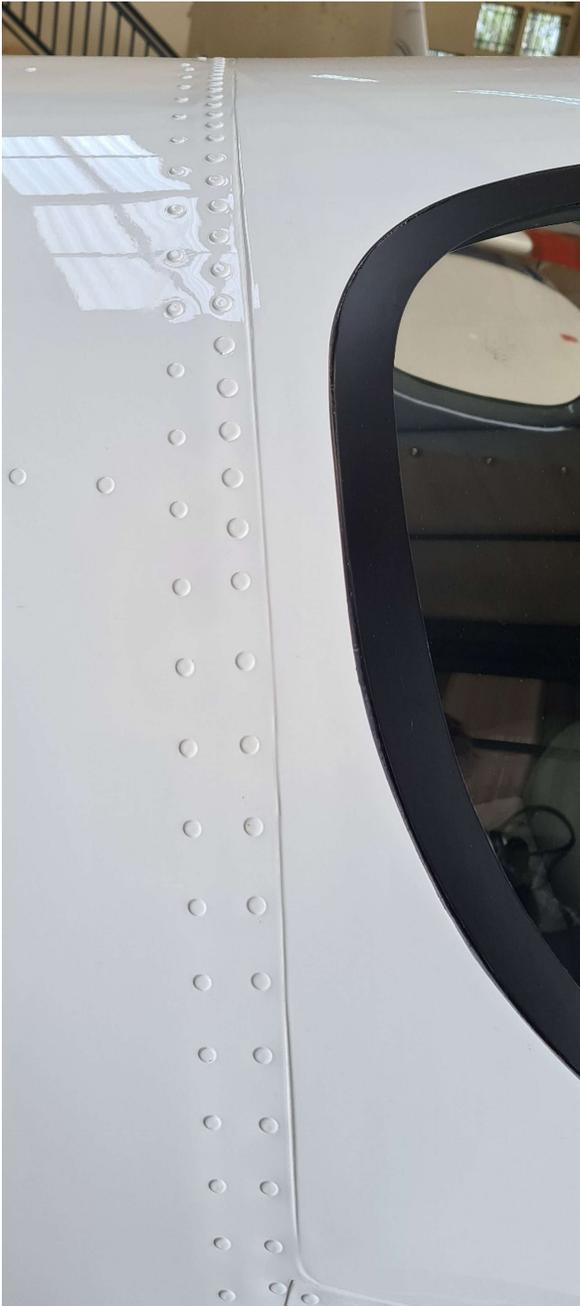
FIGURE 2 | CORRECT SPACING
