SERVICE BULLETIN

#0014 Revision 1

SUBJECT: Rivet replacement along fuselage main spar carry-through and on upper and lower inboard wing skins

MODELS AFFECTED: All Sling aircraft

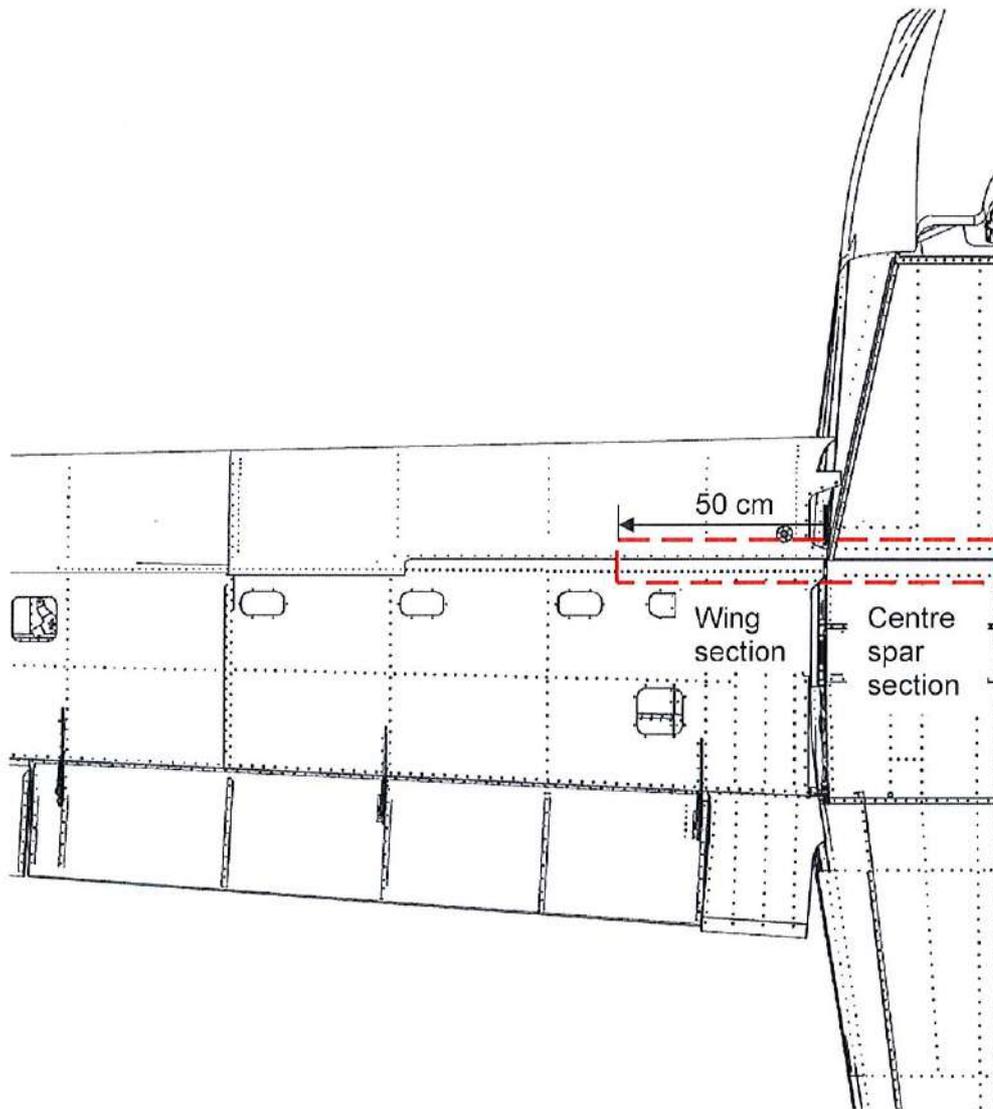
Figure 2 – Region of rivet replacement on the underside of starboard (right) wing

2. On the fuselage (of Sling TSi, Sling 2 and Sling 4 aircraft), this region is along the two rows of rivets that attach the underside centre fuselage skin to the centre spar (see Figure 2).

3. Figure 2 shows one half of the affected region on the underside of the starboard wing and fuselage and Figure 3 shows half the affected region on the upper starboard wing. The quantity of rivets recommended should cover these regions sufficiently.

5. Ensure that rivet removal is complete on the top of the wing before starting with the underside.
6. Using the powered drill with the 4 mm drill bit, drill the heads off rivets in the affected regions indicated in Figure 2 and 3 (specifically Figure 4 for Sling 2 and Figure 5 for Sling 4 wings). If rivets are filled, indent the centre of the rivet head with a centre punch and hammer before drilling.

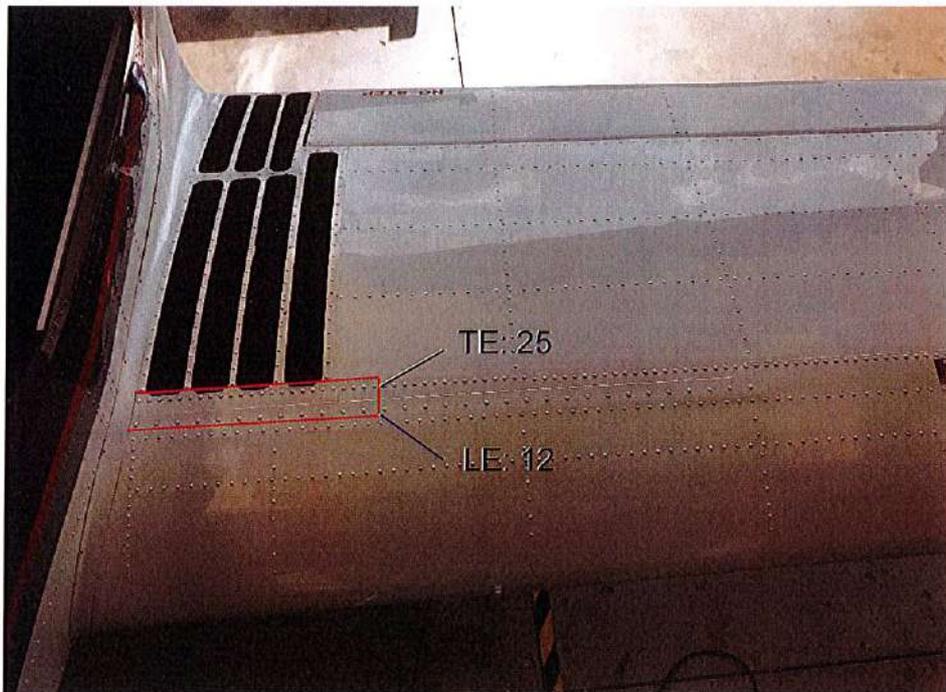
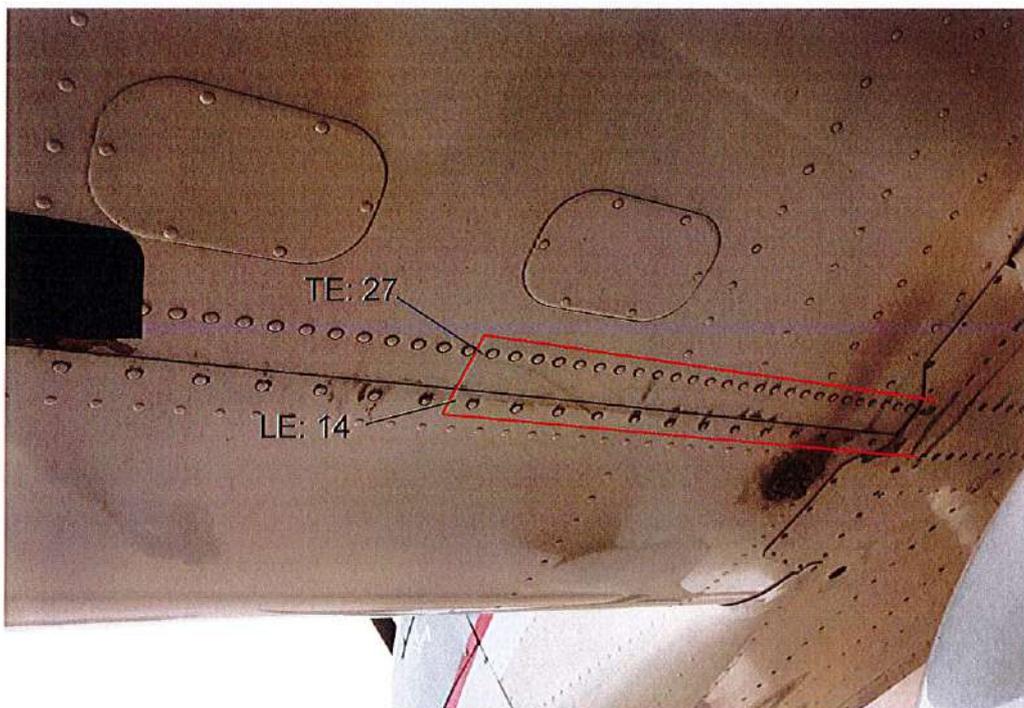
Figure 4 - Number of rivets to replace on Sling 2 and Sling LSA wings

At approximately 50cm (spanwise distance) from the wing root, on the Sling 2 wings, the rivets to be replaced are 12 on the front section (leading edge) and 25 on rear section (trailing edge) of the upper wing spar. On the underside of the Sling 2 wing, the rivets to be replaced are 14 on the leading edge and 27 on the trailing edge as shown in Figure 4.

Hence, the total number of rivets, for both wings = $[(12 + 25) + (14 + 27)] \times 2 \rightarrow 156$ (wings only).

In total: $(156 + 62) \rightarrow 218$ rivets (Sling 2)
