**Sling Aircraft (Pty) Ltd**  
**Registration no 2002/022837/07**  
Approved Maintenance Organisation AMO1264  
Manufacturing Organisation M677

## SERVICE BULLETIN

#0016

**SUBJECT:** Modification of ECU standoffs

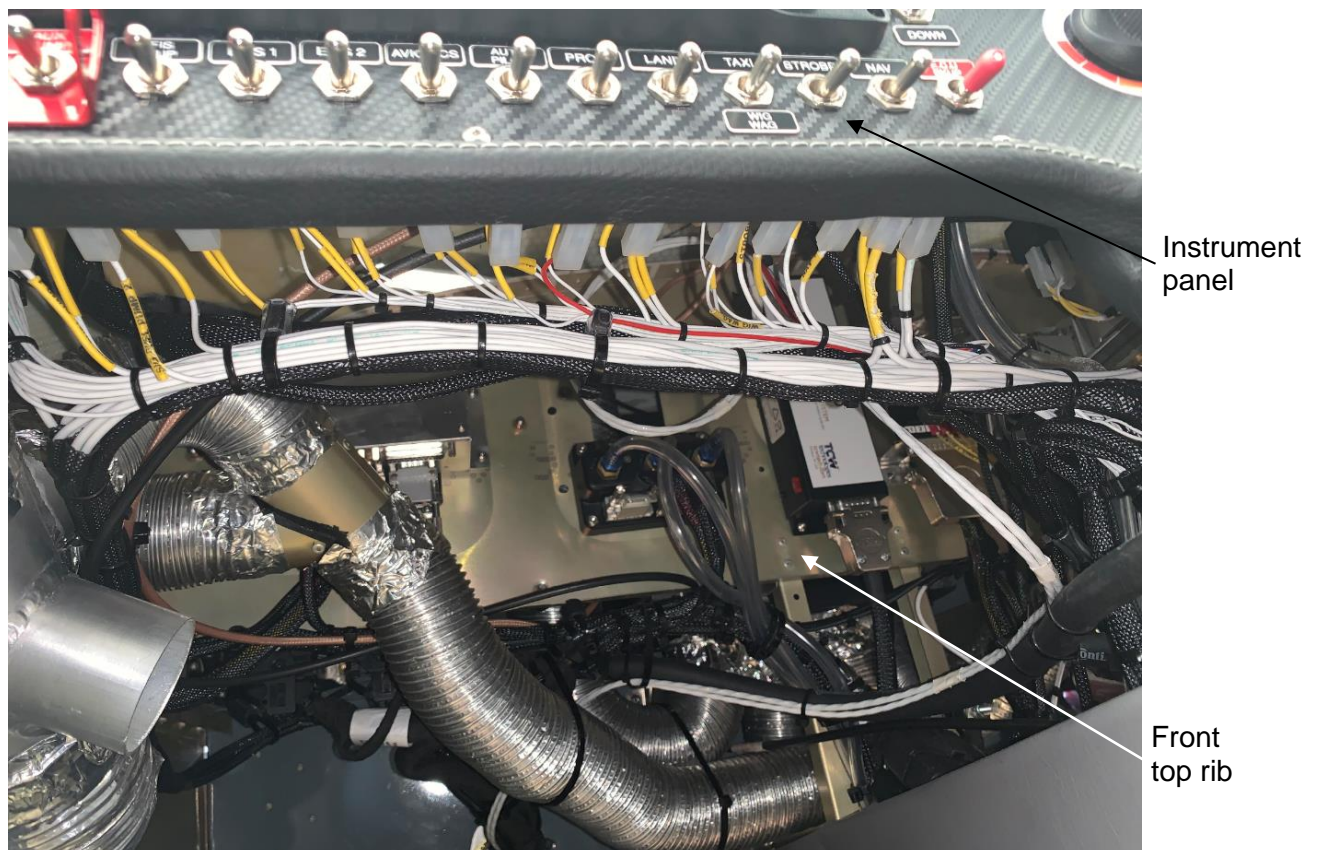
Figure 1 – Location of front top rib (CF-RIB-003-C-C-5)

The ECU is mounted on the back of the rib located behind the instrument panel (refer to part number CF-RIB-003-C-C-5). You will find Garmin instruments mounted on the front of this rib whose mounting screws, particularly the GEA 24, could come into contact with the casing of the ECU and ground it.

1. Remove the left-hand seat for room to work.
2. The front top rib (Part number CF-RIB-003-C-C-5) is located behind the instrument panel as shown in Figure 1. Use the torque wrench and 8 mm socket to remove the installed M5 bolts shown in Figure 2 and replace with longer M5 x 40 bolts.
3. Figure 3 shows a machined aluminium (aluminum) spacer with dimensions OD = 16 mm, ID = 5.4 mm and t = 10 mm installed for a longer standoff. Alternatively, use the recommended four washers on each standoff as shown in Figure 4. Apply Loctite 222 to the thread of the bolts during installation.

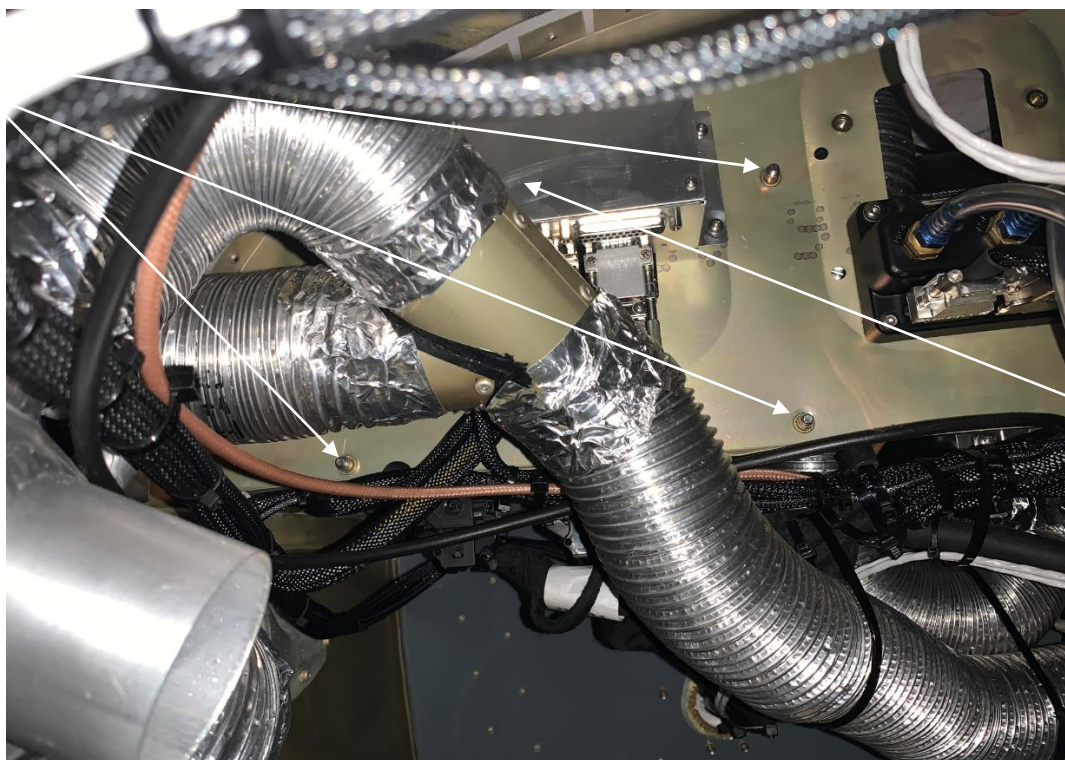
Figure 2 – Location of ECU mounting bolts

ECU  
mounting  
bolts

GEA 24

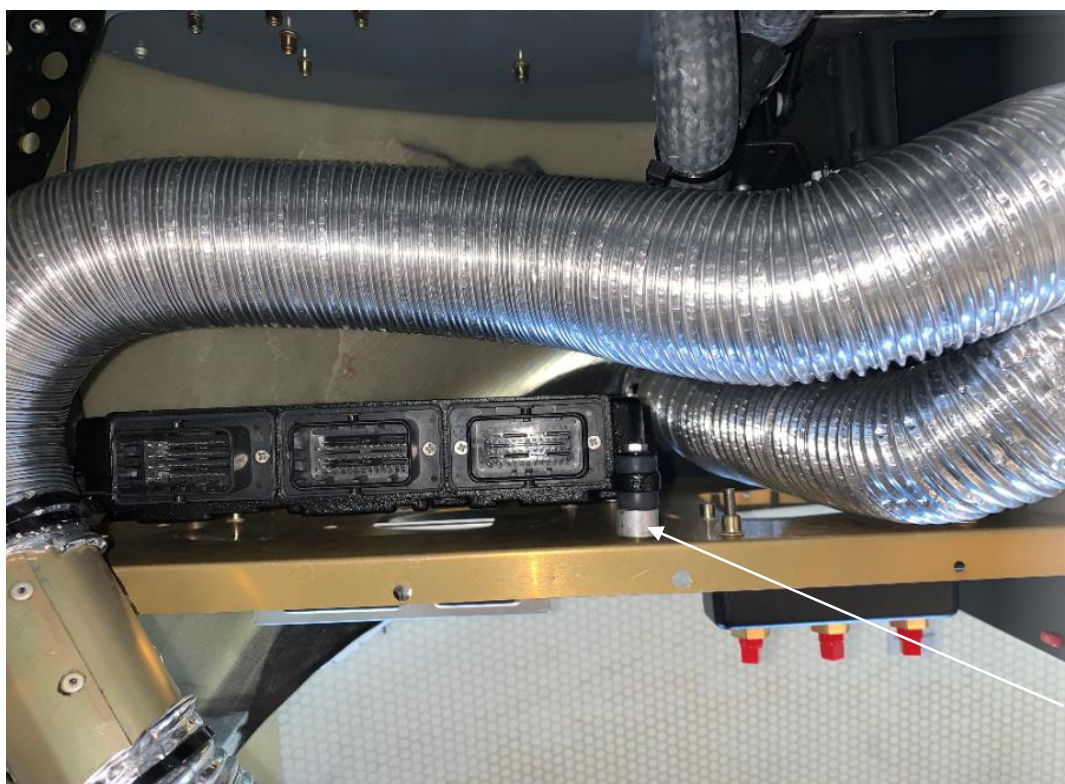
Figure 3 – Spacer installed on ECU standoff

OD = 16 mm  
ID = 5.4 mm  
t = 10 mm

GEA 24  
screw  
ends

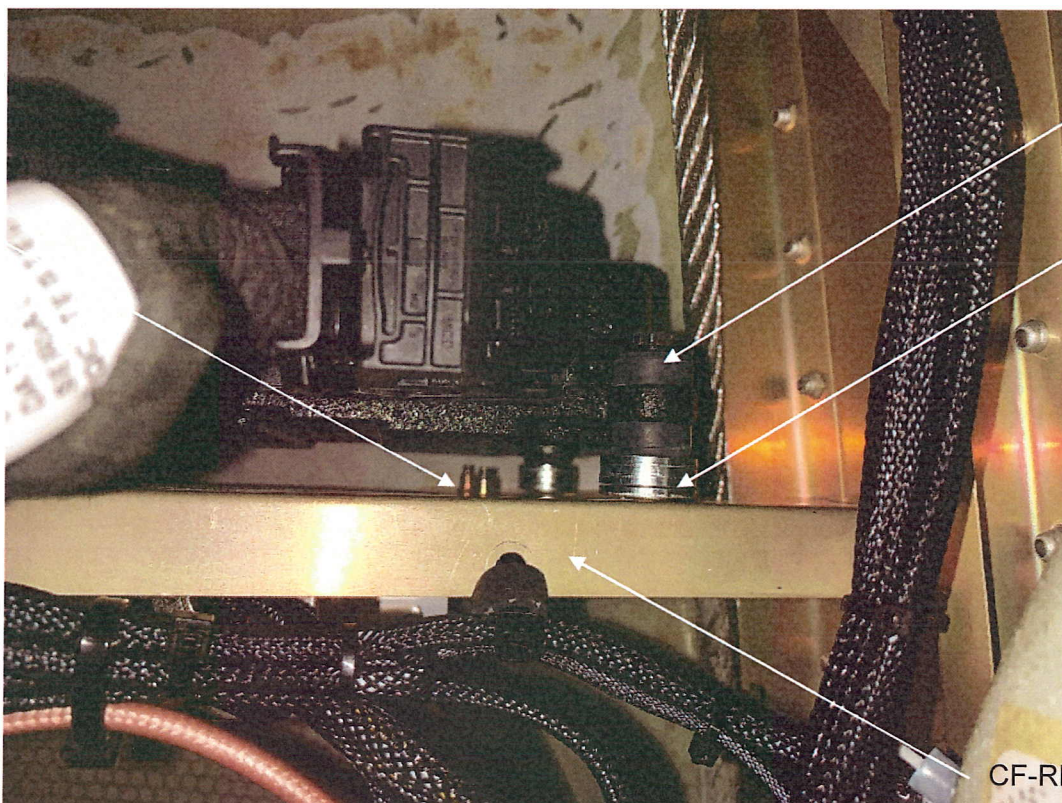
Figure 4 – Washers installed on ECU standoff

ECU  
stand  
off

Four steel  
washers  
inserted
