SERVICE BULLETIN

#0017

SUBJECT: Potential risk of shearing of control stop plate rivets

MODELS AFFECTED: Sling 4 and Sling 4 TSi aircraft

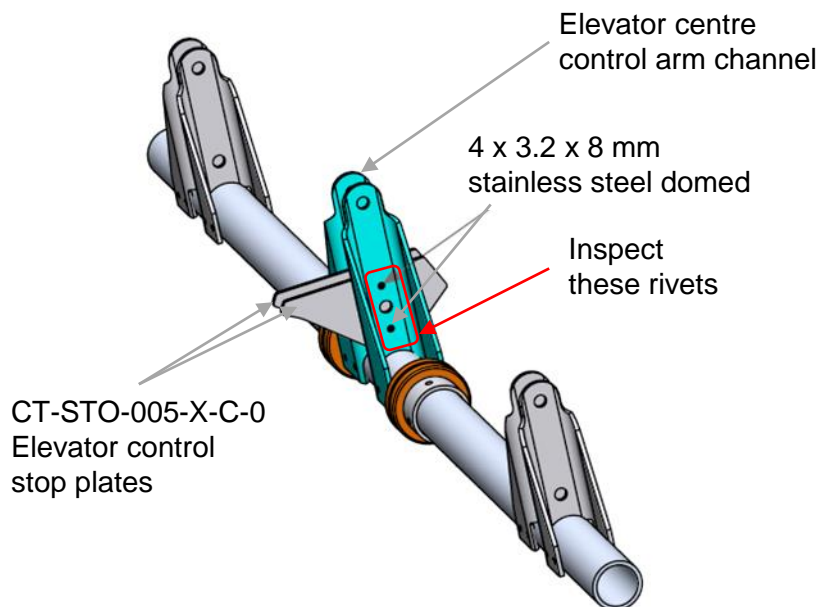
Figure 1 - Elevator control torque tube for Sling 4 and Sling 4 TSi aircraft

1. The rivets on the torque tube that need to be inspected are shown in Figure 1. The control stop plates (CT-STO-005-X-C-0) and elevator centre control arm channels are also shown in Figure 1.
2. Remove a front seat from the fuselage then use the 2 mm / 2.5 mm Allen key to remove the floor skin (refer to CF-SKN-016-R-C-0) shown in Figure 2.
3. The inspection region when the floor skin is removed is shown in Figure 3. Use the light source to determine if control stop rivets are aluminium or stainless steel. Use Figure 4 as a guide for making the distinction.
4. Alternatively (or in addition to using the light source) use a magnet to identify rivets. The mandrel of the aluminium rivet used is magnetic, so a magnet will attract to the aluminium rivet (see Figure 4).

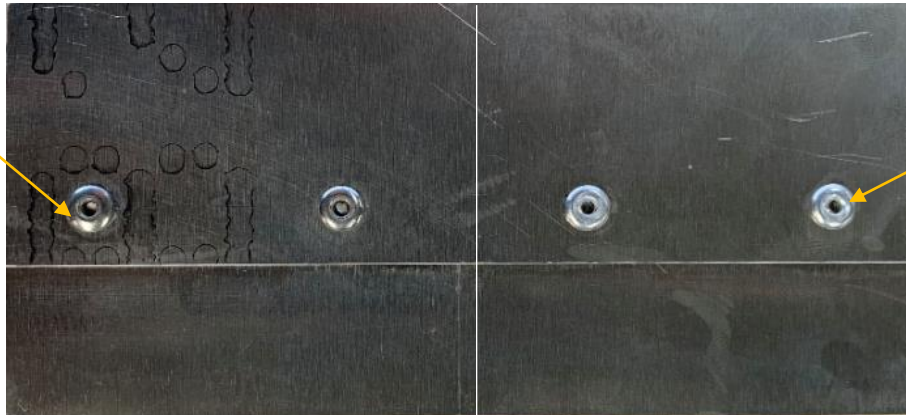
Figure 4 – Identification of stainless steel and aluminium rivets

Stainless steel
(non-magnetic
attraction)

Aluminium
(magnetic
attraction)

5. Should it be determined that the control stop rivets are stainless steel, no repair will be required, in which case the floor skin and seat can be re-installed.
6. However, should it be determined that rivets are aluminium, stainless steel rivets will need to be installed. Remove both front seats prior to repair so that the remedy can be applied to both control stop plates.
