Sling Aircraft (Pty) Ltd
Registration no 2002/022837/07
Approved Maintenance Organisation AMO1264
Manufacturing Organisation M677

SERVICE BULLETIN #0002 (rev. 2)

RELEASE DATE: 11/02/2021
EFFECTIVE DATE: 11/02/2021
SUBJECT: Reinforcement of the upper join between the centre and rear fuselages
MODELS AFFECTED: rev. 1 – Sling 4 and Sling 4 TSi (*all from SN#001 to SN#060*)
rev. 2 – Sling 4 and Sling 4 TSi (*all from SN#001 to SN#060 and non-parachute versions from SN#060 to #306*)
COMPLIANCE TIME: At the next MPI (*Mandatory Periodic Inspection*)
LABOUR TIME: Inspection only: 0.25 hours
Inspection & Repair: 2 hours

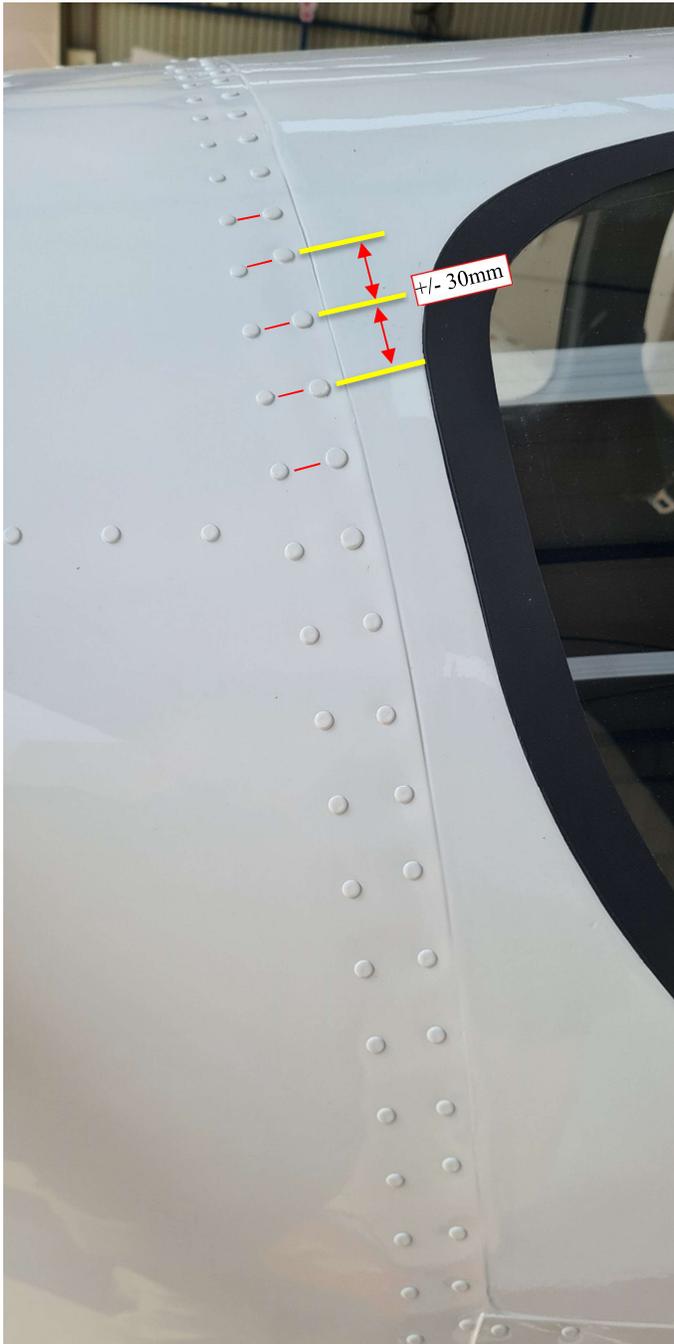
FIGURE 3 | ALTERNATIVE SPACING

If the spacing of the rivets differs from the diagrams provided above, but has the same as seen in Figure 3 (left), then an alternative spacing is required. The red markup in the figure is to show that the forward and aft rivets are inline.

If moving from bottom to top, the pitching does not change from 1/2 to 1/3 (original pitching) as in the technical drawings in section 6. This is still a sufficient number of rivets in this section and are required to remain. If the rivets in this section are 3.3mm, then they are required to be drilled out and replaced with 4.0mm rivets, as described in point 8. in INSTRUCTIONS.

This requirement, in this appendix, is due to the original holes being misplaced in the 1/3 section, and if the diagrams/above instructions were to be obeyed, there will be an additional hole/rivet every 3rd rivet.

The additional rivets may be added in the 1/4 pitching section, as per diagrams in section 6.
