SERVICE BULLETIN

#0019

SUBJECT: Throttle cable replacement to prevent potential loss of engine power control

MODELS AFFECTED: 912 iS and 915 iS fitted aircraft delivered prior to June 2021

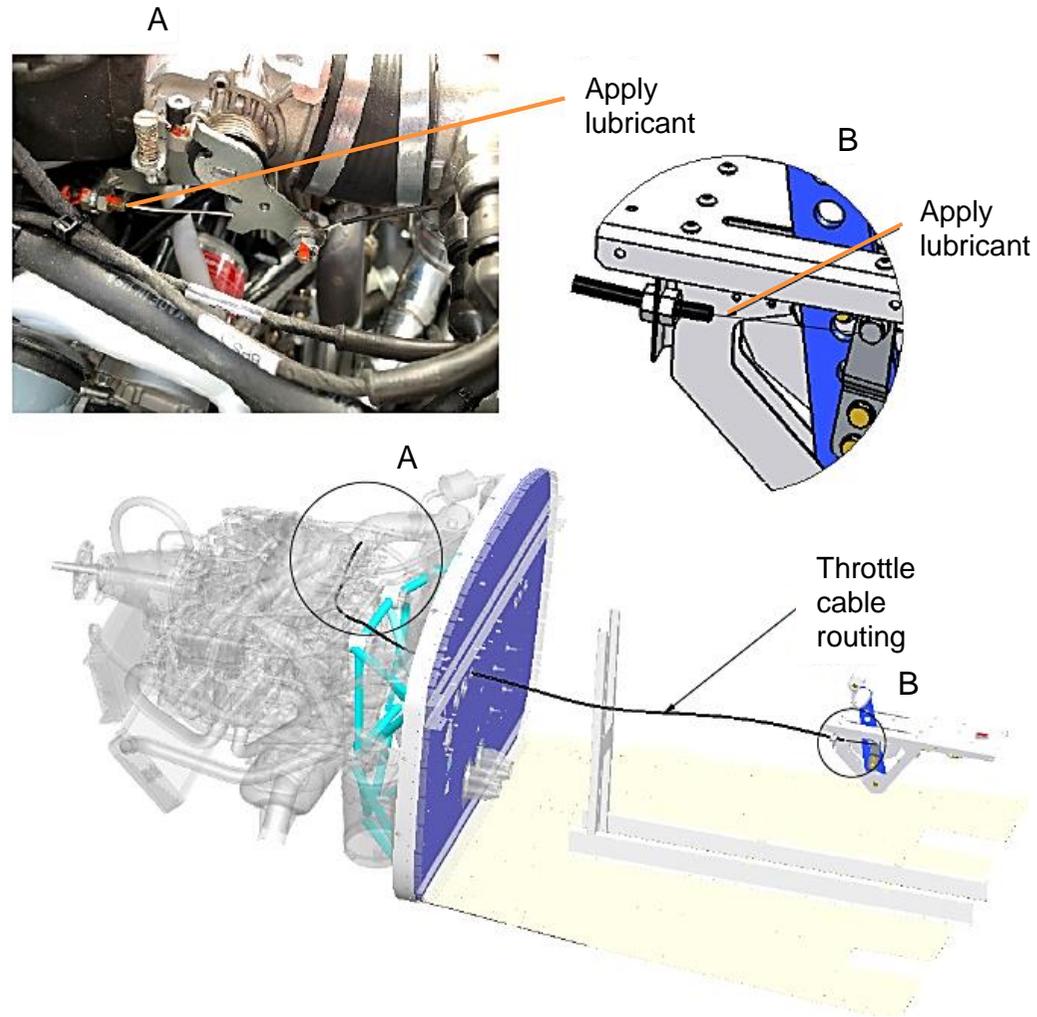
Figure 1: Installation guide and lubrication requirements

- or inner cable fraying.
- c) Check that the bolt (A), shown in Figure 2, which attaches the inner stainless-steel cable to the throttle link, can swivel freely.
- d) Verify that the throttle cable is routed such that the minimum bend radius is 70mm as shown in Figure 1.
- e) Lubricate both ends of the throttle cable as shown in Figure 1. Hold the aerosol straw into the end fitting (in the direction indicated by the arrows in Figure 1) then apply the lubricant; moving the throttle knob forward and aft to guide the lubricant into the fitting.
- f) Verify that the inner cable does not kink as shown in Figure 2.

- a) Remove the top engine cowling.
- b) Hold the aerosol straw into the end fitting on the engine side (in the direction indicated by the arrows in Figure 1) then apply the lubricant; moving the throttle knob in the cabin forward and aft to guide the lubricant into the fitting.
- c) Wrap a rag / paper towel around the cable end to force the lubricant into the sheath.

- a) If this malfunction has occurred in flight, replace the throttle cable before the next flight. Contact Airworthiness@slingaircraft.com or Technical@slingaircraft.com for the Service Bulletin kit.
- b) The reinstalled cable should meet routing and lubrication requirements shown in Figure 1.
