SERVICE BULLETIN

#0027

SUBJECT: Interference of TSi firewall cutout and left nose gear pushrod

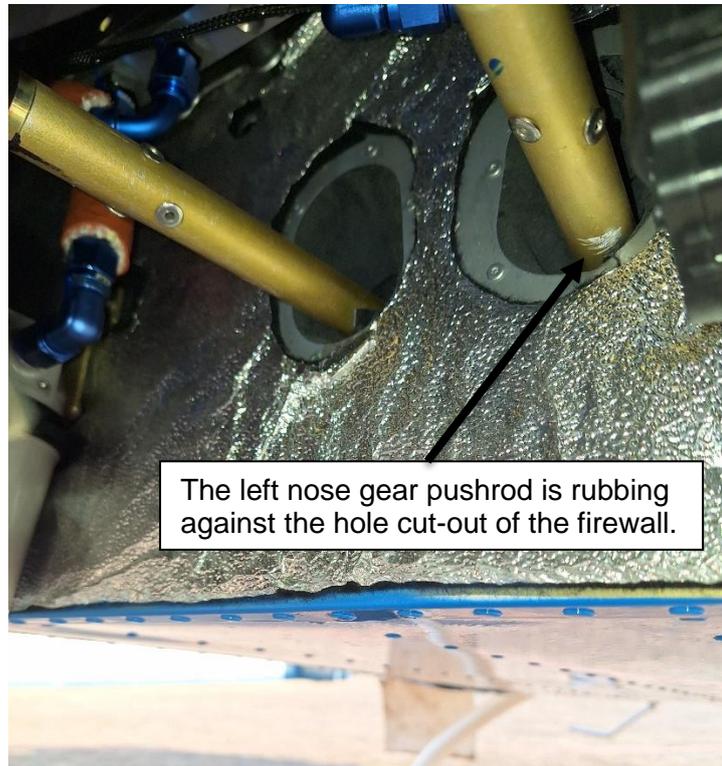
Figure 1

There is some interference between the slot of the firewall and the left nose gear pushrod that goes through it. When the left rudder pedal is extended fully, the left nose gear pushrod contacts the edge of the hole cutout in the firewall. Due to this interference the pushrod becomes scratched and will continue to wear over time. Refer to Figure 1.

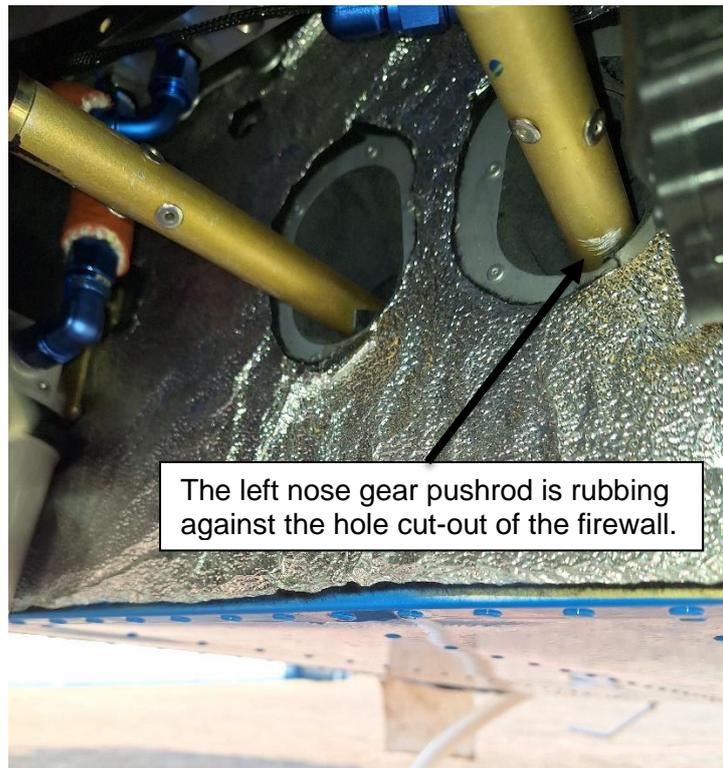
Figure 2

This section details the inspection and corrective action required to prevent the wearing on the left nose gear pushrod, as seen in Figure 2.

Only the left nose gear pushrod is affected by the interference.

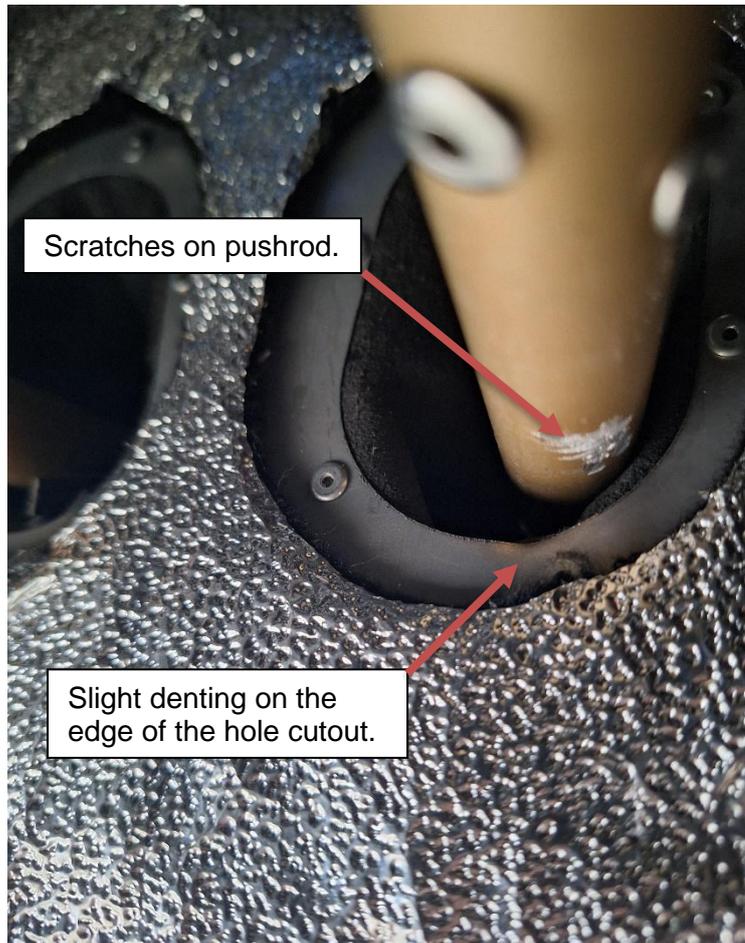
It is possible to inspect the nose gear pushrod without removing the cowling. Inspect the pushrod and look for any scratches as well as denting along the edge of the firewall cutout. Refer to Figure 3 on what this will look like. If this is present on the aircraft, the clearance between the pushrod and the hole cutout will need to be increased. Refer to Section 3.2 for the instructions on how to do this.

Note: Should the pushrod be gouged, a new one can be requested. Refer to the Section 2.5 for the applicable contact details.

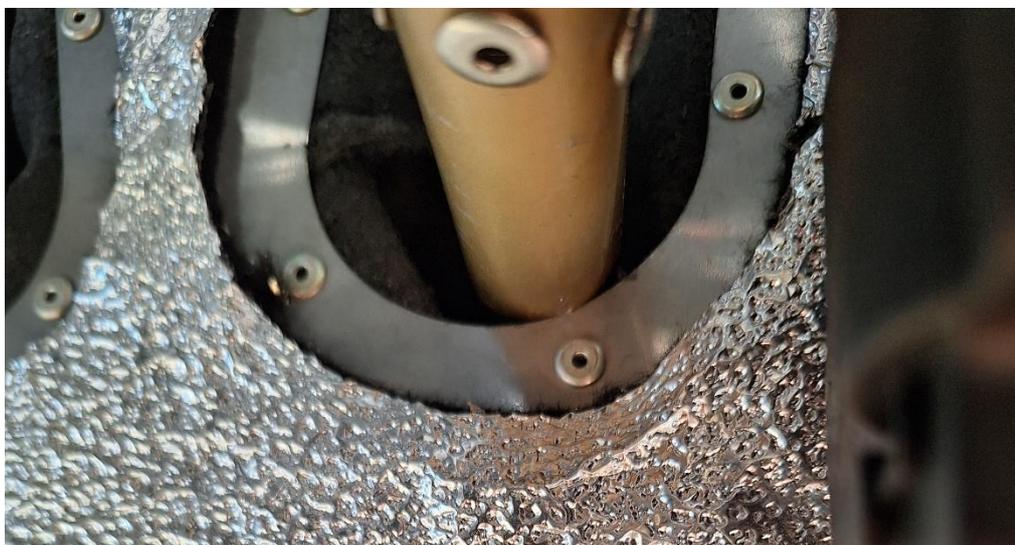
Figure 4

It is also possible that the pedals have not been extended to their extreme points yet, in which case no scratches or dents will be visible yet. Extend the right peddle to its max deflection and check the clearance between the pushrod and the cutout. If it is seen that the pushrod touches the edge of the hole cutout, it will need to be filed down to increase the clearance, refer to Section 3.2.
