SERVICE BULLETIN

#0014 Revision 1

SUBJECT: Rivet replacement along fuselage main spar carry-through and on upper and lower inboard wing skins

MODELS AFFECTED: All Sling aircraft

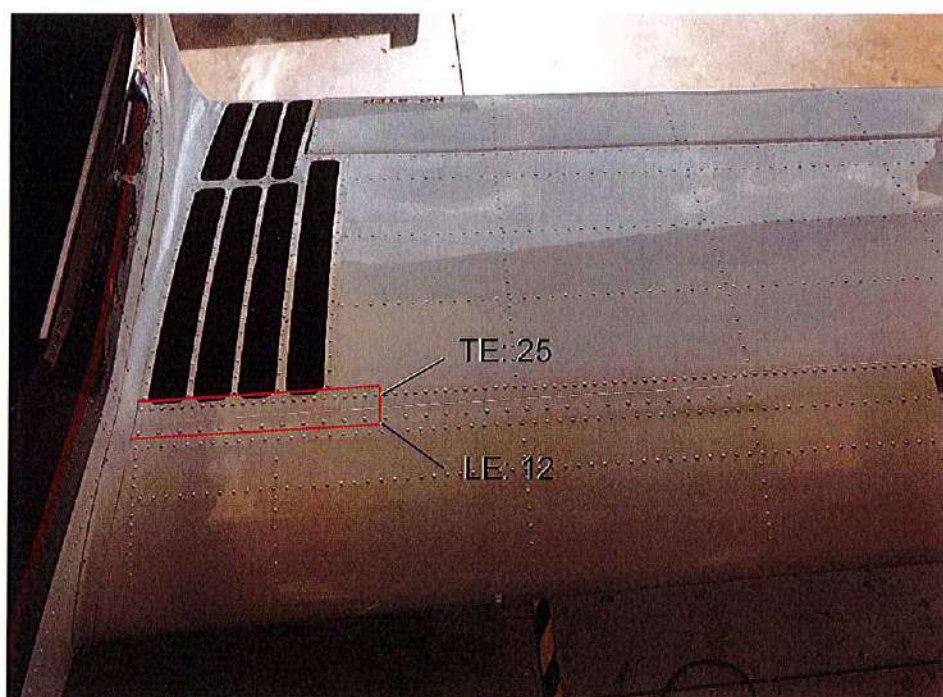
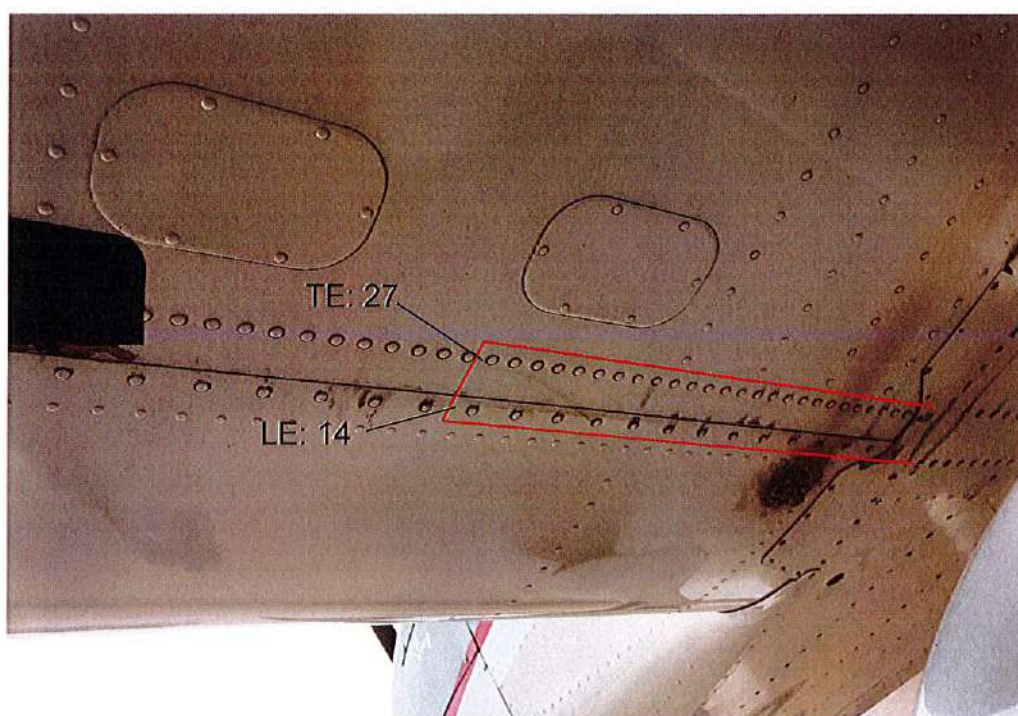
Figure 4 - Number of rivets to replace on Sling 2 and Sling LSA wings

At approximately 50cm (spanwise distance) from the wing root, on the Sling 2 wings, the rivets to be replaced are 12 on the front section (leading edge) and 25 on rear section (trailing edge) of the upper wing spar. On the underside of the Sling 2 wing, the rivets to be replaced are 14 on the leading edge and 27 on the trailing edge as shown in Figure 4.

Hence, the total number of rivets, for both wings = $[(12 + 25) + (14 + 27)] \times 2 \rightarrow 156$ (wings only).
