SERVICE BULLETIN

#0014 Revision 1

SUBJECT: Rivet replacement along fuselage main spar carry-through and on upper and lower inboard wing skins

MODELS AFFECTED: All Sling aircraft

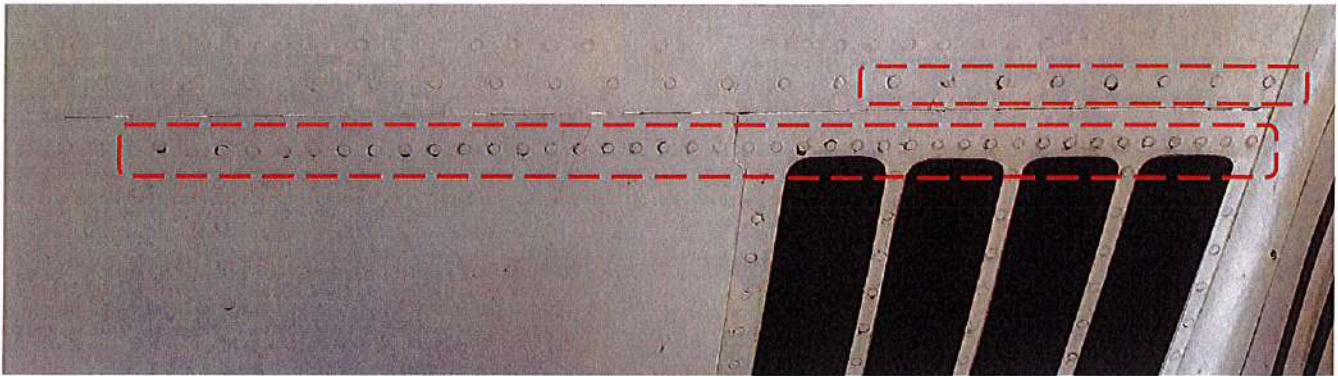
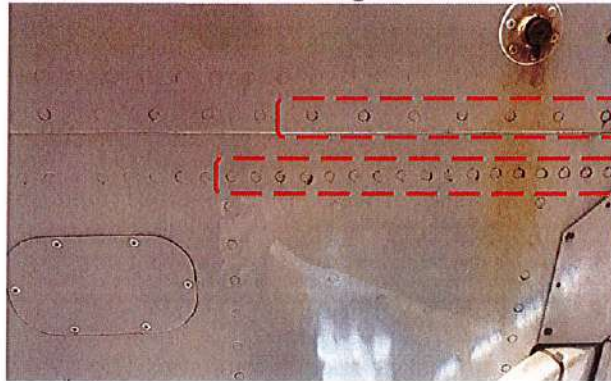
Figure 1 - Paint cracking around rivets on Sling 2 wing

In aircraft, fretting may occur when rivets loosen due to vibration and/or flexing allowing slight motion between skin mating surfaces.

In some Sling aircraft, an indication of this condition is paint cracking around the rivets. The affected regions are usually located on the underside of the fuselage along the main spar carry-through and on upper and lower inboard wing skins. Figure 1 shows paint cracking on the inboard skins of a Sling 2 aircraft.

To minimise fretting, rivets in the affected areas should be replaced with Avinox stainless steel rivets (Part number BE61-00512).

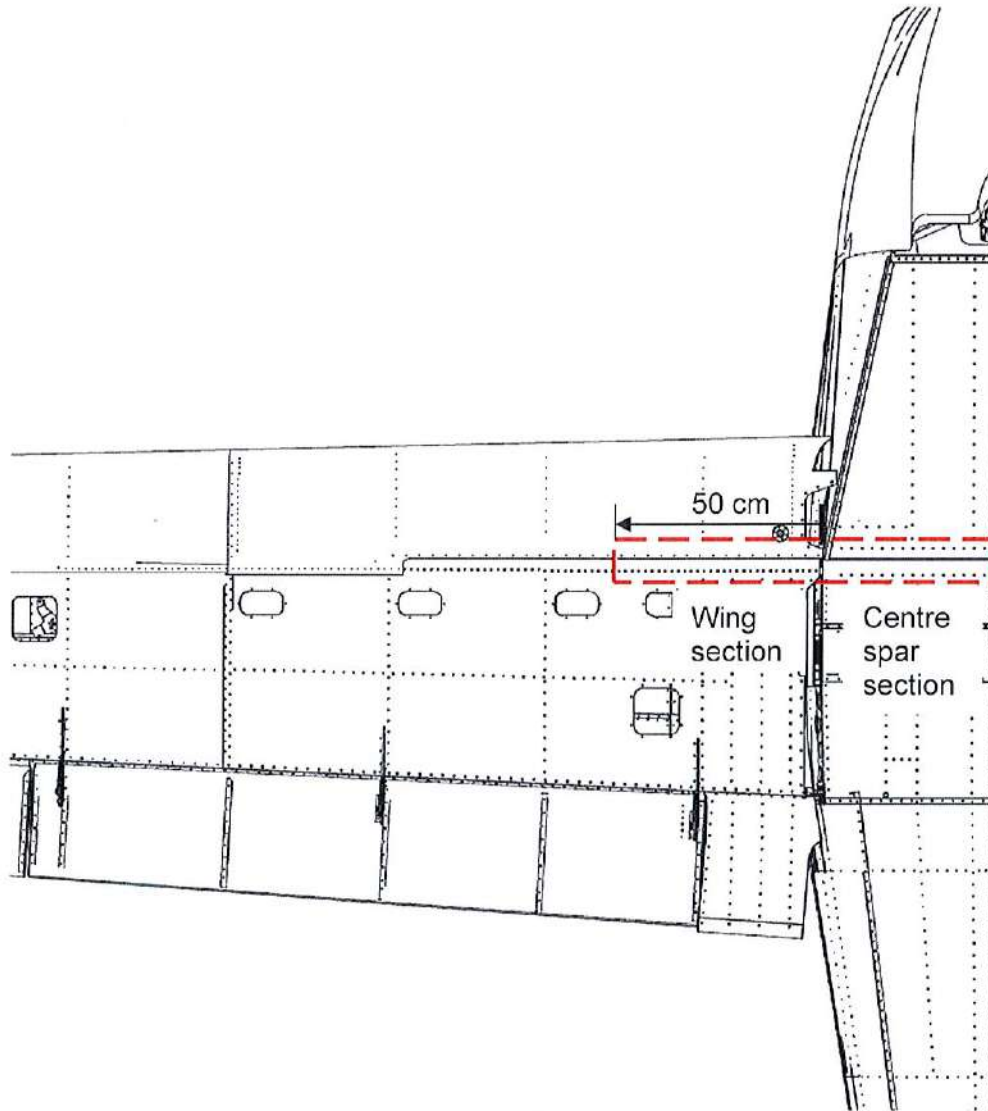
Figure 2 – Region of rivet replacement on the underside of starboard (right) wing

2. On the fuselage (of Sling TSi, Sling 2 and Sling 4 aircraft), this region is along the two rows of rivets that attach the underside centre fuselage skin to the centre spar (see Figure 2).

3. Figure 2 shows one half of the affected region on the underside of the starboard wing and fuselage and Figure 3 shows half the affected region on the upper starboard wing. The quantity of rivets recommended should cover these regions sufficiently.

5. Ensure that rivet removal is complete on the top of the wing before starting with the underside.
6. Using the powered drill with the 4 mm drill bit, drill the heads off rivets in the affected regions indicated in Figure 2 and 3 (specifically Figure 4 for Sling 2 and Figure 5 for Sling 4 wings). If rivets are filled, indent the centre of the rivet head with a centre punch and hammer before drilling.

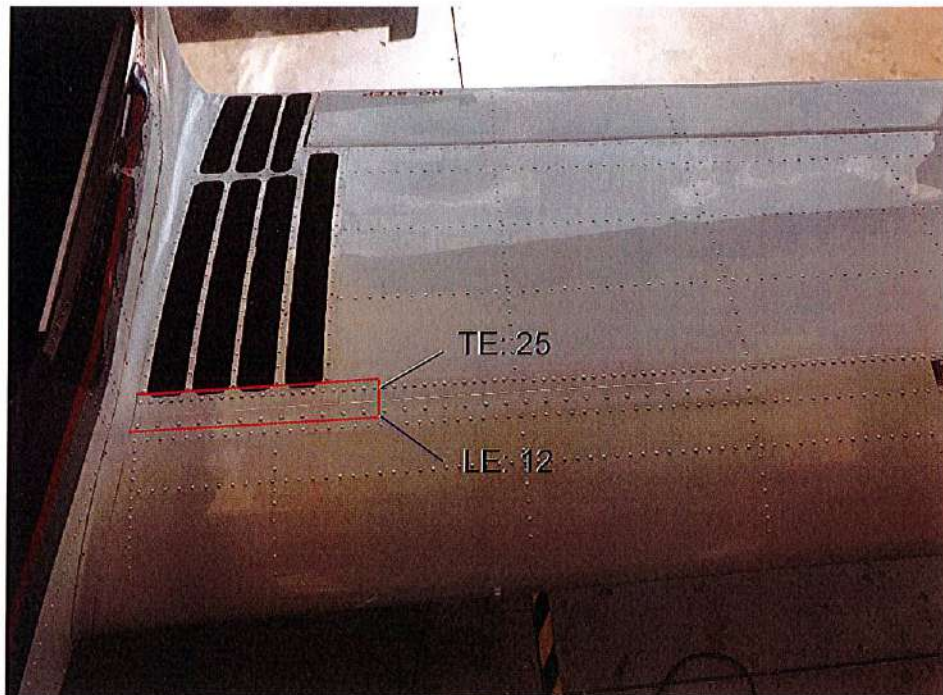
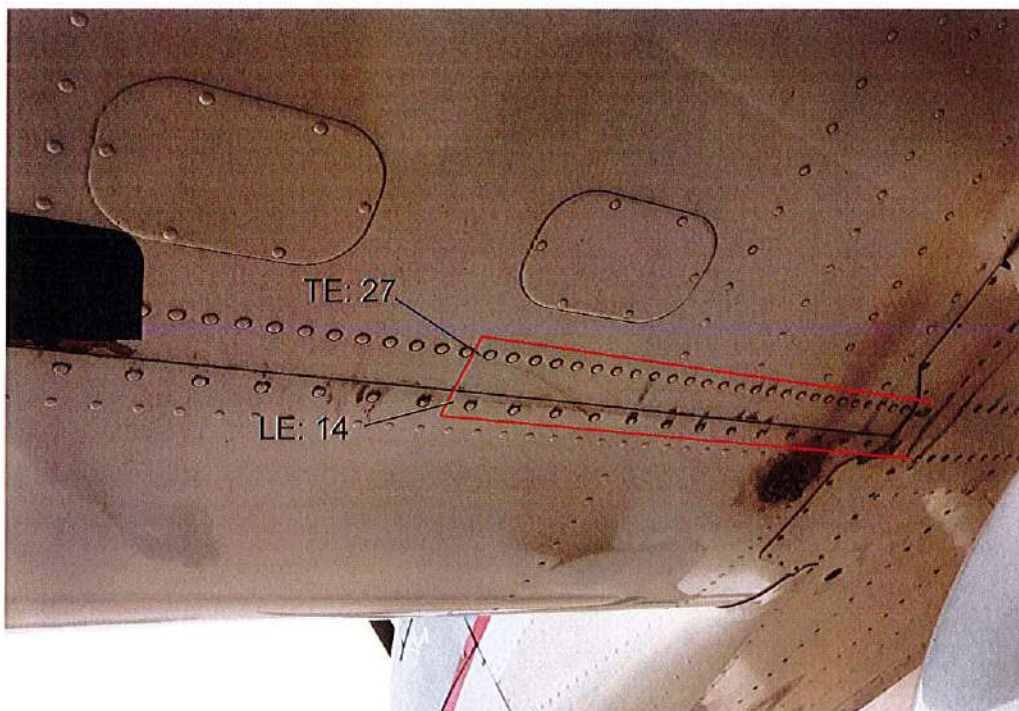
Figure 4 - Number of rivets to replace on Sling 2 and Sling LSA wings

At approximately 50cm (spanwise distance) from the wing root, on the Sling 2 wings, the rivets to be replaced are 12 on the front section (leading edge) and 25 on rear section (trailing edge) of the upper wing spar. On the underside of the Sling 2 wing, the rivets to be replaced are 14 on the leading edge and 27 on the trailing edge as shown in Figure 4.

Hence, the total number of rivets, for both wings = $[(12 + 25) + (14 + 27)] \times 2 \rightarrow 156$ (wings only).

The number of rivets along the centre spar carry-through under the fuselage $\rightarrow 62$ (centre spar only).

In total: $(156 + 62) \rightarrow 218$ rivets (Sling 2)

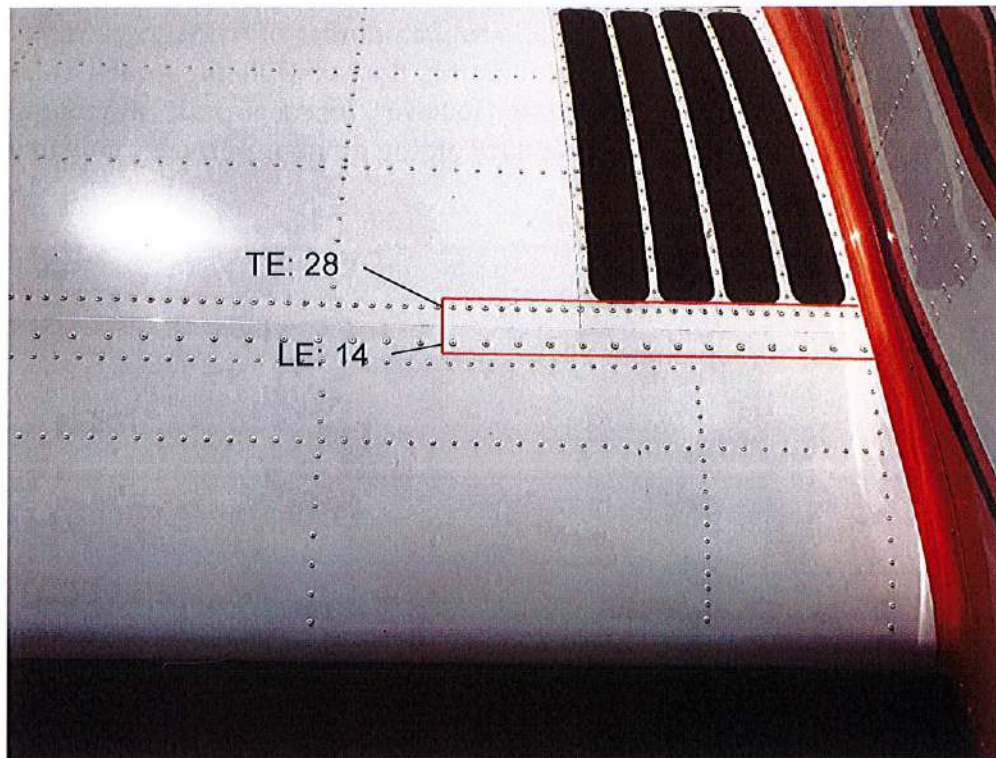
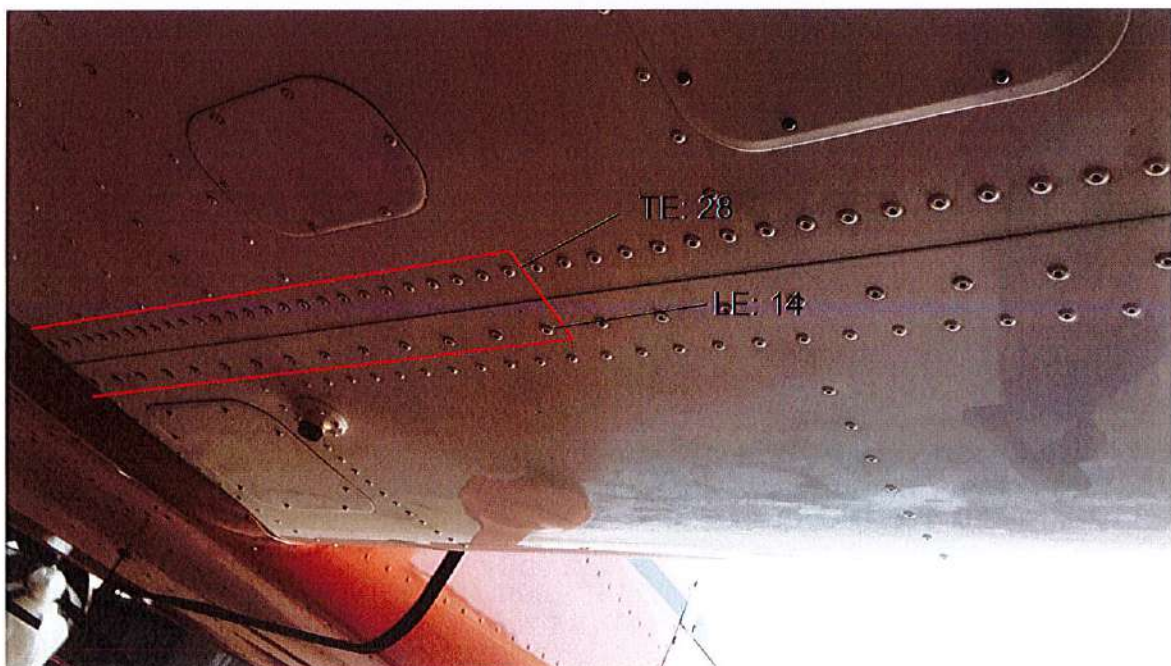
Figure 5 - Number of rivets to replace on Sling 4 wings

As illustrated below, on the Sling 4 wings, the rivets to be replaced are 14 on the front section (leading edge) and 28 on rear section (trailing edge) of the upper wing spar. On the underside of the Sling 4 wing, the rivets to be replaced are again 14 on the leading edge and 28 on the trailing edge. Hence, the total number of rivets, for both wings = $[(14 + 28) + (14 + 28)] \times 2 \rightarrow 168$ (wings only). The number of rivets along the centre spar carry-through under the fuselage $\rightarrow 62$ (centre spar only). In total: $(168 + 62) \rightarrow 230$ rivets (Sling 4)
