SERVICE BULLETIN

#0005

SUBJECT: Incorrect material used on guides which could lead to premature wear on pushrods

MODELS AFFECTED: All Sling LSA, Sling 2, Sling Taildragger, Sling 4 – Manufactured after January 2015

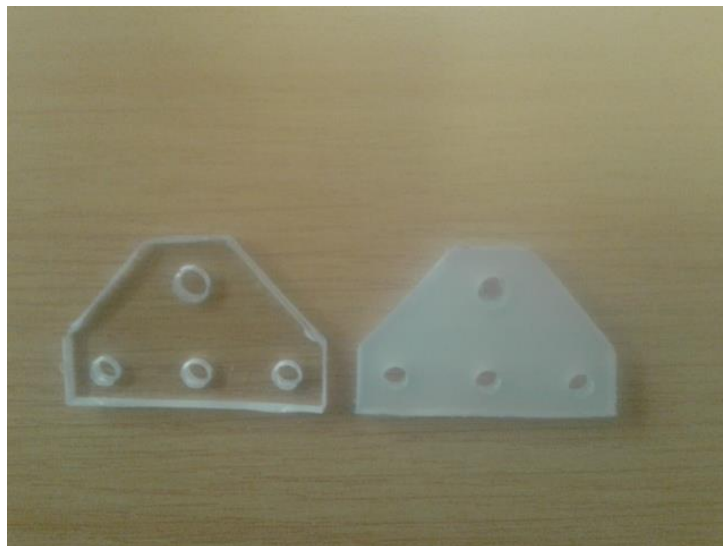
The pictures below are purely for illustration purposes of showing the incorrect and correct material. The material on the left is incorrect and the material on the right is correct.
