SERVICE BULLETIN

#008

| TITLE: | Inspection of propeller hub – ground adjustable Warp Drive propellers |
| MODELS AFFECTED: | All Sling LSA and Sling 2 aircraft fitted with a Rotax 912 iS engine and a ground adjustable Warp Drive propeller. |

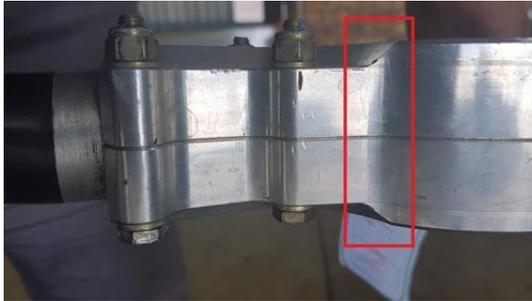
| REASON: | Risk of failure of propeller hub in ground adjustable Warp Drive propeller systems fitted to Rotax 912 iS engines. |
| INSTRUCTIONS: | <ol style="list-style-type: none">1. Remove aircraft propeller and propeller hub in accordance with the currently applicable aircraft maintenance and Warp Drive installation and maintenance manuals.2. Following removal of the propeller hub carefully inspect the hub for cracks using penetrant dye or other appropriate NDT test equipment, paying special attention to the areas indicated in the photograph below. |

3. If no evidence of cracking is found, re-assemble and re-fit propeller hub, blades and spinner in accordance with the currently applicable aircraft maintenance and Warp Drive installation and maintenance manuals.
4. If any cracks are found, The Airplane Factory should be notified and the hub replaced prior to the aircraft being placed back into service.
