SERVICE BULLETIN

#0019

SUBJECT: Throttle cable replacement to prevent potential loss of engine power control

MODELS AFFECTED: 912 iS and 915 iS fitted aircraft delivered prior to June 2021

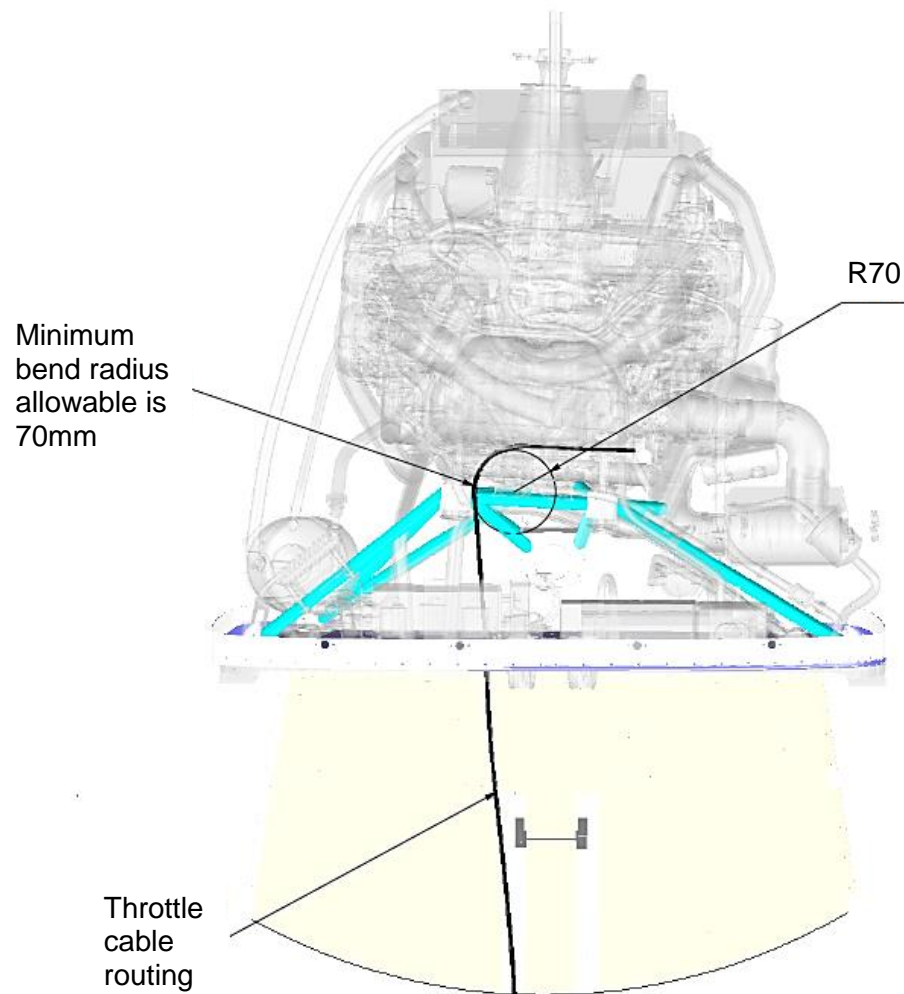
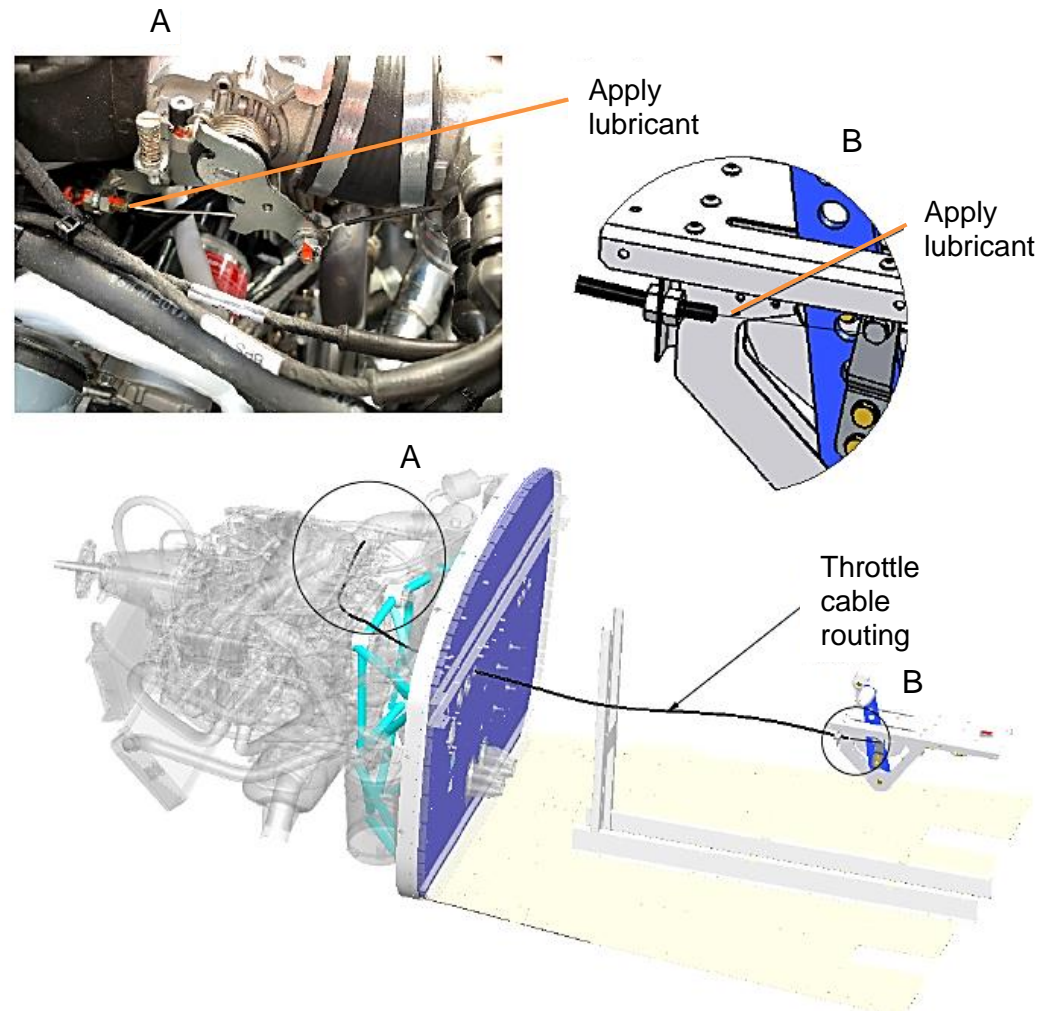
Figure 1: Installation guide and lubrication requirements

THROTTLE CABLE ROUTING

THROTTLE CABLE LUBRICATION

- a) Remove the top engine cowling.
- b) Hold the aerosol straw into the end fitting on the engine side (in the direction indicated by the arrows in Figure 1) then apply the lubricant; moving the throttle knob in the cabin forward and aft to guide the lubricant into the fitting.
- c) Wrap a rag / paper towel around the cable end to force the lubricant into the sheath.

- or inner cable fraying.
- c) Check that the bolt (A), shown in Figure 2, which attaches the inner stainless-steel cable to the throttle link, can swivel freely.
- d) Verify that the throttle cable is routed such that the minimum bend radius is 70mm as shown in Figure 1.
- e) Lubricate both ends of the throttle cable as shown in Figure 1. Hold the aerosol straw into the end fitting (in the direction indicated by the arrows in Figure 1) then apply the lubricant; moving the throttle knob forward and aft to guide the lubricant into the fitting.
- f) Verify that the inner cable does not kink as shown in Figure 2.

- a) If this malfunction has occurred in flight, replace the throttle cable before the next flight. Contact Airworthiness@slingaircraft.com or Technical@slingaircraft.com for the Service Bulletin kit.
- b) The reinstalled cable should meet routing and lubrication requirements shown in Figure 1.

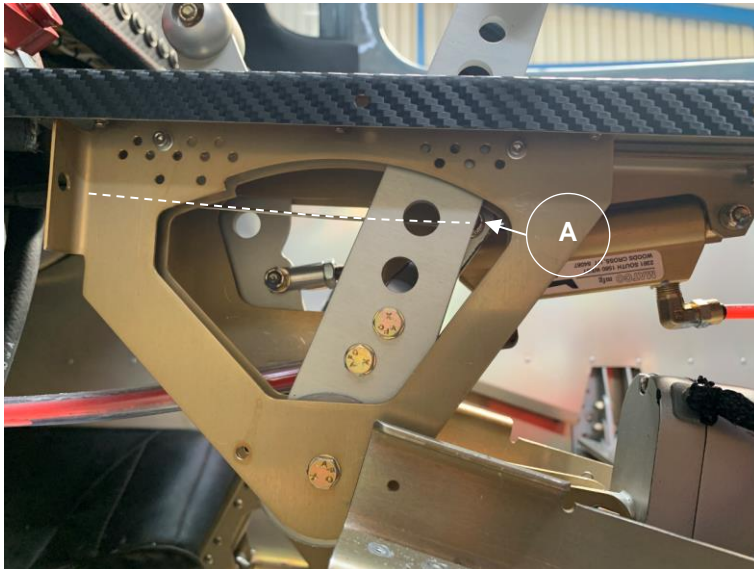
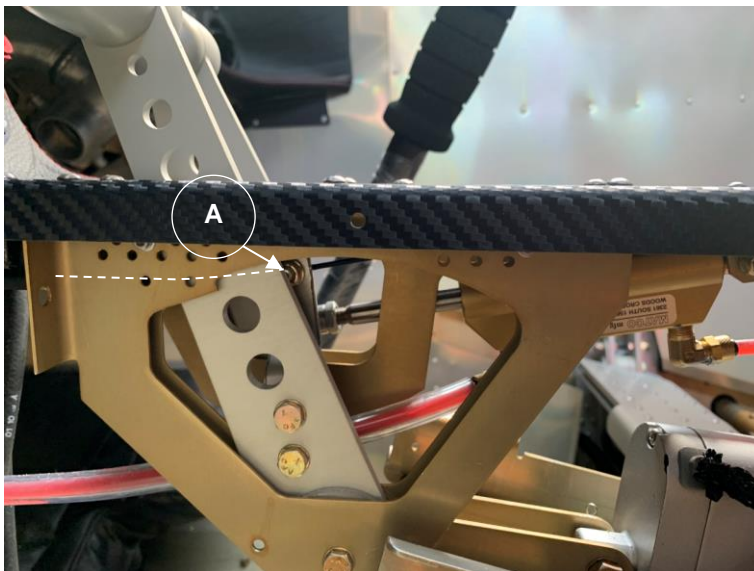
Figure 2: Inspect inner cable for kinking

Acceptable

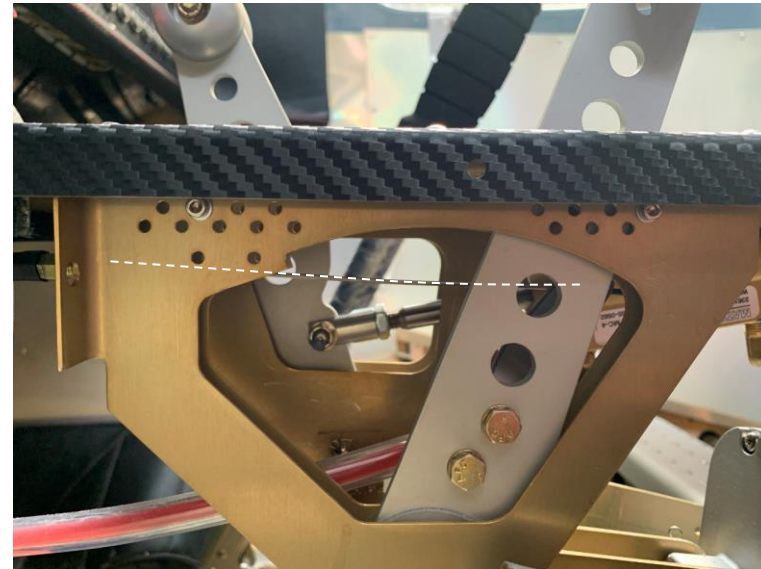
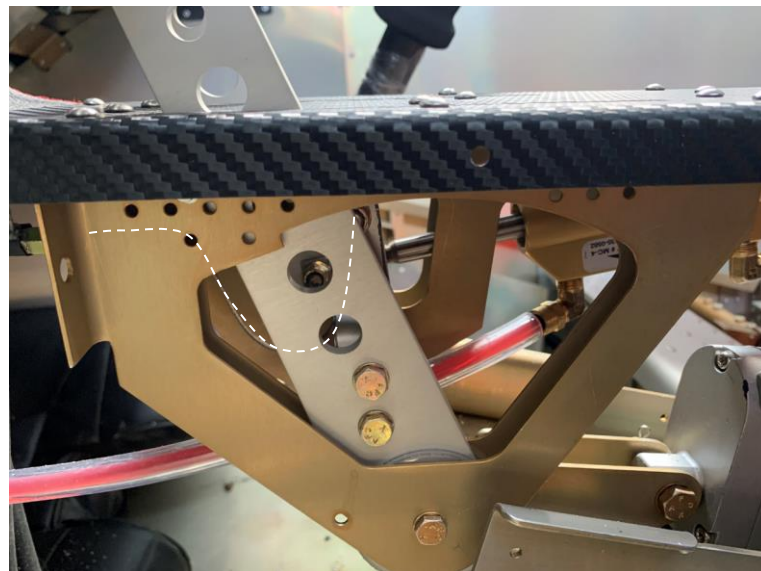
Unacceptable
