Sling Aircraft (Pty) Ltd
Registration no 2002/022837/07
Approved Maintenance Organisation AMO1264
Manufacturing Organisation M677

SERVICE BULLETIN

#0023

SUBJECT: Incorrect Nose Gear Bolt Replacement

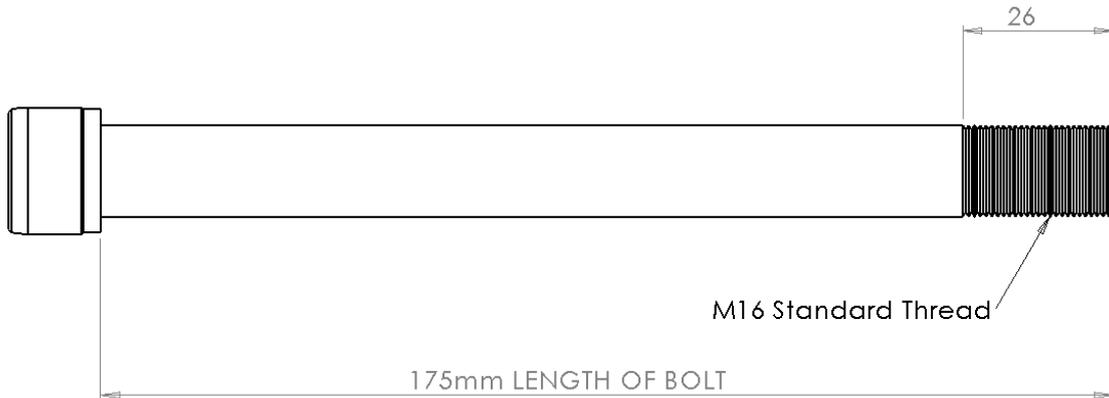
Figure 1: Correct Nose Gear Bolt thread length

The threaded section on the nose gear bolt provided to the affected aircraft is too long. This results in the threaded section of the bolt being loaded and may make the bolt more likely to fatigue and/or possibly break with a rough landing. This bolt needs to be replaced with one of the correct thread length to ensure that the thread does not get loaded.

Figure 1 shows the correct nose gear bolt dimensions. The nose gear bolt (HW-MCB-612-X-X-0) dimensions should be checked and if the bolt's thread length is incorrect it must be replaced with a new bolt of the correct dimensions. These bolts can be ordered from Sling Aircraft.

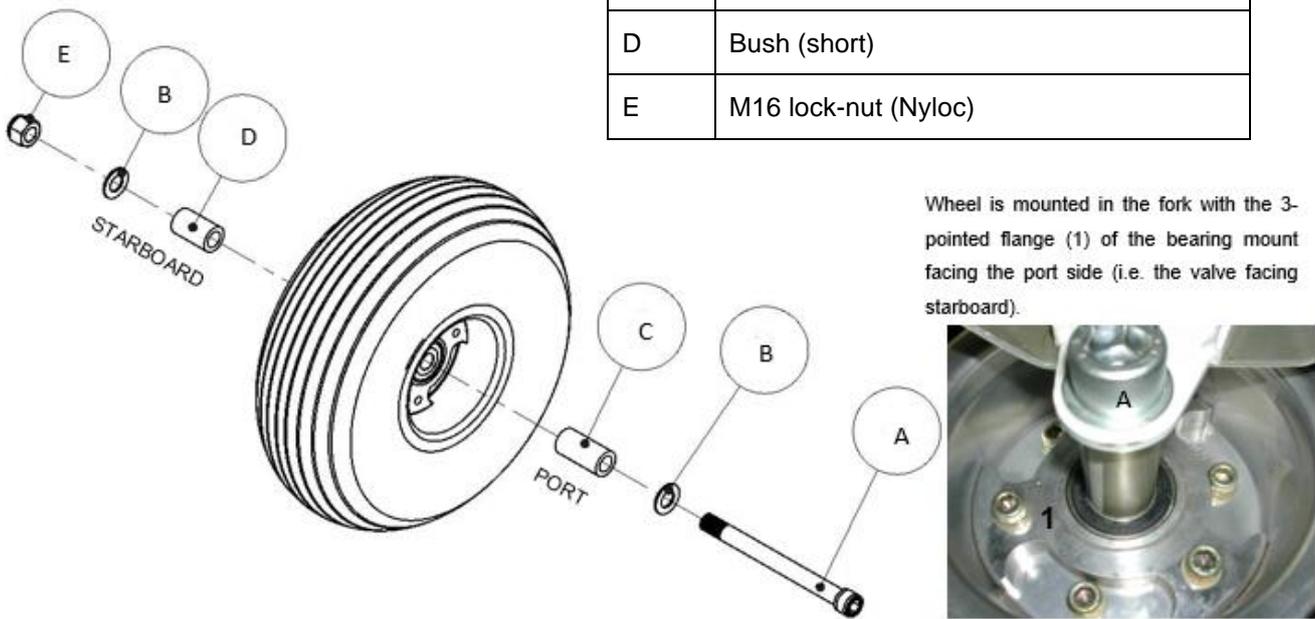
Figure 4: Nose gear wheel assembly

A	M16 x 175 mm Allen cap bolt, Class 12.9
B	M16 washer
C	Bush (long)
D	Bush (short)
E	M16 lock-nut (Nyloc)

Step 1: In order to install the new replacement bolt with the correct thread length, reverse the procedure specified in Section 3.1. Ensure that the assembly of the wheel get reassembled correctly. Refer to the exploded view of the wheel axle assembly to ensure the components get placed in the correct positions, refer to Figure 4.

- Step 2: Torque the M10 Allen cap bolt to 10.5 Nm.
- Step 3: Apply torque seal into the bolt.
- Step 4: Verify free rotation for the wheel.
- Step 5: Apply Loctite 222 to the failing screws and reinstall the nose gear fairing.
