Sling Aircraft (Pty) Ltd
Registration no 2002/022837/07
Approved Maintenance Organisation AMO1264
Manufacturing Organisation M677

NOTIFICATION

#0011

SUBJECT: Throttle cable inspection

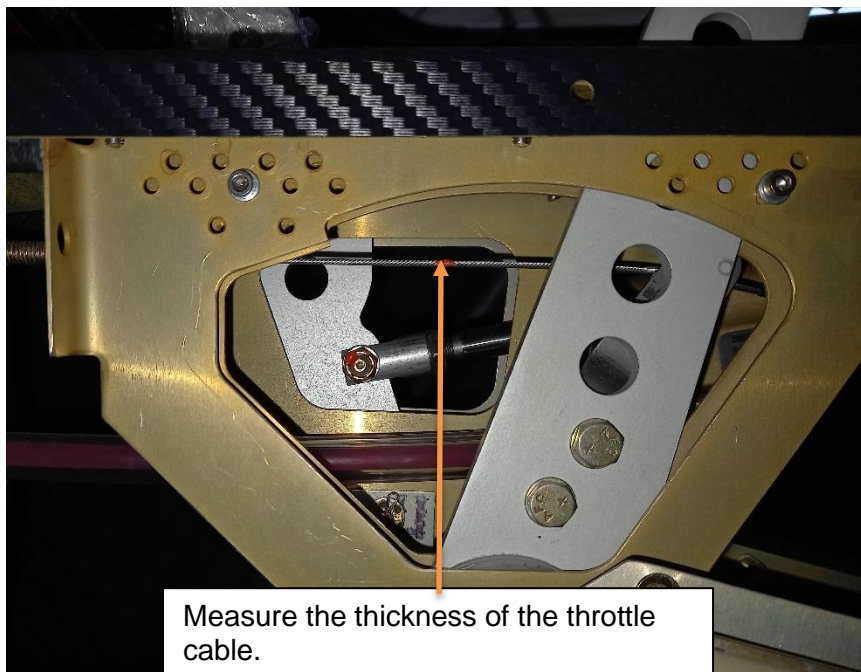
It was discovered that 2mm throttle cables installed on a limited number of aircraft may pose a risk of jamming. Any 2mm thick throttle cable that has been installed must be replaced with a 1.5mm cable. If the 2mm cable is not replaced with the 1.5mm cable there is the potential for the throttle cable to stick, resulting in reduced throttle control/travel.

Figure 1: Throttle cable to be measured

If the cable is found to be a 2mm cable and not a 1.5mm cable, replace the cable with a 1.5mm cable. If the correct cable is installed, reinstall the inspection hatch and front seat.

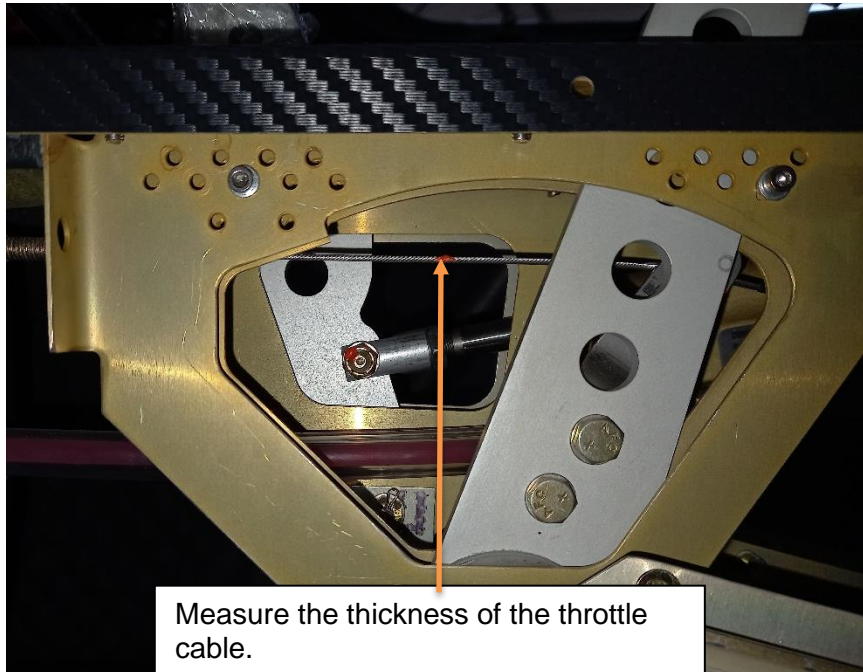
Figure 2: Throttle cable to be measured

If the cable is found to be a 2mm cable and not a 1.5mm cable, replace the cable. If the correct cable is installed, reinstall the inspection hatch and front seat.
