NOTIFICATION

#0009

SUBJECT: Static Longitudinal Stability – Permitted Removal of Elevator Centre Balance Weights.
Optional modification to be referred to as “Sling 4 TSi Optional Elevator Centre Balance Weight Removal Modification”

MODELS AFFECTED: Sling 4 TSi (All)

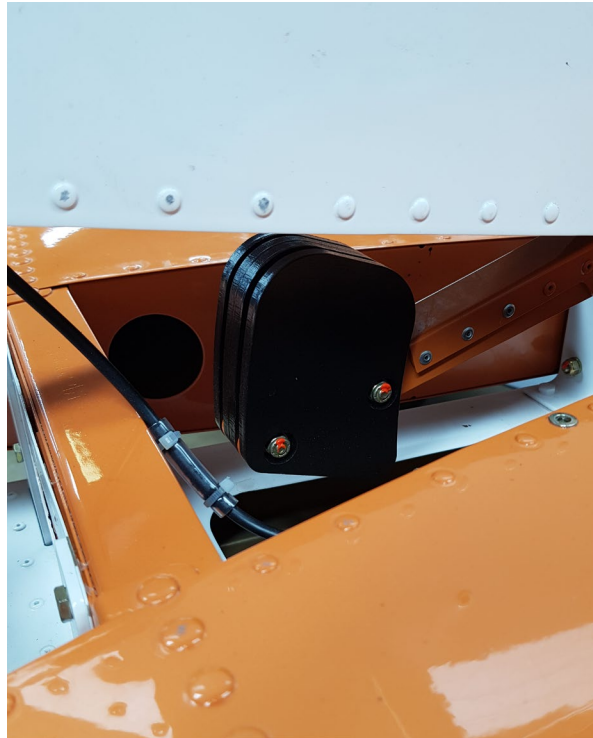
Figure 1 Elevator centre balance weight visible after removing empennage fairing

1. Ensure the master switch is off.
2. Remove the empennage fairing.
 - a. With the 4mm hex key, by removing all 4mm button screws fastening the fairing to the rear fuselage.
 - b. Once all button screws are removed, pull the fairing forwards and upwards, away from the empennage. Be mindful that the fairing can scratch paintwork if removed incorrectly.

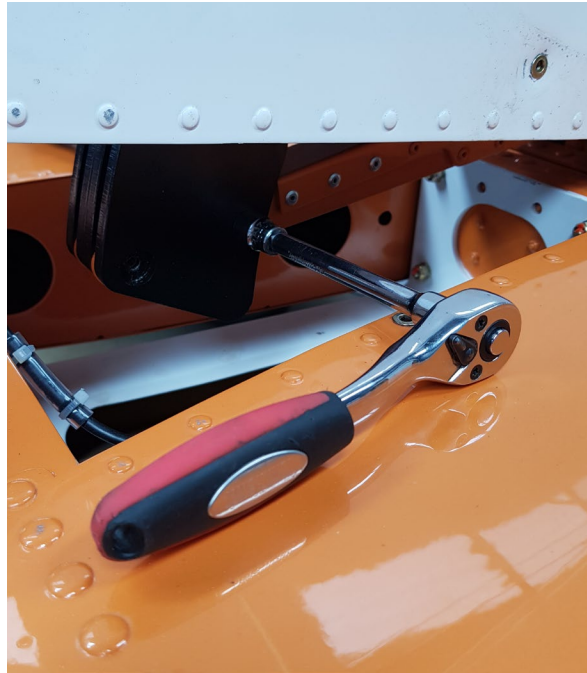
Figure 2 Removal of the balance weight bolts

3. Remove the balance weight plates
 - a. Once fairing is removed, remove the two 10mm bolts that fasten the weight plates with the 10mm hex socket, extension bar and ratchet handle/sliding bar.

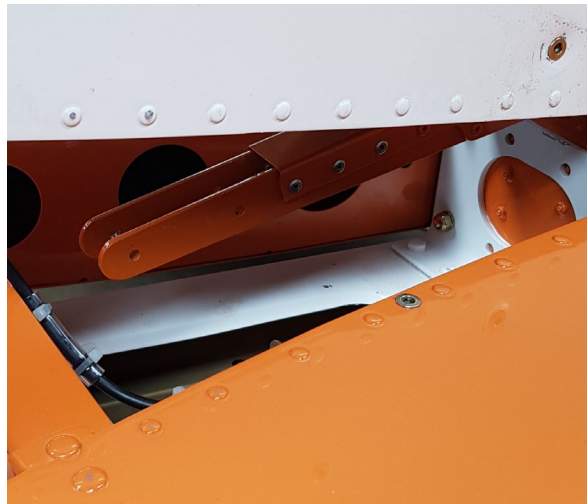
Figure 3 Balance weight arm after weight removal

4. Replace the empennage fairing.
 - a. Similar to when removed, reinstall the fairing from the front. Be mindful of getting the lower fingers of the fairing underneath the horizontal stabilizer.
 - b. Reinstall all 4mm cap screws.

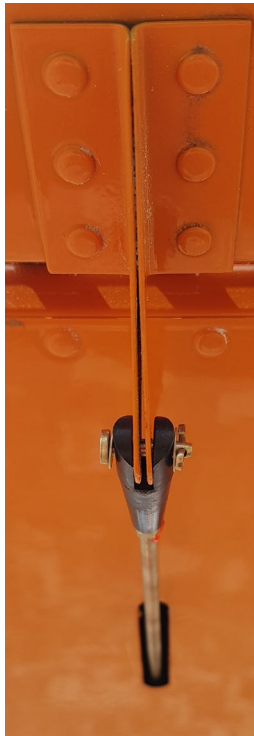
Figure 4 Trim arm with clevis, split pin and pin visible

1. Remove the split pin, that secures the clevis/trim tab connecting pin, with long/needle-nose pliers.

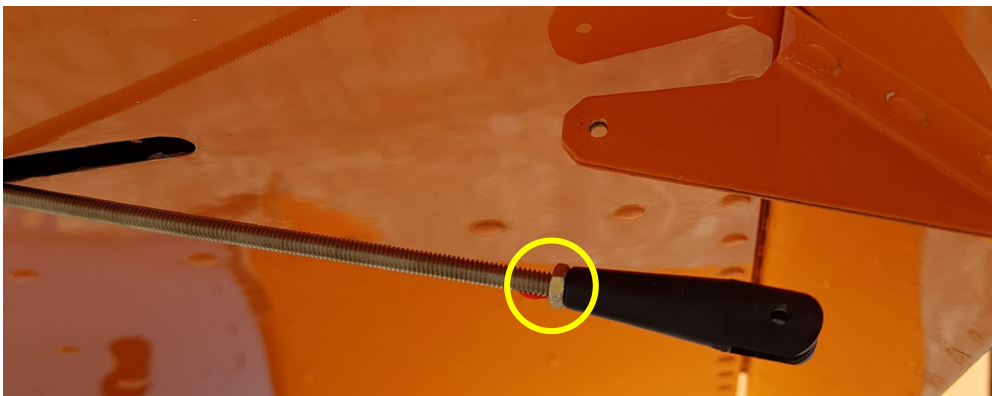
Figure 5 Trim arm clevis locking nut

2. Remove the clevis/trim tab connecting pin.
3. Loosen the $\frac{1}{4}$ " nut, with the appropriate wrench, and turn the nut such that there is at least a 10mm gap between the nut and plastic clevis.

4. Turn the clevis a full 3 revolutions clockwise (inwards).
5. Tighten the locking nut against the clevis, without letting the clevis rotate.
6. Re-insert the clevis/trim tab control horn pin.
7. Insert a new split pin and secure in place.
