(Sling Aircraft (Pty) Ltd. considers compliance with all Service Bulletins mandatory)

RELEASE DATE:	14/06/2024
EFFECTIVE DATE:	08/07/2024
SUBJECT:	Inspection and possible replacement instructions of the Sling 4 TSi seatbelt shoulder guide anchor bolts.
MODELS AFFECTED:	All Sling 4 TSi aircraft, up to (and including) SN 584.
COMPLIANCE TIME:	Next MPI (Mandatory Periodic Inspection) or annual inspection, whichever comes first.
LABOUR TIME:	45 minutes

1. DESCRIPTION AND PURPOSE:

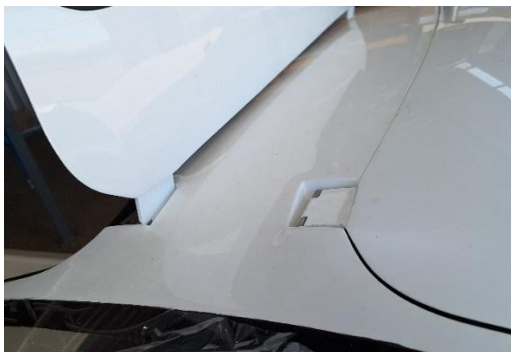
Figure 1: Canopy 1

Canopy 1 has door hinges that are bonded into the door. These hinges get bolted to the canopy, as seen in Figure 1.

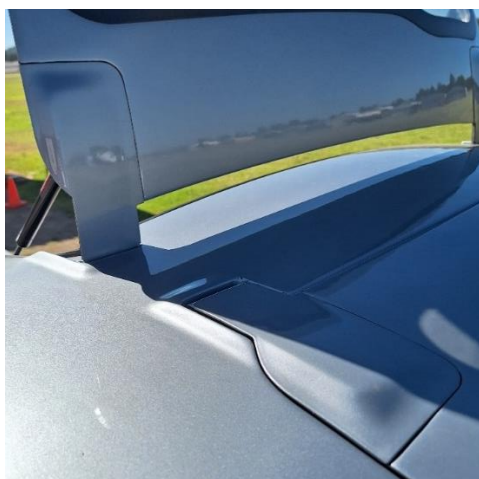
Figure 2: Canopy 2

Canopy 2 has door hinges that are bolted to the door. These hinges also get bolted to the canopy. Once installed the hinges get a composite cover, as seen in Figure 2.

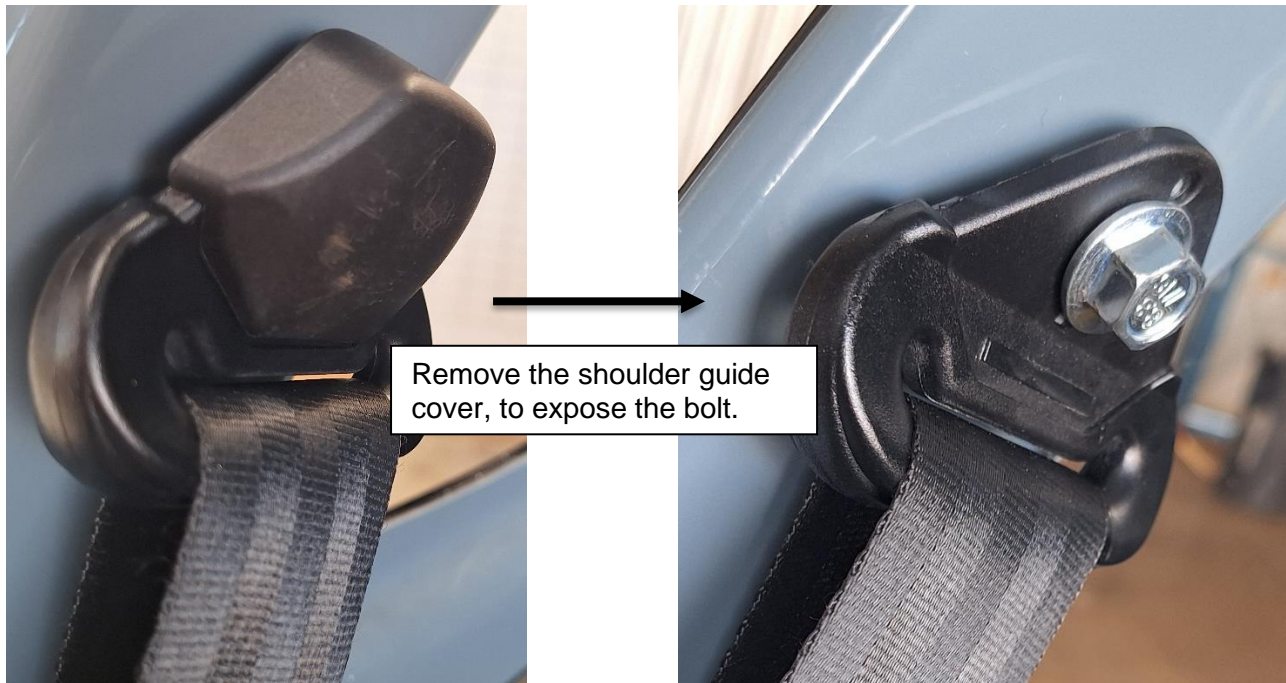
Figure 3: removal of the shoulder guide cover

Step 1: Remove the shoulder guide cover, to expose the bolt.

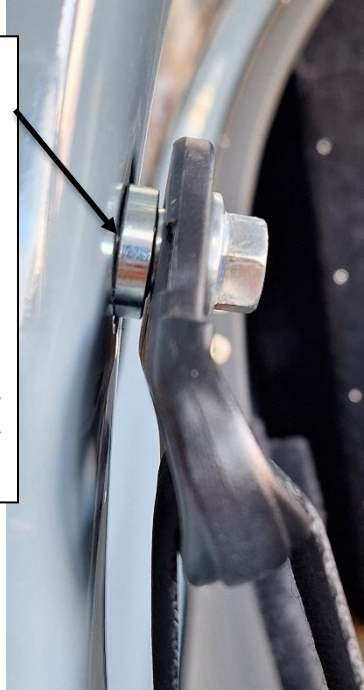
Figure 4: Correct bolt installation.

Step 2: Ensure the bolt and spacer are installed correctly, the spacer should fit flush with the composite canopy. The shoulder of the bolt presses up against the spacer (this can be seen in Figure 4 and when tightened compresses the spacer to the canopy). The correct installation can be seen in Figure 4, the incorrect installation can be seen in Figure 5. If the issues shown in Figure 5 are present in the installation, the bolt may not be screwed in all the way. **Do not** force the bolt into the hole, there may be debris on the nut's thread which need to be removed using a thread tap. This will be explained in Sections 3.3 and 3.4. It is also possible that the dog point of the bolt may be pressing up on the composite behind the nut. The bolts supplied with the service bulletin kits have this tip removed and will not cause interference.

The bolt is fully tightened such that the bottom of the shoulder sits against the spacer, and that the spacer sits flush with and compressed against the canopy inside skin.

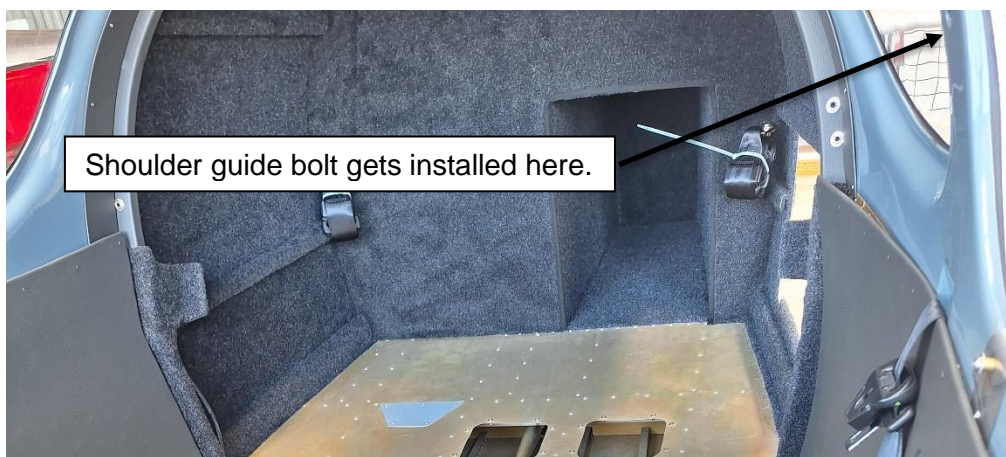
Figure 6: Seatbelt shoulder bolt installation location

- Step 1: Due to the manufacturing process, there is a potential for contaminants to be present on the thread of the hole that the shoulder bolt of the seatbelt screws into. Due to this, the threads need to be inspected, and are to be free and clear of any debris (such as weld splatter, paint, resin etc.). These will be present on both the left- and right-hand side of the cockpit. Figure 6 shows the location of the hole on left side of the cockpit.

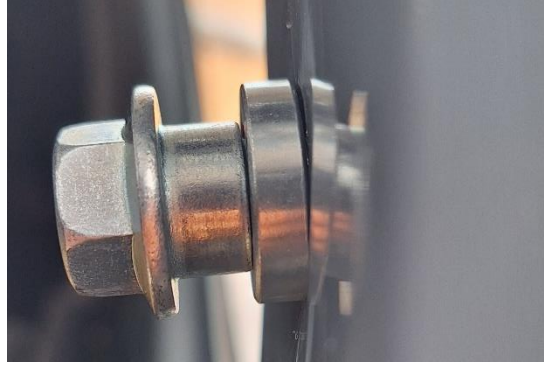
Figure 8: Shoulder bolt and spacer installation.

- Step 2: If there is debris present on the thread of the hole, an M11 tap must be used to clean the threads of the hole.
- Step 3: Once the holes have been tapped, the threads must be reinspected to ensure they are free of debris.
- Step 4: Once the holes are free of debris, install just the shoulder bolt and spacer as depicted in Figure 8.

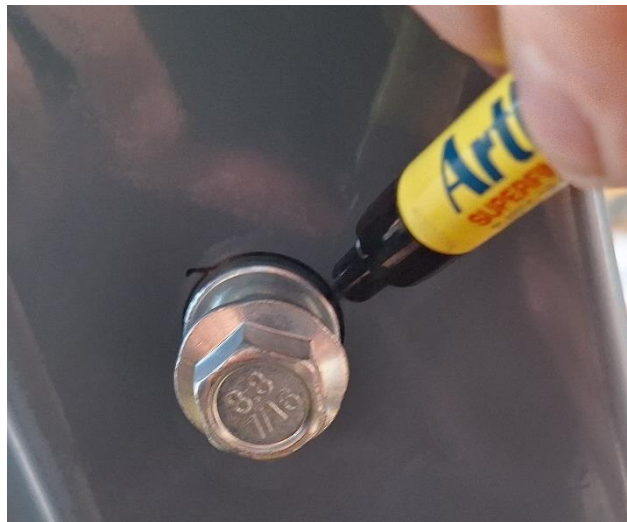
Figure 9

Step 5: After the bolt and spacer have been installed, use a permanent marker and draw a line around the spacer, as seen in Figure 9.

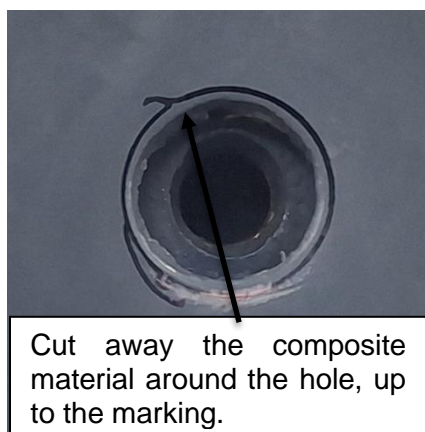
Figure 10

Step 6: Remove the bolt and spacer and use a Dremel or a file to sand away the composite up to the marking, that was made around the spacer. This hole should now be wide enough for the spacer to pass through the composite and sit flush on the mounting plate that is bonded into the canopy.

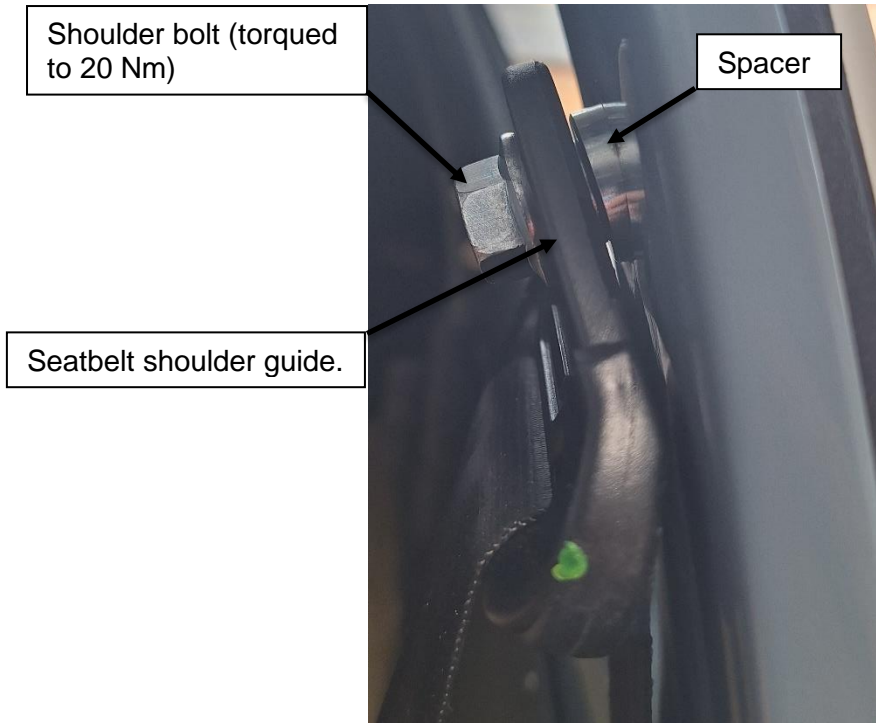
Figure 11: Seatbelt shoulder guide installation

Step 7: Once the cutout has been widened, install the bolt, spacer and shoulder anchor guide of the seatbelt as seen in Figure 11. Ensure that the spacer fits through the cutout and is able to locate on the mounting plate that is bonded into the canopy. Loctite 243, or an equivalent, should be used on the bolt thread to ensure it does not unscrew on its own. Torque the bolt to 20 Nm.

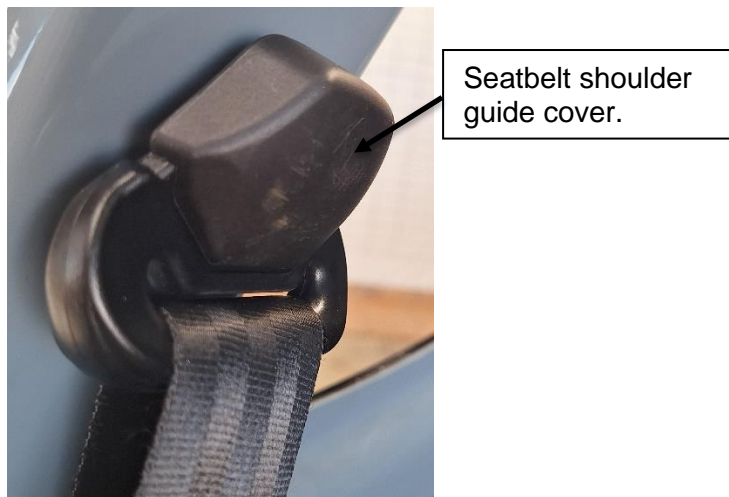
Figure 12: Seatbelt shoulder guide cover

Step 8: Install the seatbelt shoulder guide cover.

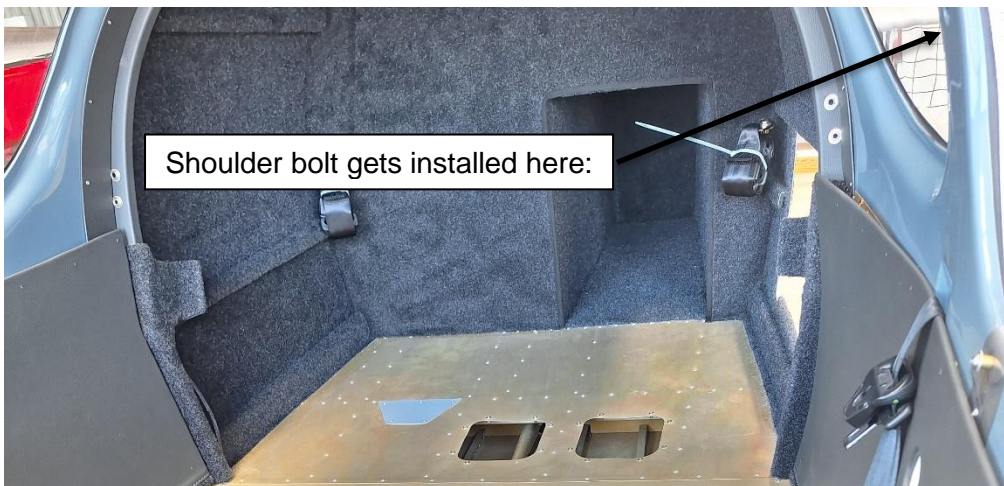
Figure 13: Seatbelt shoulder bolt installation location

- Step 1: Due to the manufacturing process, there is a potential for contaminants to be present on the thread of the hole that the shoulder bolt of the seatbelt screws into. Due to this, the threads need to be inspected, and are to be free and clear of any debris (such as weld splatter, paint, resin etc.). These will be present on both the left- and right-hand side of the cockpit. Figure 13 shows the location of the hole on left side of the cockpit.

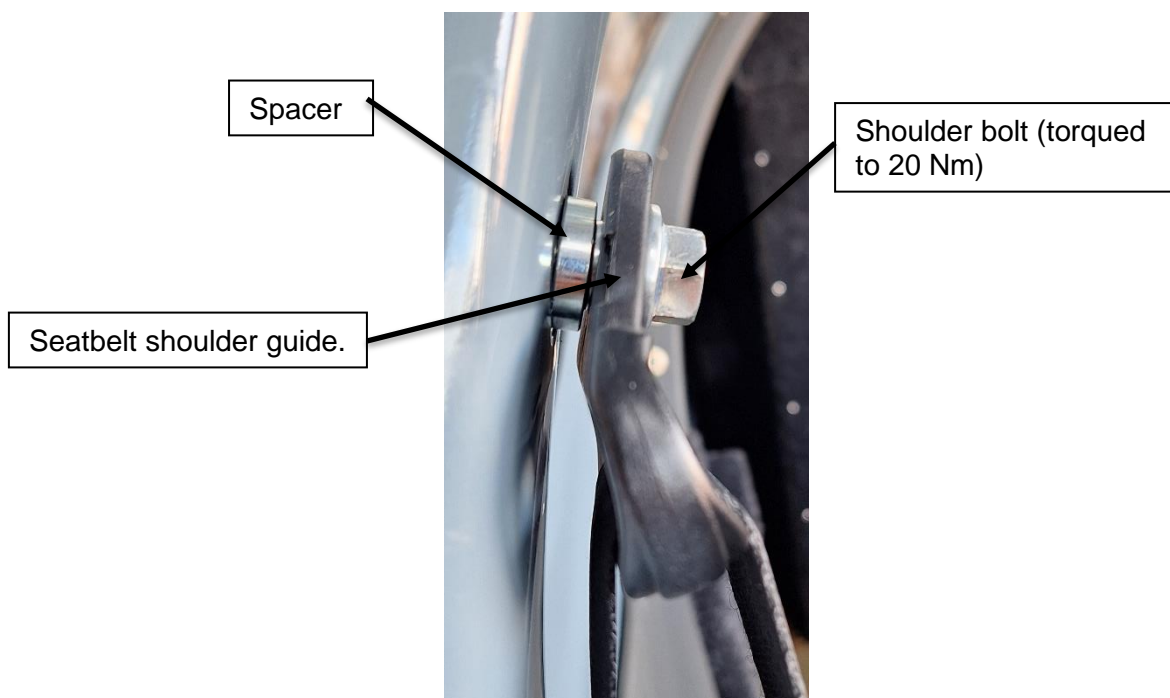
Figure 15: Seatbelt shoulder guide installation

Step 4: Install the bolt, spacer and shoulder anchor guide of the seatbelt as seen in Figure 15. Loctite 243, or an equivalent, should be used on the bolt thread to ensure it does not unscrew on its own. Torque the bolt to 20 Nm.

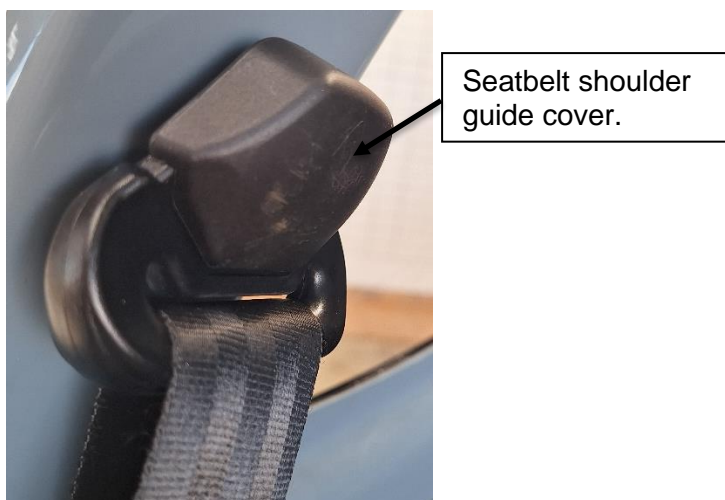
Figure 16: Seatbelt shoulder guide cover

Step 5: Install the seatbelt shoulder guide cover.
