## NOTIFICATION

#0001

**SUBJECT:** MGL OAT probe grounding.

**MODELS AFFECTED:** Sling LSA, Sling 2, Sling Taildragger and Sling 4

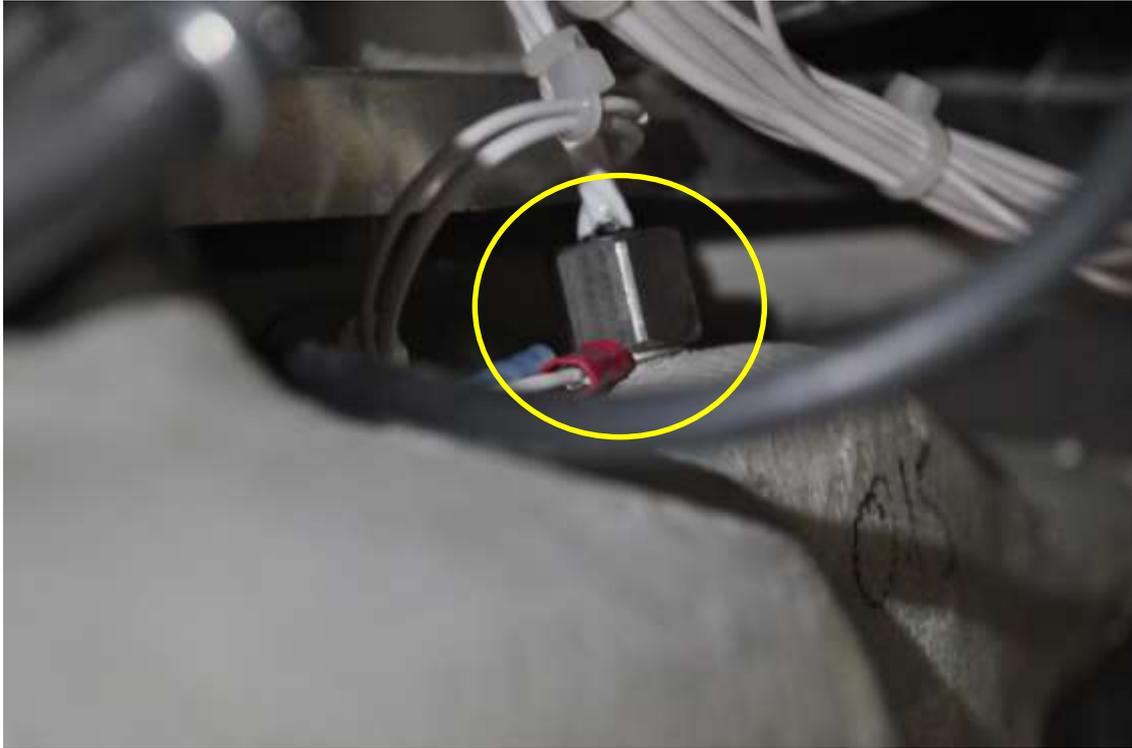
Figure 1: Grounding wire attached to the OAT probe

7. Unscrew the OAT probe so as to slide the 10 mm terminal onto the probe.
8. Tighten the OAT probe to ensure a tight fit.
9. Notification of this service bulletin needs to be sent to the Airplane Factory (Pty) Ltd. Please make use of the following contact details: [Airworthiness@airplanefactory.co.za](mailto:Airworthiness@airplanefactory.co.za)
