SERVICE BULLETIN

#0003

SUBJECT: Amendment to the Sling 2 series annual inspection

MODELS AFFECTED: Sling LSA, Sling 2, Sling 2 Taildragger

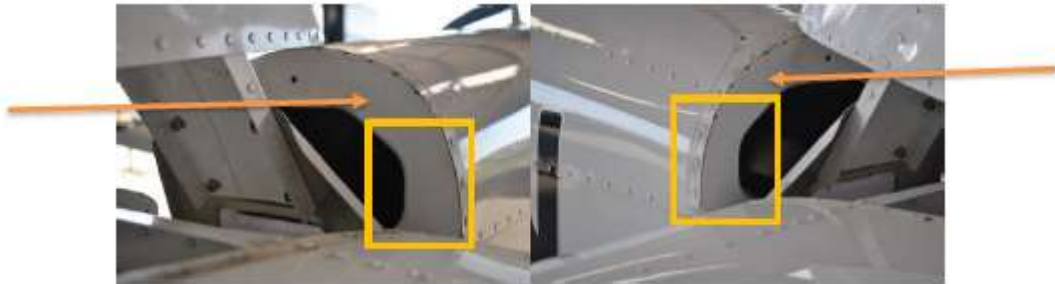
1. With reference to the below pictures, the rib should be replaced at 2000 hours as a mandatory requirement, however it should be inspected annually and be replaced immediately if a crack is noticed, after which the rib must still be inspected annually. Should the rib be satisfactory and without any cracks and corrosion an entry should be made into the logbook that this inspection has taken place and has been found satisfactory.

2. Again with reference to the above pictures, the entire rib needs to be inspected and the areas within the yellow boxes need to be inspected closely and these are the areas where the cracks are most likely to be found.
3. Should the rib fail the inspection for corrosion or cracks being found, the entire rib 601 component will need to be replaced with thicker and stronger material which can be ordered through The Airplane Factory Store.
4. If the rib has failed the inspection the next steps will need to be followed in order to remove and replace the rib.
5. Using the two 3/8" spanners you will need to loosen the two bolts that attach the rudder cables to the rudder. With reference to the below picture, loosen the bolts that are within the yellow circles.

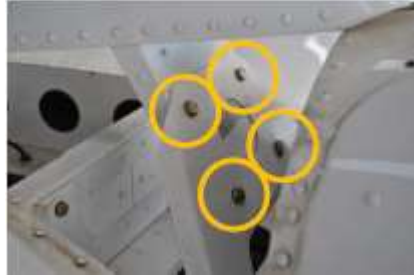
6. Once the two rudder cables have been removed, push the rudder over to either the left or right, this will enable you to loosen the three rudder hinge bolts using 3/8" spanners.
7. Using the two 3/8" spanners, loosen the three rudder hinge bolts so as to remove the rudder from the vertical fin.
8. With reference to the below picture, loosen all four bolts using the two 3/8" spanners.

24. Attach the rudders by means of tightening all 3 bolts through the rudder hinges. These 3 bolts should be torqued to the value of 2.0 – 2.7 NM or 1.475 – 1.991 ft.lb and torque seal applied to all 3 bolts.
