**THE AIRPLANE FACTORY (Pty) Ltd**, Registration no 2002/022837/07  
Hangar 8 Tedderfield Airpark, Nettleton Road, Eikenhof, 1872, Johannesburg South  
PO Box 308, Eikenhof, 1872, South Africa. Tel: +27 (0) 11 948 9898 Fax: +27 (0) 86 632 4493  
E-mail: sales@airplanefactory.co.za Web: www.airplanefactory.co.za  
Approved Maintenance Organisation AMO1264 Manufacturing Organisation - M677

**SERVICE BULLETIN**

**#0013**

**SUBJECT:** Rudder Pedal Stop Replacement

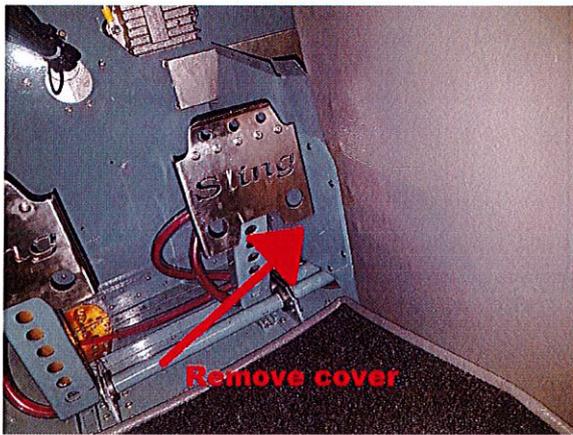
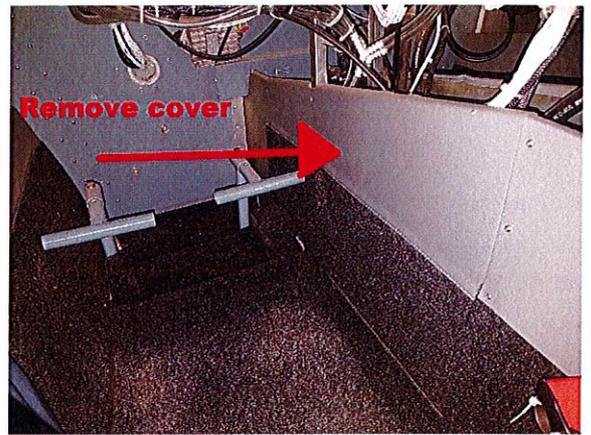
Figure 1 – Illustrates the covers to be removed

Sling LSA and Sling 2

Sling 4

3. Remove inspection covers on both right-hand and left-hand side granting access to the rudder pedal stops using 2mm Allen key. (Figure 1)
4. Remove the pushrods from the nose wheel only by detaching the AN5 bolt with the 1/2" spanner/ratchet respectively (Shown in Figure 2).

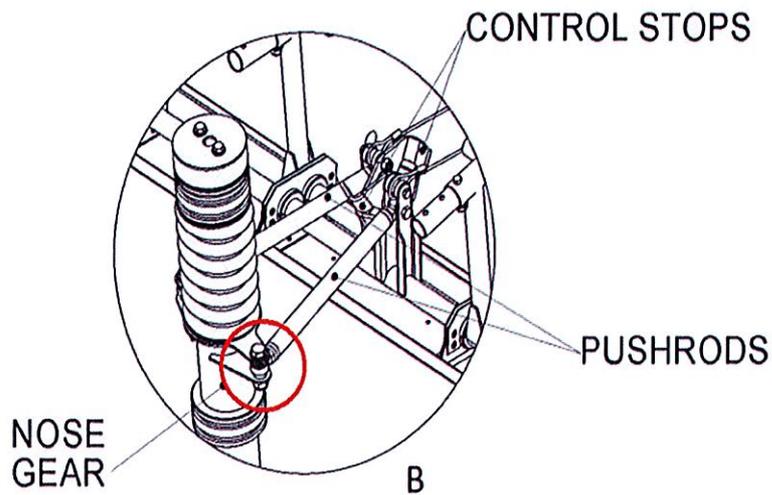
Figure 2 – Illustrates the AN5 bolt to be removed, disconnecting the pushrod. No adjustments should be made to the pushrod and/or eyebolt.

13. Reinstall the pushrods using the AN5 bolt and tighten using a 1/2" spanner/ratchet respectively.
14. Ensure satisfactory rudder cable stop movement by turning the wheel to either side and observe clearance of each stop and ensure the two stops interlock at the end of their travel.
