SERVICE BULLETIN

#0012

SUBJECT: Potential risk of failure when attempting to activate the parachute rocket due to incorrect installation of rocket activation cable.

MODELS AFFECTED: Sling LSA, Sling 2, Sling 2 Taildragger and Sling 4.

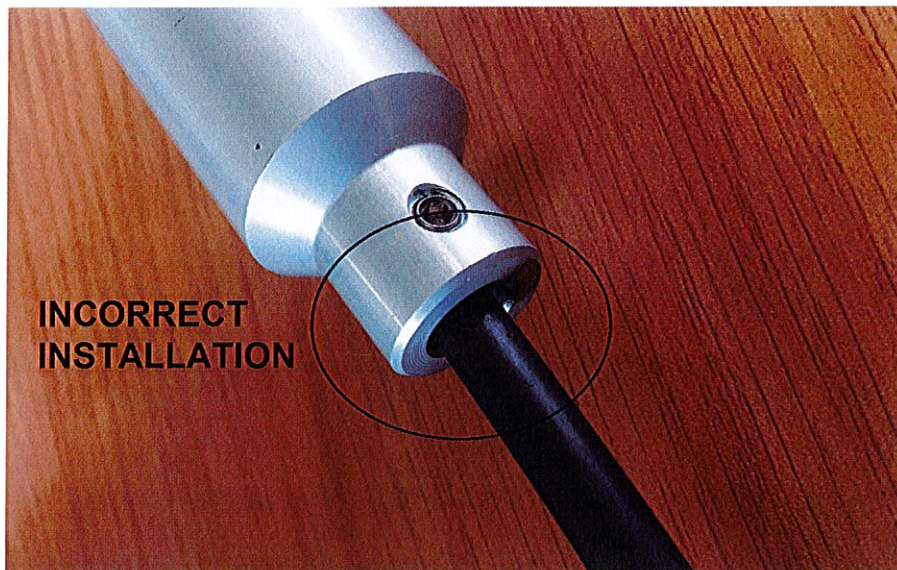
Figure 1 shows no steel end piece protruding and indicates an incorrect installation.

4. Check that the activation cable steel end piece protrudes beyond the rocket base by 1 – 2mm.
5. If no part of the steel end piece is visible, then undo the grub screw using the 2.5mm allen key and slide the cable outwards until it clearly stops in position.

6. Very carefully put a small drop of Loctite onto the screw threads and firmly retighten the grub screw.
7. Slide the heatshrink back into place.
8. Set up your 0.4mm shim stock to look like figure 4.

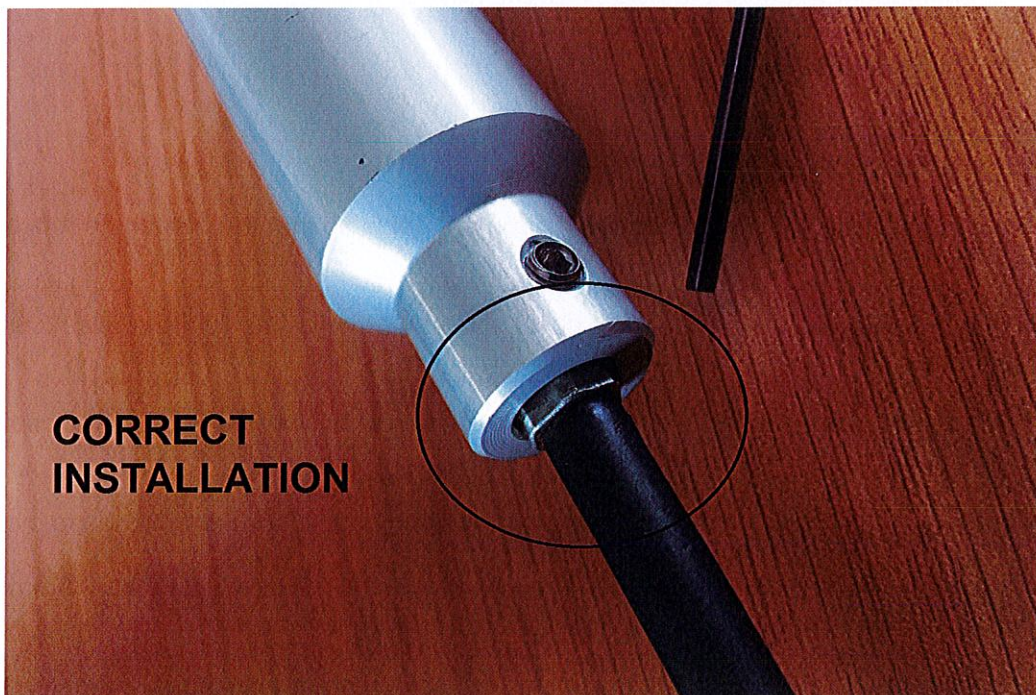
Figure 2 shows the steel end piece protruding out of the rocket base and indicates a correct installation.
