## SERVICE ALERT

#0012 Revision 1

**SUBJECT:** Sub-standard high pressure rubber fuel hose rupturing between high pressure pumps and engine fuel rail.

**MODELS AFFECTED:** All Rotax 912 iS, 915 iS and 916 iS fitted Sling ready to fly aircraft and kits ex-factory after 1 January 2023.

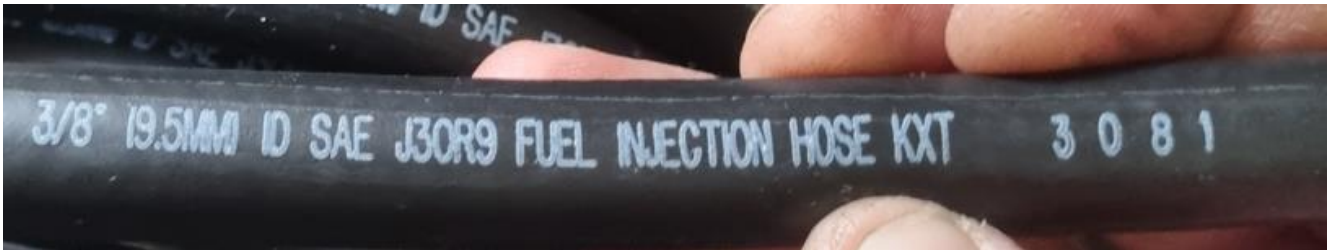
The fuel hose that is affected (ie – is of the defective type) can be identified by the white lettering printed on the hose that looks like the below. Note the stamped lettering with sharp white edges, not a uniform colour, and the absence of the word “Continental”:

Figure 1: **Sub-standard** fuel hose - stamped lettering

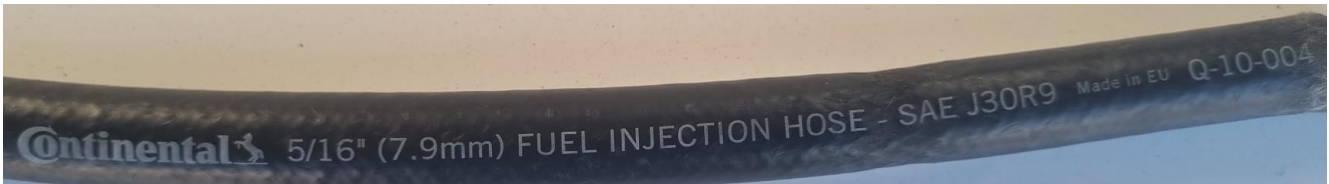
The correct fuel hose branding is printed in a uniform manner and looks like the below. Note the even coloured lettering that is printed on and includes the trademarked “Continental” branding:

Figure 2: **Correct** fuel hose - printed and branded lettering

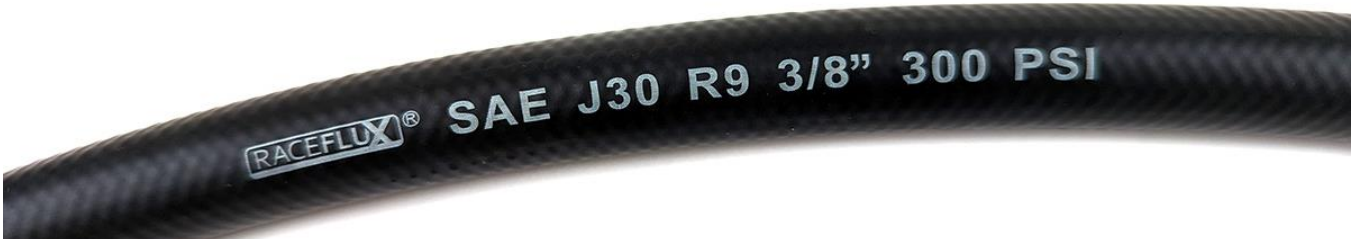
There is an alternative fuel hose brand that may be installed in place of continental fuel hose. This fuel hose is from a manufacturer known as RaceFlux, as seen in Figure 3.

Figure 3: Alternative approved fuel hose – RaceFlux

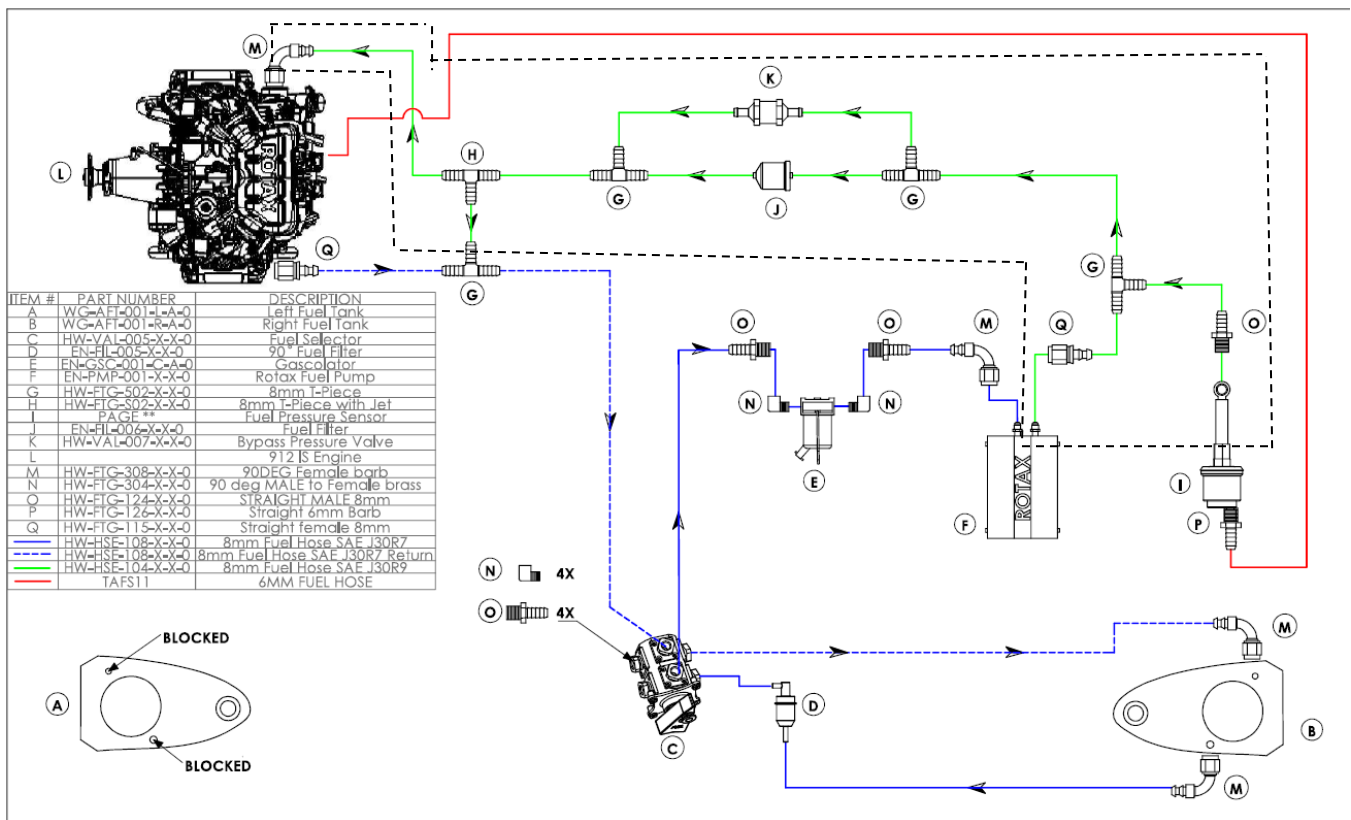
There are two fuel system configurations applicable to the Sling 2 and Sling LSA. These can be seen in Figure 4 and Figure 5.

With reference to Figure 4 and Figure 5, all the fuel lines bounded within the dashed line “----” must be inspected and replaced should they be of the sub-standard type of fuel hose. It must be replaced with the correct fuel hose as described in Section 2.

Figure 4: 912 iS Fuel System Diagram

- Step 1: In order to inspect the fuel lines shown in the diagrams above, remove the cowling. Refer to Section 5.1.1 of the Sling 2 & LSA Maintenance Manual for the instructions to remove the cowling.
- Step 2: The heat sleeve around the fuel hose will be fixed in place using either locking wire or metal cable ties. Once the cowling has been removed, used the side cutters to remove these so that the heat sleeve can be moved to inspect the hose underneath. Refer to Figure 6 for an example of how the heat sleeve is attached using the cable ties. Please note, Figure 6 is just for reference purposes, all the fuel lines (as shown in Figure 4 and Figure 5.) must be checked.

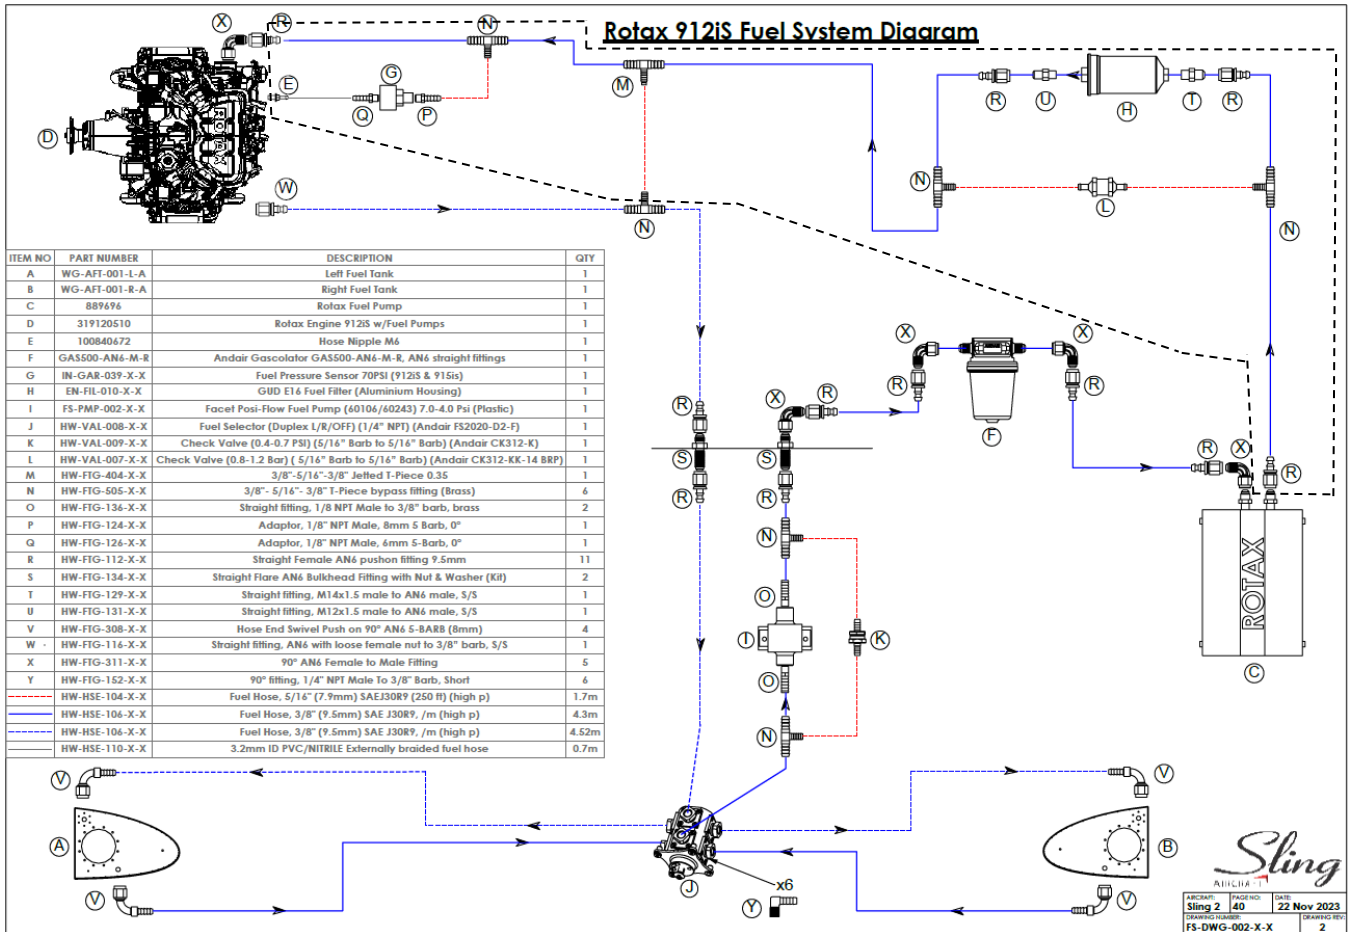
Figure 5: 912 iS Fuel System Diagram

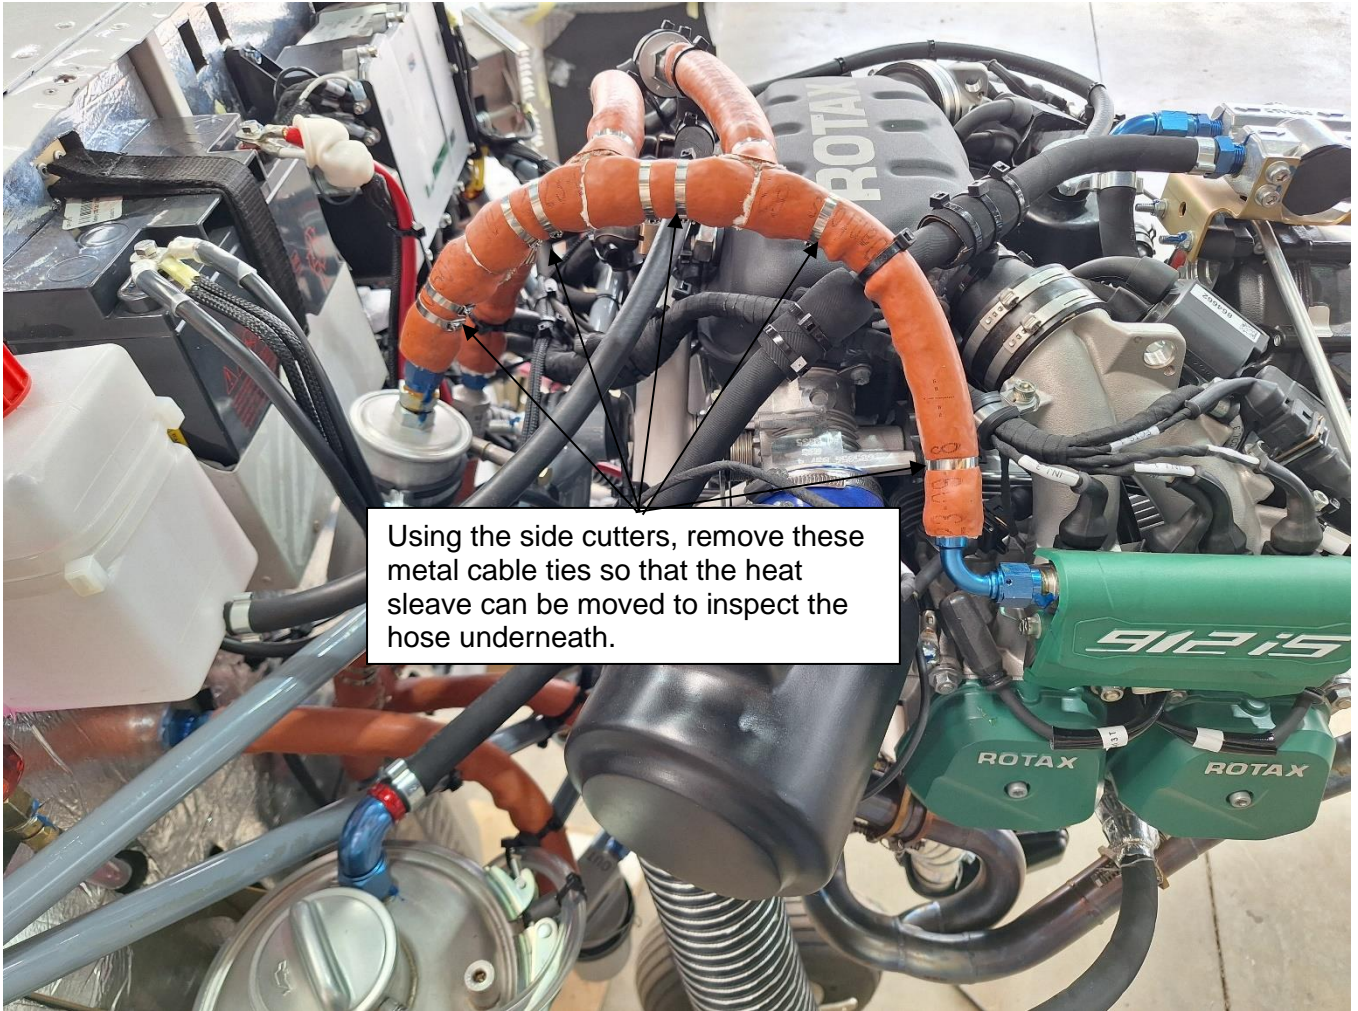
Figure 6: Example of cable ties to be removed.

- Step 3: If it is found that the hose is of the sub-standard fuel hose type, it must be replaced with the correct fuel hose. Using the Oetiker clamp pliers, remove the Oetiker ear clamps (OET ear clamps) retaining the hose onto the hose end fittings.
- Step 4: In order to replace the fuel hose, cut the fuel hose to the correct length. Place the heat sleeve over the hose. Place the OET ear clamps onto the hose ends. Fit the hose ends to the respective fittings and then crimp the OET ear clamps.
- Step 5: Use locking wire or metal cable ties to secure the heat sleeve in place.
- Step 6: Add standoffs as needed.
- Step 7: If more detail is required on how to install the fuel lines and heat sleeve, refer to the firewall forward KAI for the Sling 2 and Sling LSA.

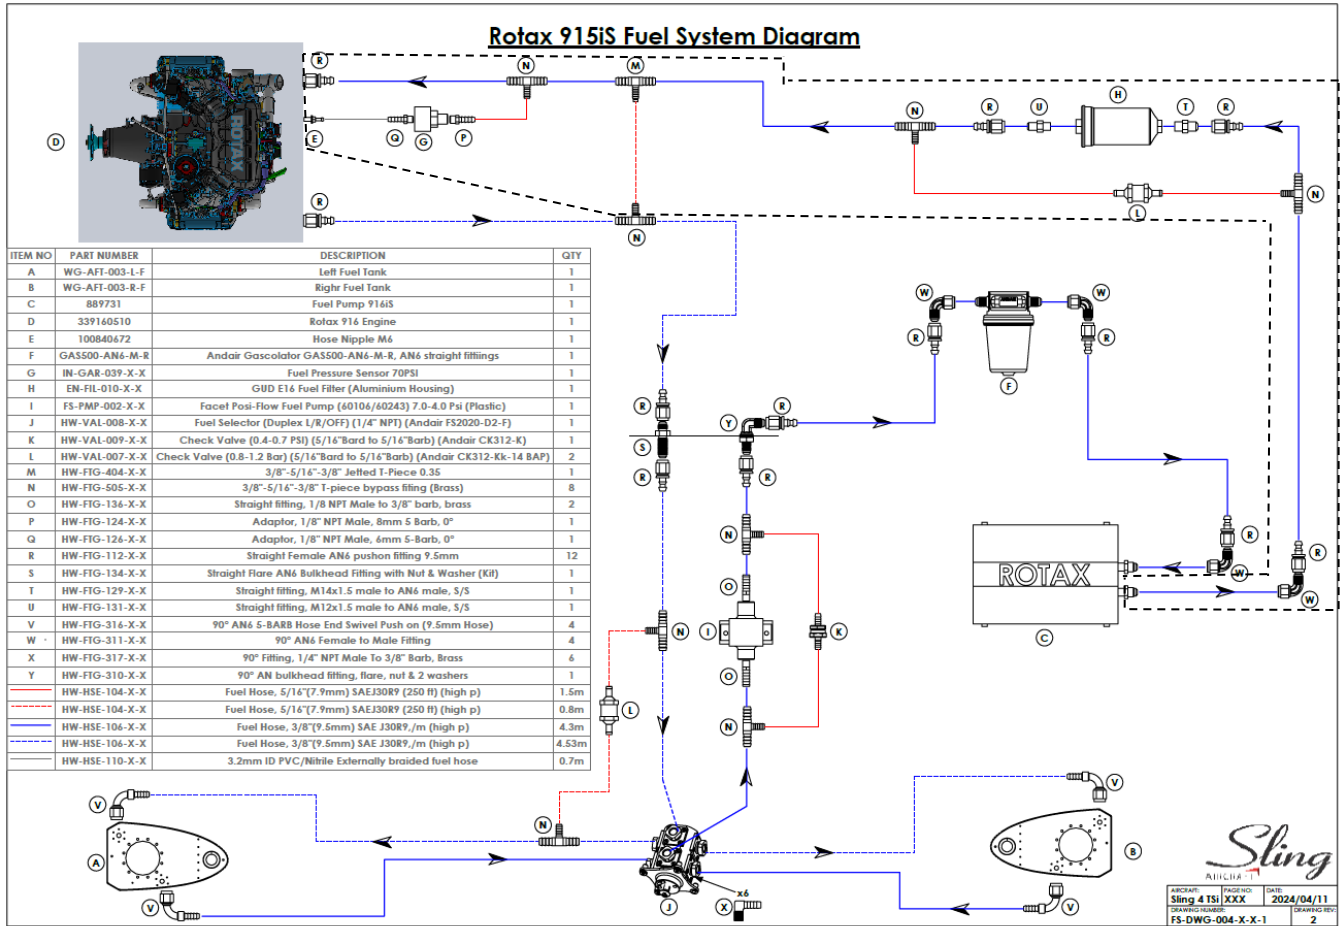
With reference to Figure 7, all the fuel lines bounded within the dashed line “----” must be inspected and replaced should they be of the sub-standard type of fuel hose. It must be replaced with the correct fuel hose as described in Section 2.

Figure 7: 915 iS Fuel System Diagram

- Step 1: In order to inspect the fuel lines shown in the diagram above, remove the cowling. Refer to Section 5.1.1 of the Sling 4 TSi Maintenance Manual for the instructions to remove the cowling.
- Step 2: The heat sleeve around the fuel hose will be secured in place using either locking wire or metal cable ties. Once the cowling has been removed, used the side cutters to remove these so that the heat sleeve can be moved to inspect the hose underneath. Refer to Figure 8 for an example of how the heat sleeve is attached using the cable ties. Please note, Figure 8 is just for reference purposes, all the fuel lines (as shown in Figure 7) must be checked.

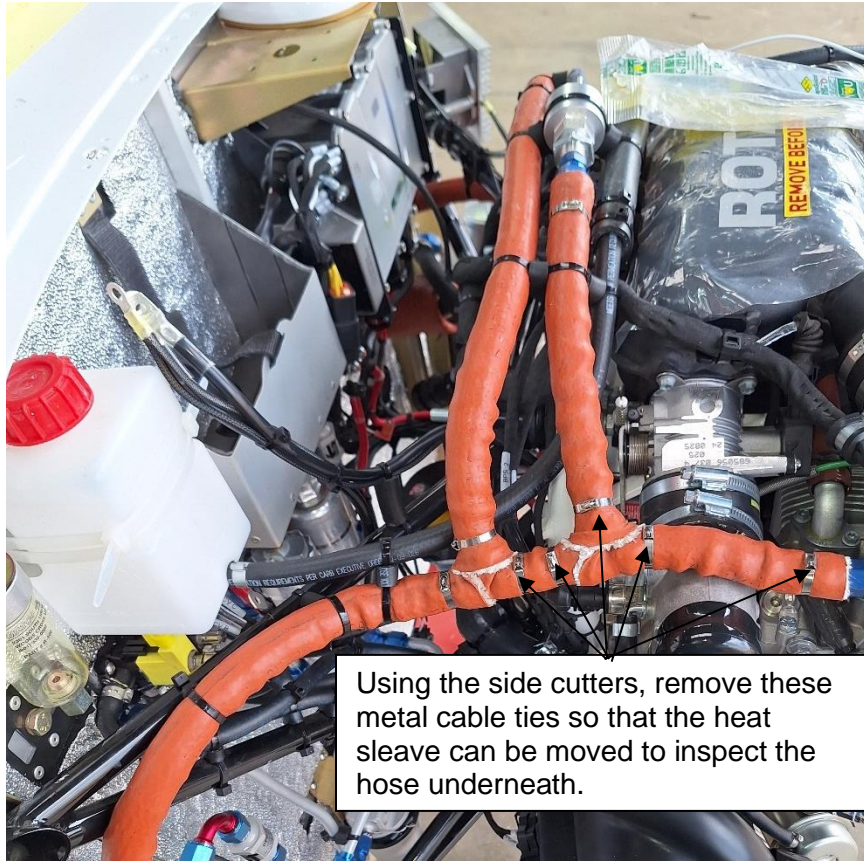
Figure 8: Example of cable ties to be removed.

- Step 3: If it is found that the hose is of the sub-standard fuel hose type, it must be replaced with the correct fuel hose. Using the Oetiker clamp pliers, remove the Oetiker ear clamps (OET ear clamps) retaining the hose onto the hose end fittings.
- Step 4: In order to replace the fuel hose, cut the fuel hose to the correct length. Place the heat sleeve over the hose. Place the OET ear clamps onto the hose ends. Fit the hose ends to the respective fittings and then crimp the OET ear clamps.
- Step 5: Use locking wire or metal cable ties to secure the heat sleeve in place.
- Step 6: Add standoffs as needed.
- Step 7: If more detail is required on how to install the fuel lines and heat sleeve, refer to the firewall forward KAI for the Sling 4 TSi

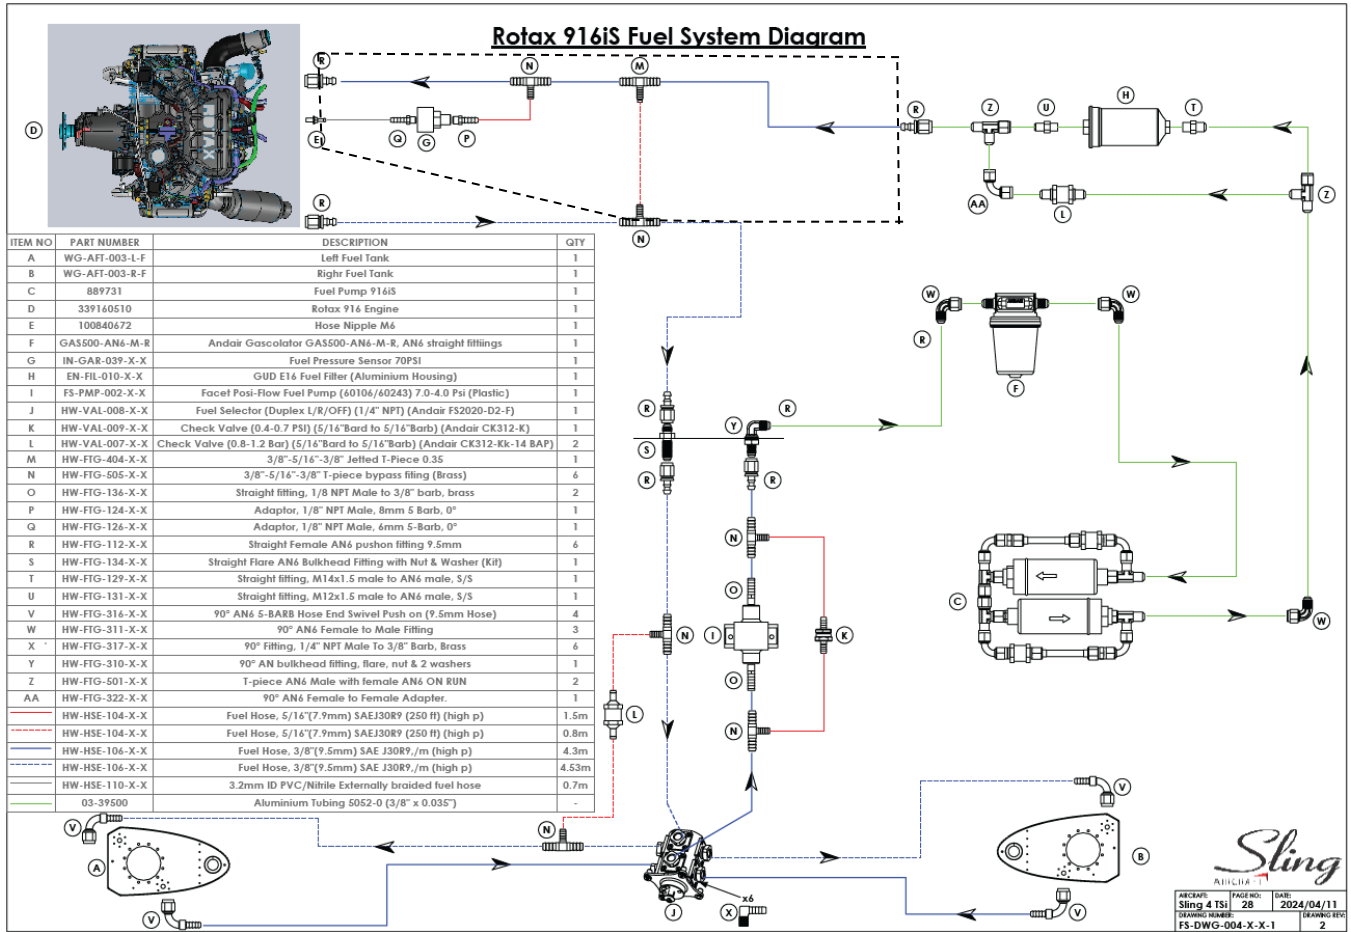
With reference to Figure 7, all the fuel lines bounded within the dashed line "----" must be inspected and replaced should they be of the sub-standard type of fuel hose. It must be replaced with the correct fuel hose as described in Section 2.

Figure 9: 916 iS Fuel System Diagram

- Step 1: In order to inspect the fuel lines shown in the diagram above, remove the cowling. Refer to Section 5.1.1 of the Sling 4 TSi Maintenance Manual or the Sling 4 High Wing Maintenance Manual (where applicable) for the instructions to remove the cowling.
- Step 2: The heat sleeve around the fuel hose will be secured in place using either locking wire or metal cable ties. Once the cowling has been removed, used the side cutters to remove these so that the heat sleeve can be moved to inspect the hose underneath. Refer to Figure 8 for an example of how the heat sleeve is attached using the cable ties.

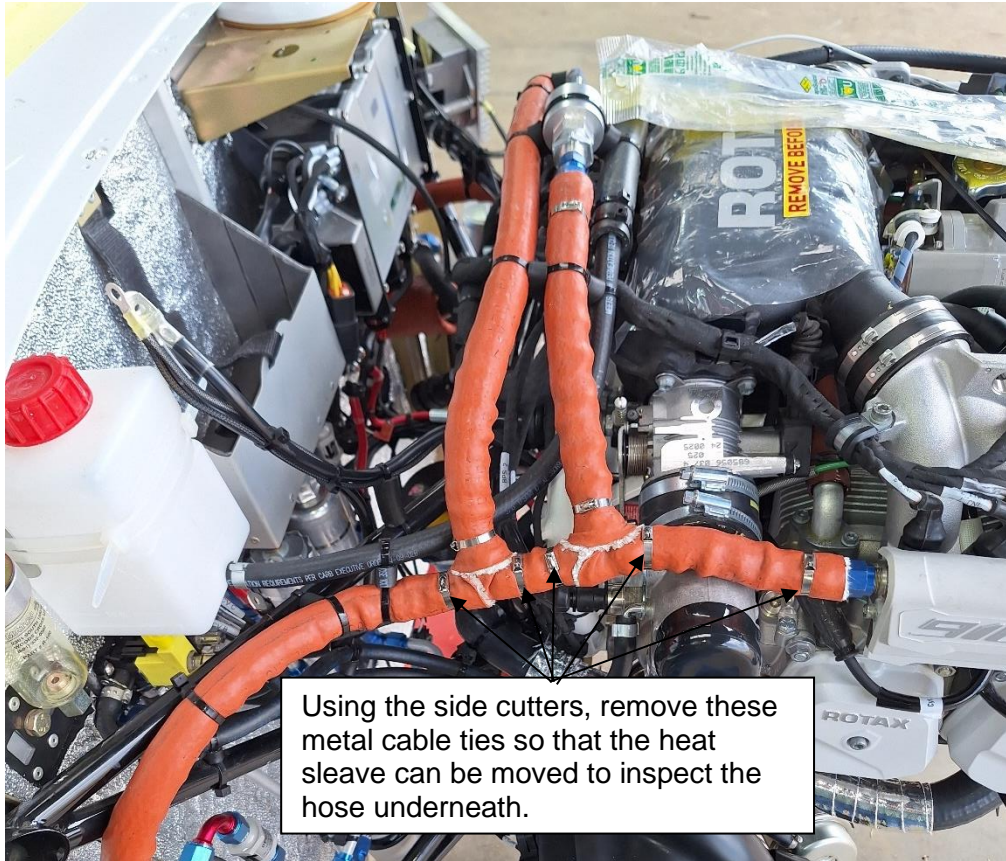
Figure 10: Example of cable ties to be removed.

- Step 3: If it is found that the hose is of the sub-standard fuel hose type, it must be replaced with the correct fuel hose. Using the Oetiker clamp pliers, remove the Oetiker ear clamps (OET ear clamps) retaining the hose onto the hose end fittings.
- Step 4: In order to replace the fuel hose, cut the fuel hose to the correct length. Place the heat sleeve over the hose. Place the OET ear clamps onto the hose ends. Fit the hose ends to the respective fittings and then crimp the OET ear clamps.
- Step 5: Use locking wire or metal cable ties to secure the heat sleeve in place.
- Step 6: Add standoffs as needed.
- Step 7: If more detail is required on how to install the fuel lines and heat sleeve, refer to the firewall forward KAI for the Sling 4 TSi or the Sling 4 High Wing, where applicable.
