# SERVICE BULLETIN

#0001

SUBJECT: Longitudinal cracks appearing in the main landing gear.

MODELS AFFECTED: Sling LSA, Sling 2, Sling Taildragger, Sling 4

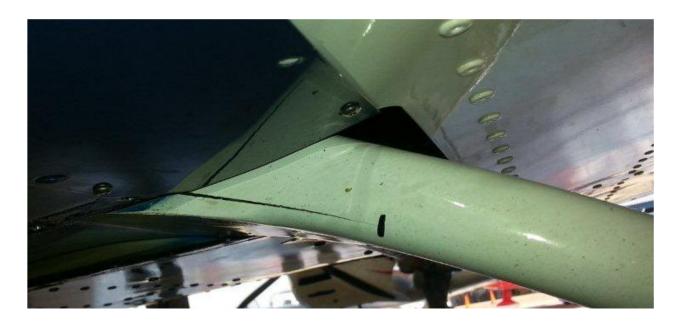
If the gear does crack as a consequence of the shortcoming identified, it will not break but may result in the gear bending slightly more than usual. This could result in the aircraft sagging to one side slightly. The increased risk of cracking is not considered to constitute a significant safety risk. Visually inspect the landing gear

See the photograph below for an indication of what to look for.

PURPOSE: A limited number of the main landing gear legs manufactured between the 1<sup>st</sup>

August 2013 and the 7<sup>th</sup> April 2014 have a slight deviation in the layup of the glass fibre which could result in longitudinal cracking of the outer section of the gear legs. Where such cracking is identified the gear leg must be replaced immediately

COMPLIANCE TIME: No compliance time is imposed. The main gear leg must be replaced immediately if

and when a crack should be detected.

Replace the cracked landing gear by doing the following:

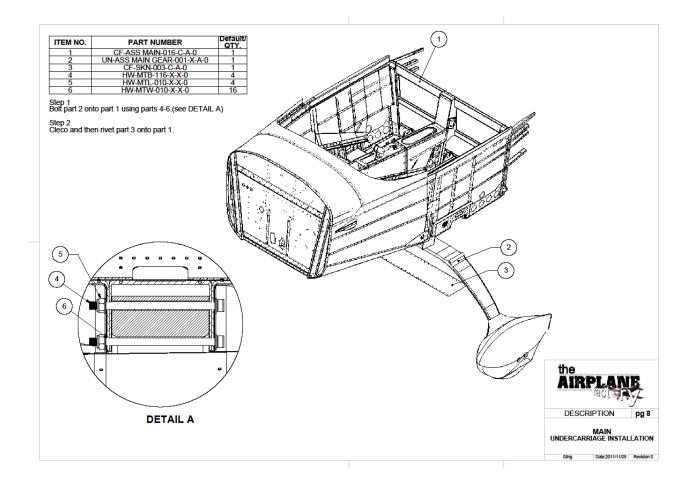
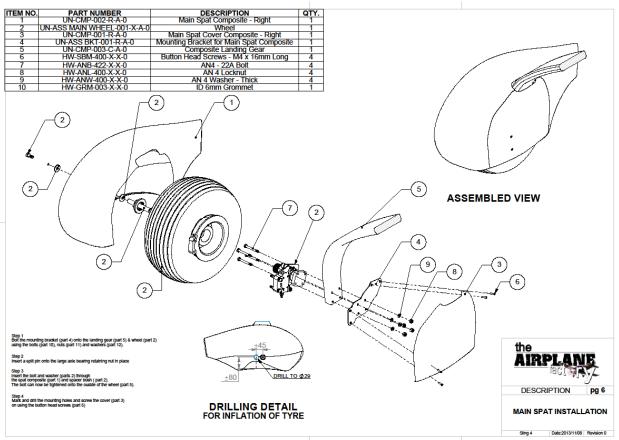
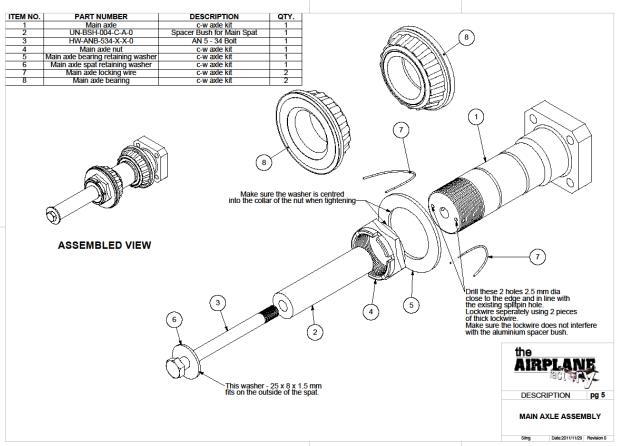
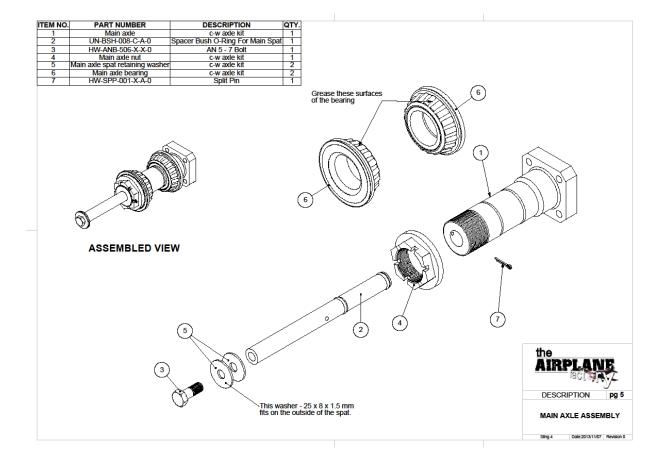
- Remove the wheel spats, wheels and axles from the main gear see the drawings attached.
- 8. Do not remove the brake pipe from the calipers just pull the brake pipe out of the groove in the gear.

- 15. Refit the axles, wheels and brakes in the opposite sequence to how they were removed. Make sure the bearings have ample grease on them before assembly. Use new locknuts and torque the AN4 axle mount bolts to 9 Nm (7 ft lbs).

- 16. To tighten the large black axle nut place a little grease on the seal and then tighten the nut until it is properly finger (hand) tight (check this) and then TIGHTEN it further until the split pin (cotter pin) holes line up for insertion of the split pin or the locking wire.
